NIST NCSTAR 2: Vol. I

# Report of the Technical Investigation of The Station Nightclub Fire

# **Report of the Technical Investigation of The Station Nightclub Fire**

June 2005

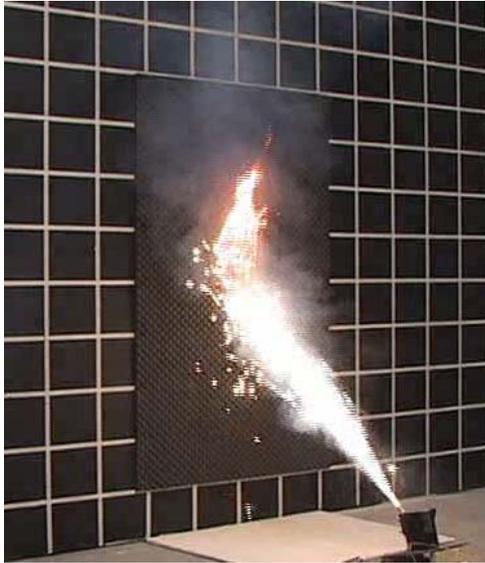
The hazard associated with the building contents was created by the close proximity of a high temperature source (a pyrotechnic device) and a substantial amount of material with a relatively low ignition energy and high flame spread rate (polyurethane foam). As could be seen in the WPRI video, flames spread rapidly over the foam, generating smoke and enough heat to ignite the wood paneling underneath and adjacent to the foam. The wood structure and paneling in the nightclub was estimated to contain over 95 percent of the fuel load, so that once most of the foam was consumed, the fire transitioned to a wood frame building fire.

**Pyrotechnic device impinging on non-fire retarded polyurethane foam panel**

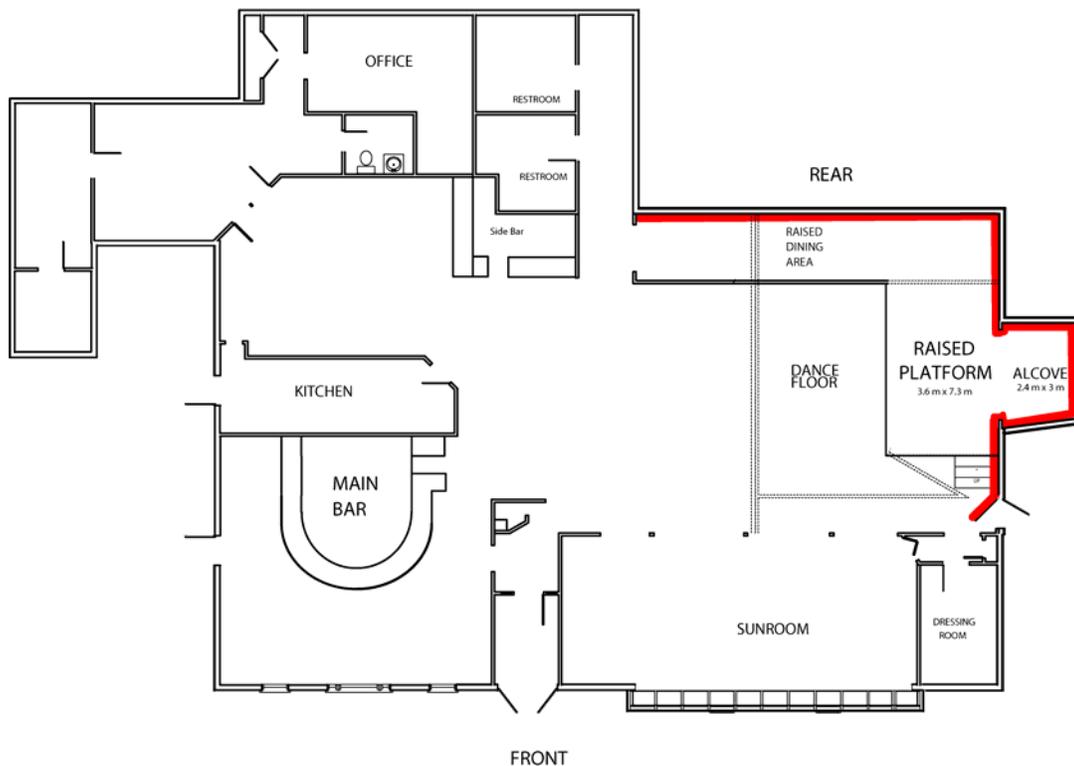
The photographs of the nightclub interior do clearly show gaps where two sheets of foam meet. Gaps between the foam and the wall can also be observed at various locations, typically at external corners of the alcove. While the gray color of the foam can be observed in some photos of various bands that had performed at The Station, later photos show a darker color, indicating that the foam may have been sprayed with a black paint. The surface of the foam also had a glittery appearance that may have been a result of the wet paint being dusted with glitter or sparkle dust. Some of the glitter would have become partially embedded in the wet paint and would have provided the more sparkling appearance that was observed in some of the video of the nightclub interior.

**Figure 4-1. Portion of Nightclub with Polyurethane Foam Mounted on Wall (shaded red section).**

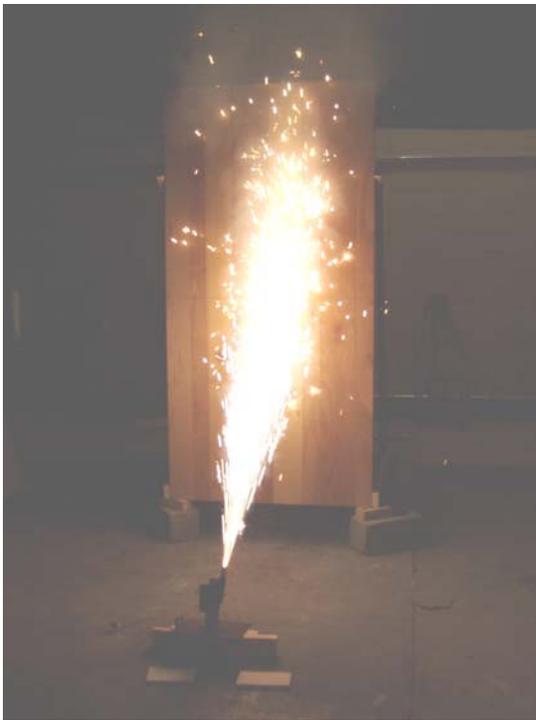
Figure 4-14a shows the sparks from the gerb impinging on the wood panel about half way through the test. No ignition was observed. The hot sparks did create small black marks and craters in the finish of the panel, as can be seen in Figure 4-14b.

Figure 4-14a. Gerb impinging on wood panel.

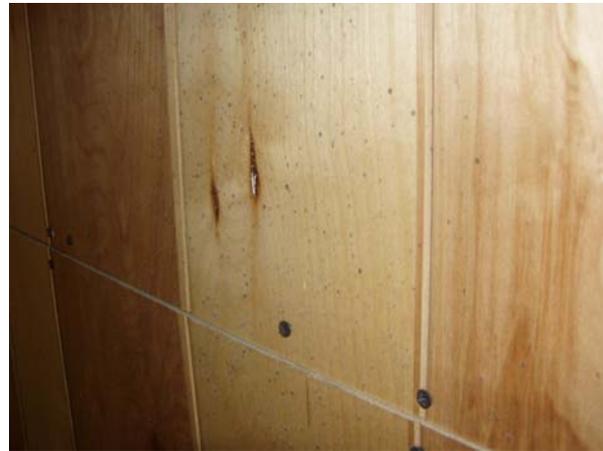
Figure 4-14b. Damage to wood panel following impingement by sparks from gerb. Lip on panel surface can be seen as line below mounting screws.

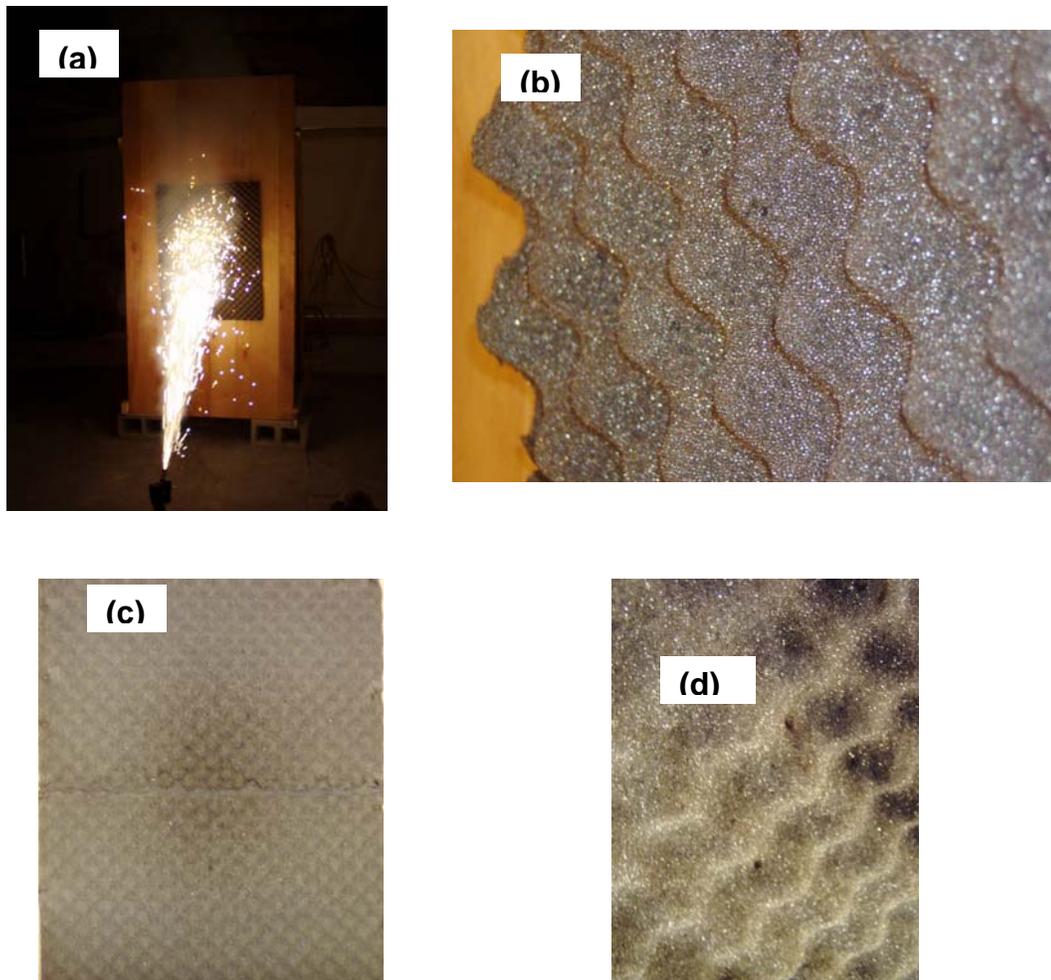
The experiment was repeated with a new piece of foam. The lower piece of foam overlapped the upper piece of foam, creating a small ledge as shown in Figure 4-15c. The positioning of the gerb was the same. The results were similar to the previous experiment; i.e., no ignition, just minor scorching and small holes in the foam from some of the sparks (see Figures 4-15c and 4-15d). The temperatures in the plume as a function of time are plotted in Appendix F, Figs. F-24 and F-25.

**Figure 4-15. Gerb impinging fire retardant polyurethane foam (a); evidence of pitting (b); horizontal ledge at mid-plane to catch sparks, and evidence of scorching in second sample (c); and close-up of scorched area (d).**

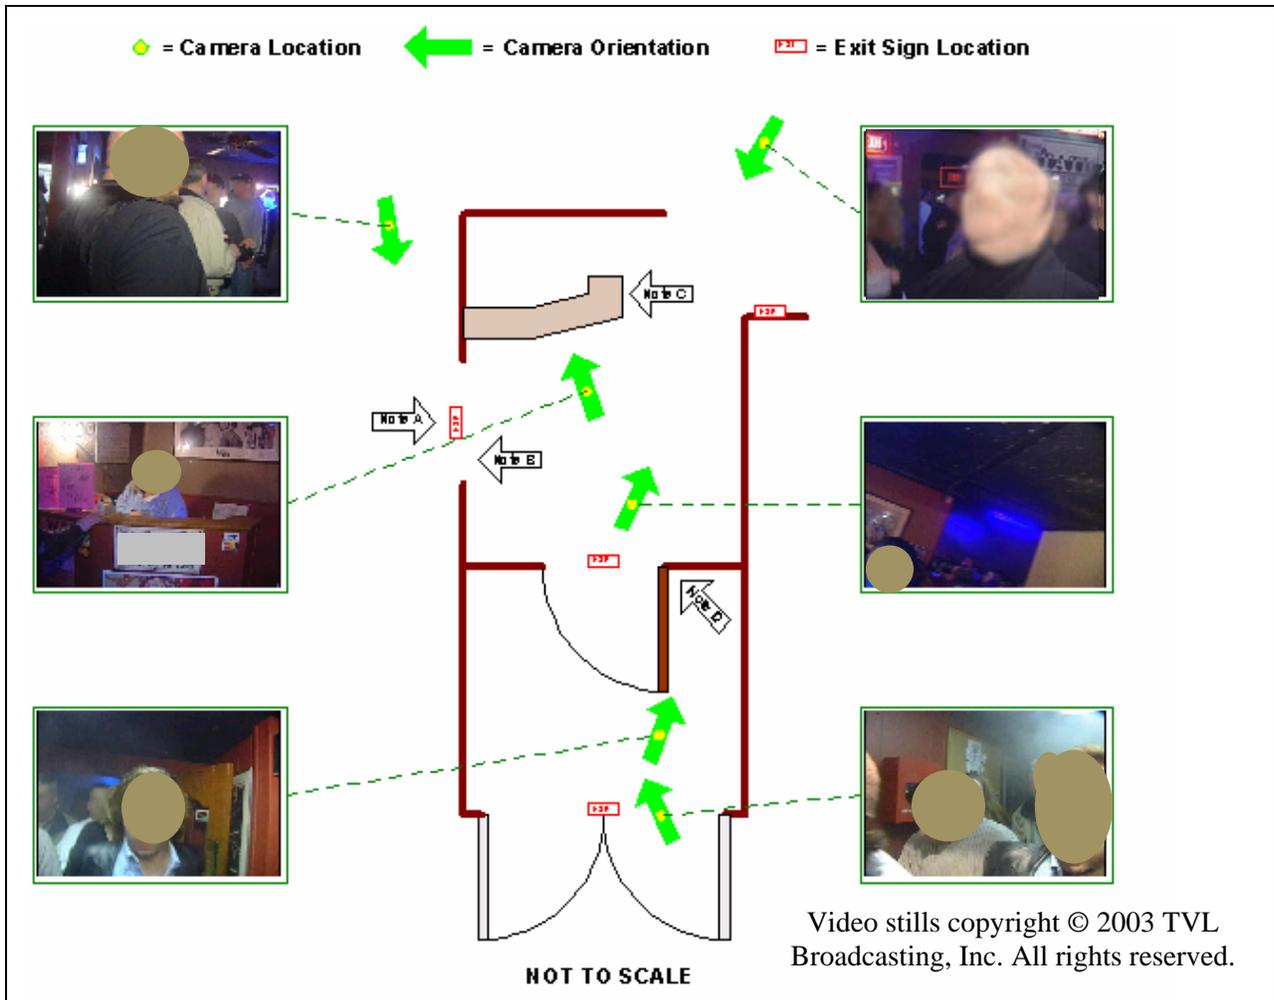
The precise event which led to the crowd-crush likely was related to the arrangement of the single interior door with merging streams of traffic and the pressure to escape the rapidly deteriorating conditions in the main area of the nightclub. Measurements of temperature, heat flux and gas species in a reconstruction of the platform area fire at NIST and computer models of the NIST experiment and the full nightclub suggest that the conditions around the platform, dance floor, sunroom, and dart room would have led to severe incapacitation or death within about 1-1/2 minutes after ignition of the foam for anyone remaining standing, and for not much longer even for those occupants close to the floor.

**Figure 6-12. Detail of Main Exit Vestibule Area (Video frames copyright © 2003 TVL Broadcasting, Inc. All rights reserved)**

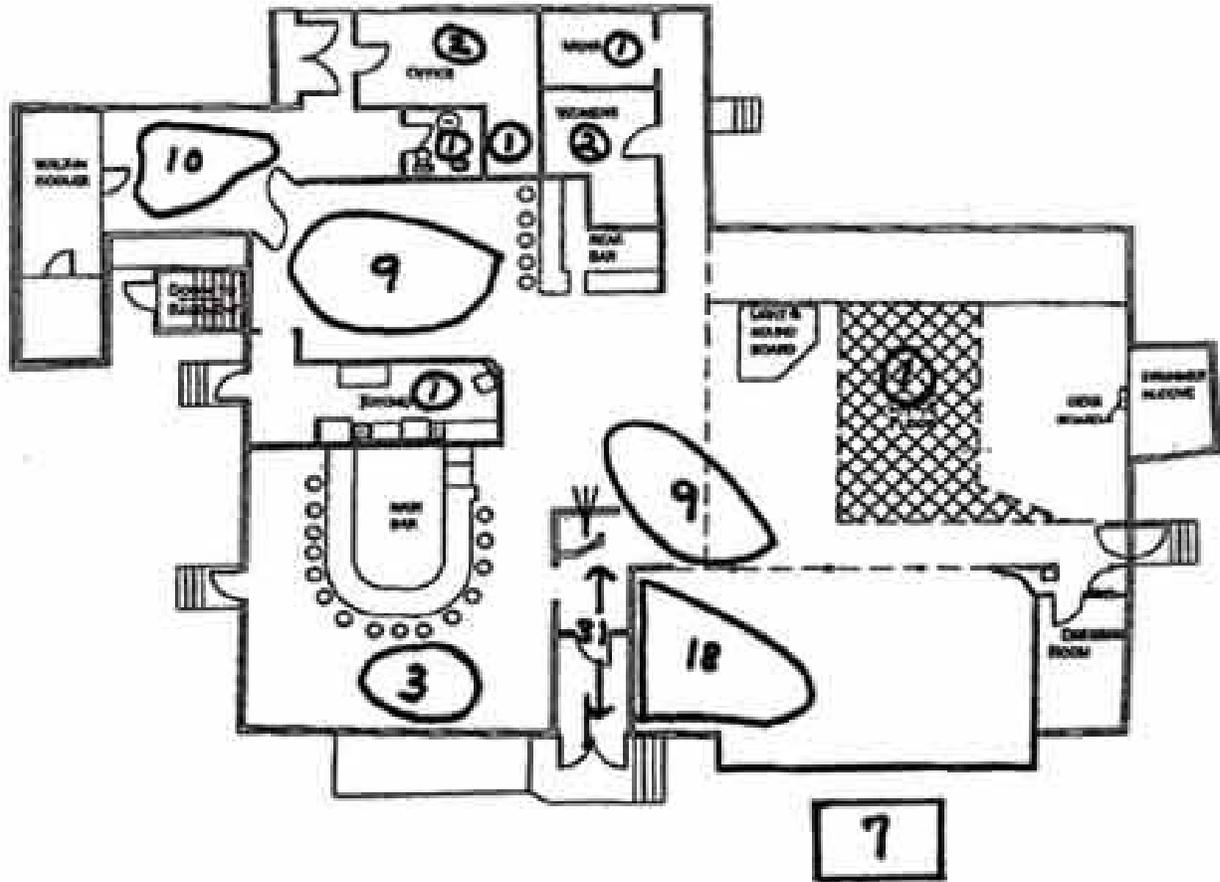
**Figure 6-14. Location of Recovered People Who Died at Scene [36]**
