NIST NCSTAR 2: Vol. I

# Report of the Technical Investigation of The Station Nightclub Fire

# **Report of the Technical Investigation of The Station Nightclub Fire**

June 2005

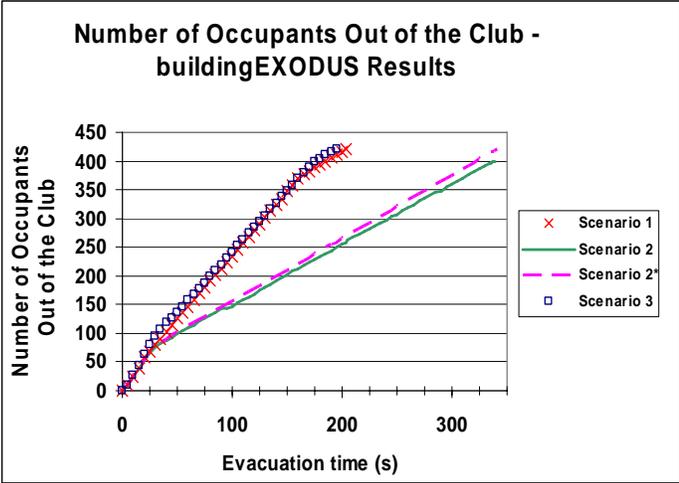
The inability of the exits to handle all of the occupants in the short time available for this fast growing fire contributed directly to the large loss of life. The number of building occupants at the time of the fire was reported by the news media to range from 440 to 458; the occupant limit for a building similar to The Station nightclub would be around 420 persons according to the 2003 model codes. Three emergency exits were available: the front main entrance on the north (limited by the single door into the vestibule), the single door on the west near the performance platform, and the single door on the east side of the main bar. A fourth door in the kitchen was not considered accessible to the patrons. The first patrons recognized the fire danger about 24 seconds after ignition of the foam; the bulk of the crowd began to evacuate shortly after that, around the time the band stopped playing (30 seconds). The rate of egress from the main entrance at the front of the building was limited initially by the single doorway inside the vestibule, not the double doors visible from the outside. From 56 percent to 66 percent of the occupants appear to have attempted to leave through the single main entrance in the front of the building; many were unsuccessful. The windows in the main bar room and the sunroom became the secondary routes of escape once the main entrance became impassable, and, according to reports, they accounted for over 1/3 of the successful evacuations.

Prior to 1-1/2 minutes into the fire, a crowd-crush occurred in the front vestibule which almost entirely disrupted the flow through the main exit. Many people became stuck in the prone position in the exterior double doors.

**Simulation of egress for different scenarios**

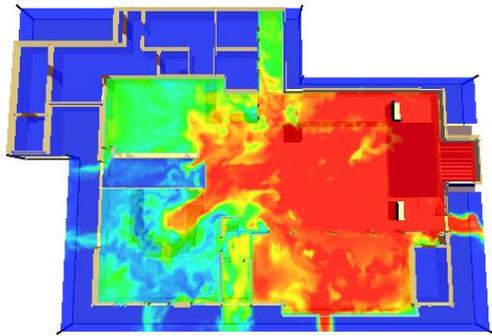
The platform area of the nightclub, including NIST-purchased flexible polyurethane foam on the walls, was reconstructed in the large fire laboratory at NIST to examine, in a controlled environment, how the fire may have spread in the full-scale nightclub, and to measure the temperature, heat flux, and gaseous products. In less than 90 seconds after ignition of foam at the corner of the reconstructed drummer's alcove, conditions in the middle of the room (5.5 m, or 18 ft, away) at head height (1.5 m, or 5 ft, above the floor) were found to be lethal.

**Temperatures 1.5 m (5 ft) above floor 90 seconds after ignition, calculated from computer simulation of full-scale nightclub fire.**

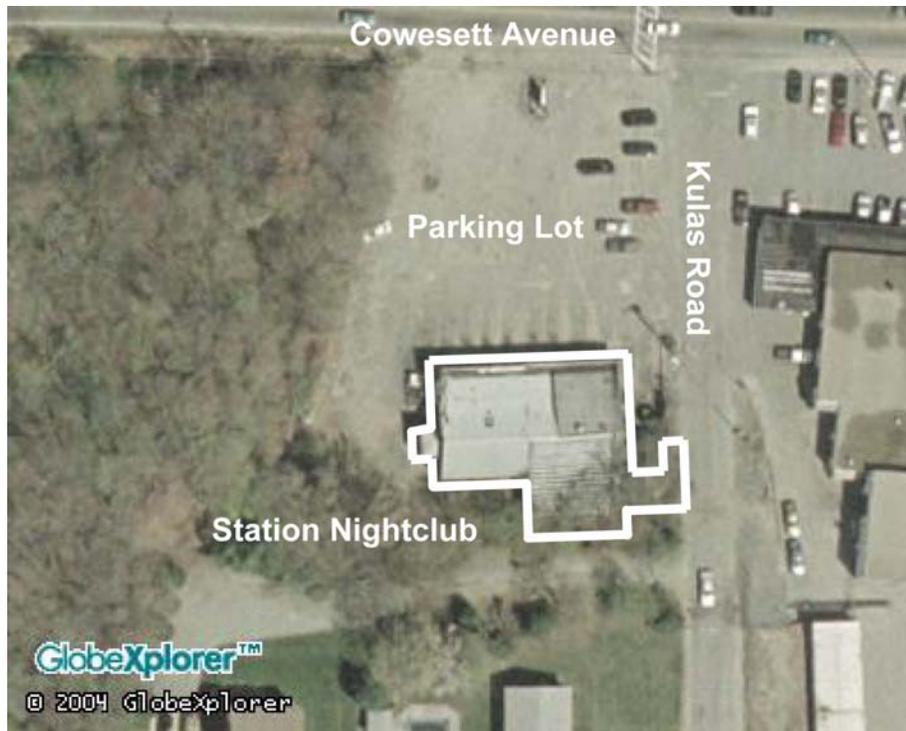
Figure 1-1. General orientation of building and site [2]

The Station nightclub was located at 211 Cowesett Avenue, West Warwick, Rhode Island. It was a single-story wood frame building with a footprint of about 412 m<sup>2</sup> (4484 ft<sup>2</sup>) and a small basement under the main bar room. Figure 1-1 is a photograph of the building on its lot. The north-facing front door of the nightclub was set back about 42 m (140 ft) from Cowesett Avenue, a three-lane, two way street that runs east-to-west. Kulas Road is two lanes wide and runs along the east side of the building, about 10 m (33 ft) east of the side bar exit. There was no direct street access to the building from either the west or south sides. Parking for over 100 cars was provided in the front and to the west side of the building.

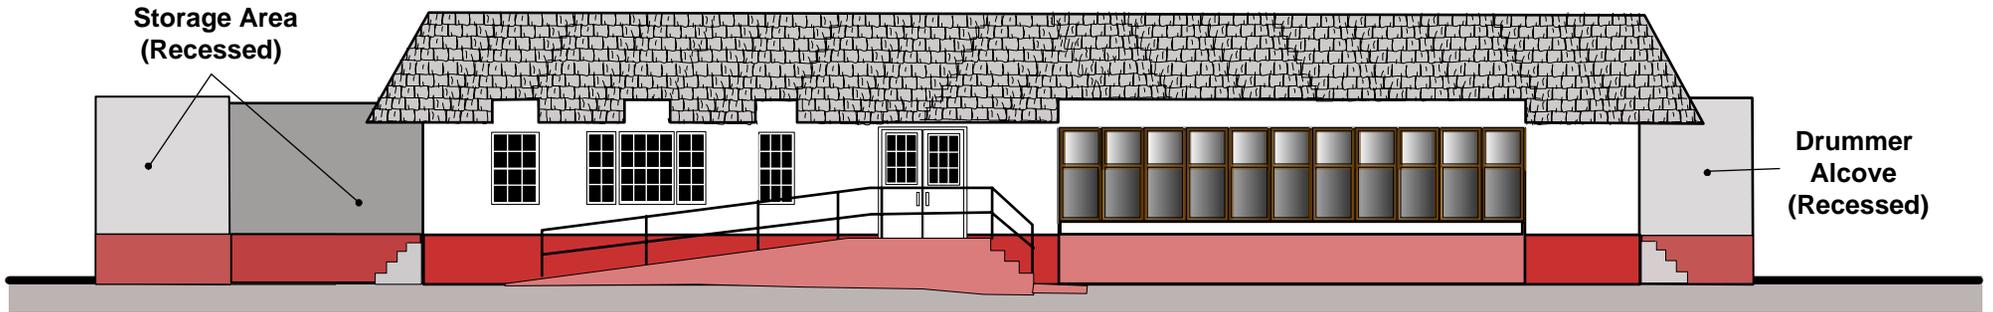
**Figure 1-3. Sketch of the north side of The Station nightclub locating the main entrance, front stairway/ramp, windows in the main bar area (left), sunroom/pool room (right), and exit stairs from the east and west sides**

Figure 1-3 is a sketch showing the north side of the building approximately as it looked on February 20, 2003. Note the windows on the left which are in the main bar area, the windows on the right in the sunroom/poolroom, the ramp and stairs leading from the main entrance in front, and the stairways leading from side exits on the west and east of the building. Inside the double doors of the main entrance is a vestibule with a single doorway. Figures 1-4a and 1-4b are photographs of the north side and north west corner of the building as they looked within a year or two of the February 20, 2003 fire. The external walls were primarily covered with painted wood shingles or panels above a concrete foundation. The roof was flat with a wood shingle façade along the front and sides, as seen in the photographs.

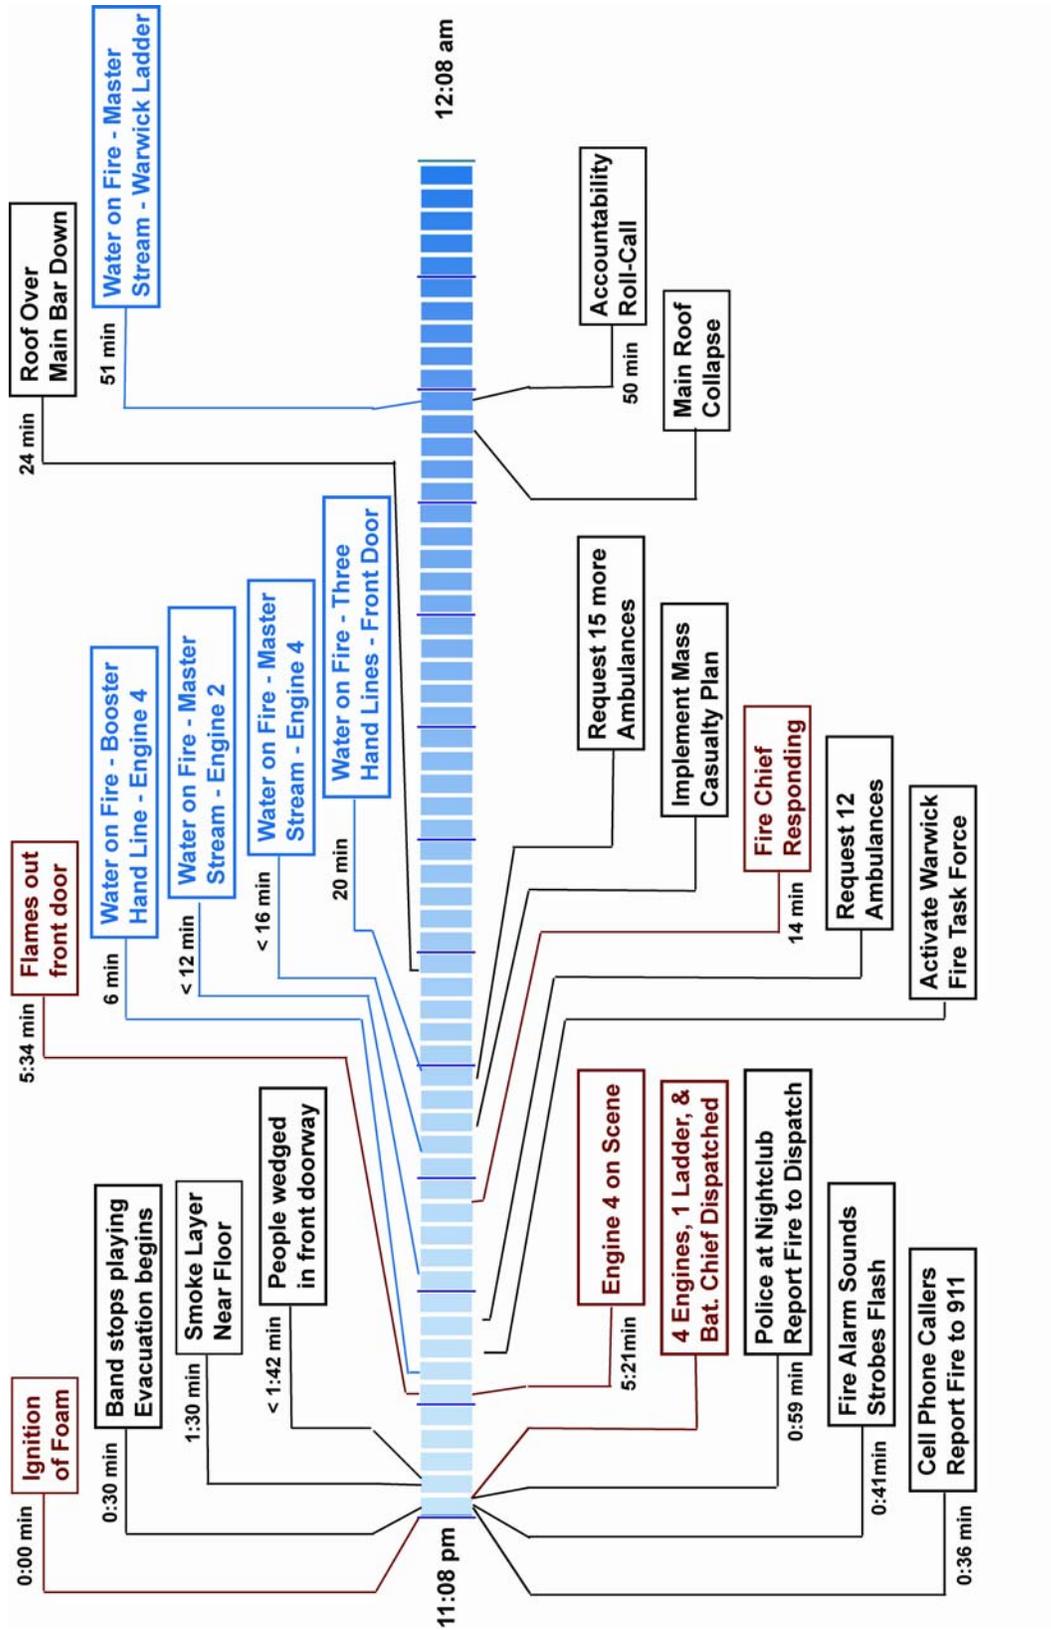
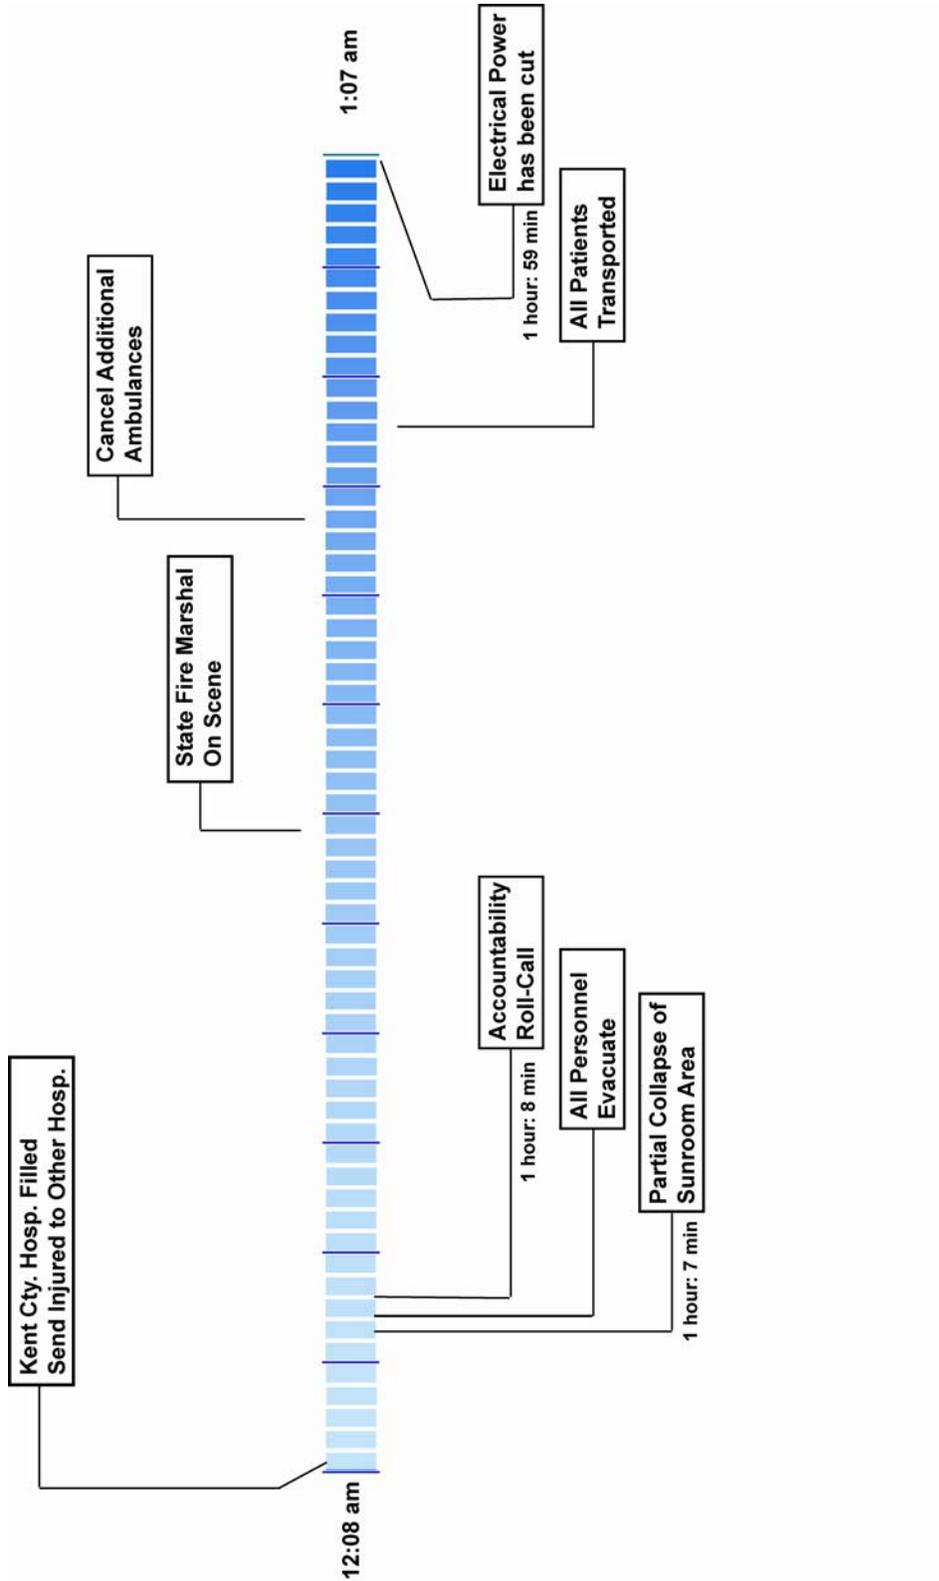
Figure 2-1a. Overview Timeline of The Station Nightclub Fire

An overview timeline is shown in Figures 2-1a and 2-1b. Detailed events are summarized in Table 2-1.

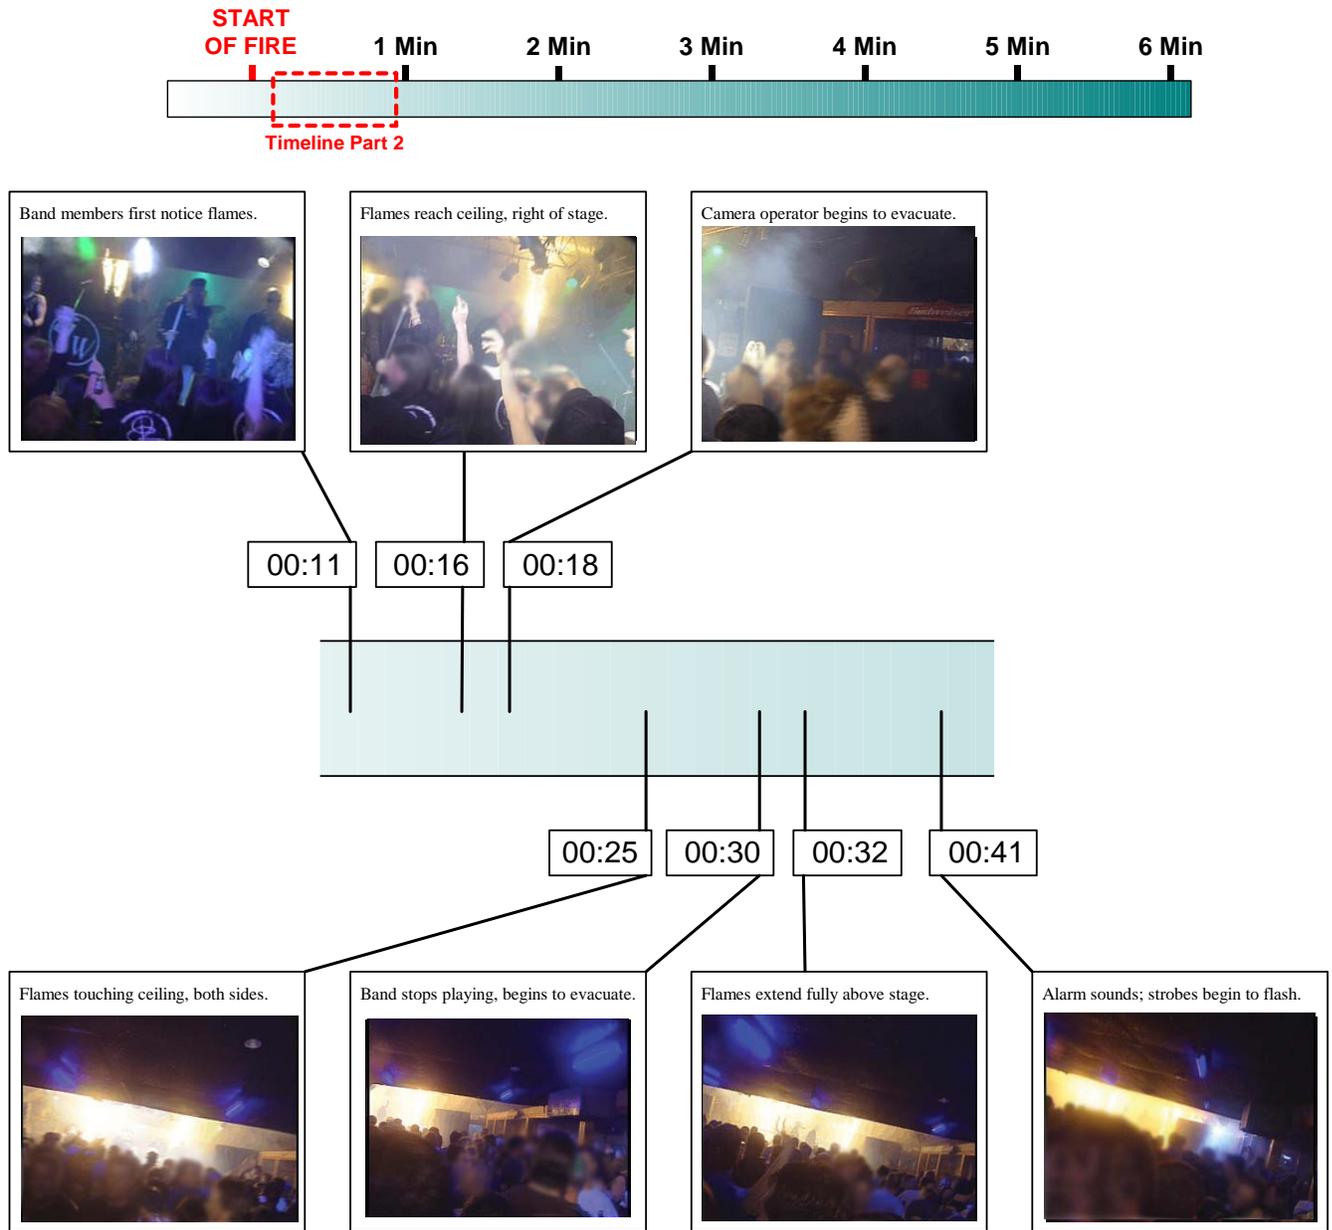
**Figure 2-2b. Evacuation Timeline (10 seconds to 50 seconds after ignition). Video stills copyright © 2003 TVL Broadcasting, Inc. All rights reserved.**

recognize the fire danger at 24 seconds. Around the time the band stopped playing (30 seconds fire time), the bulk of the crowd had begun the evacuation process. At 41 seconds the fire alarm could be heard and the strobe seen on the video. (See Fig. 2-2b.)

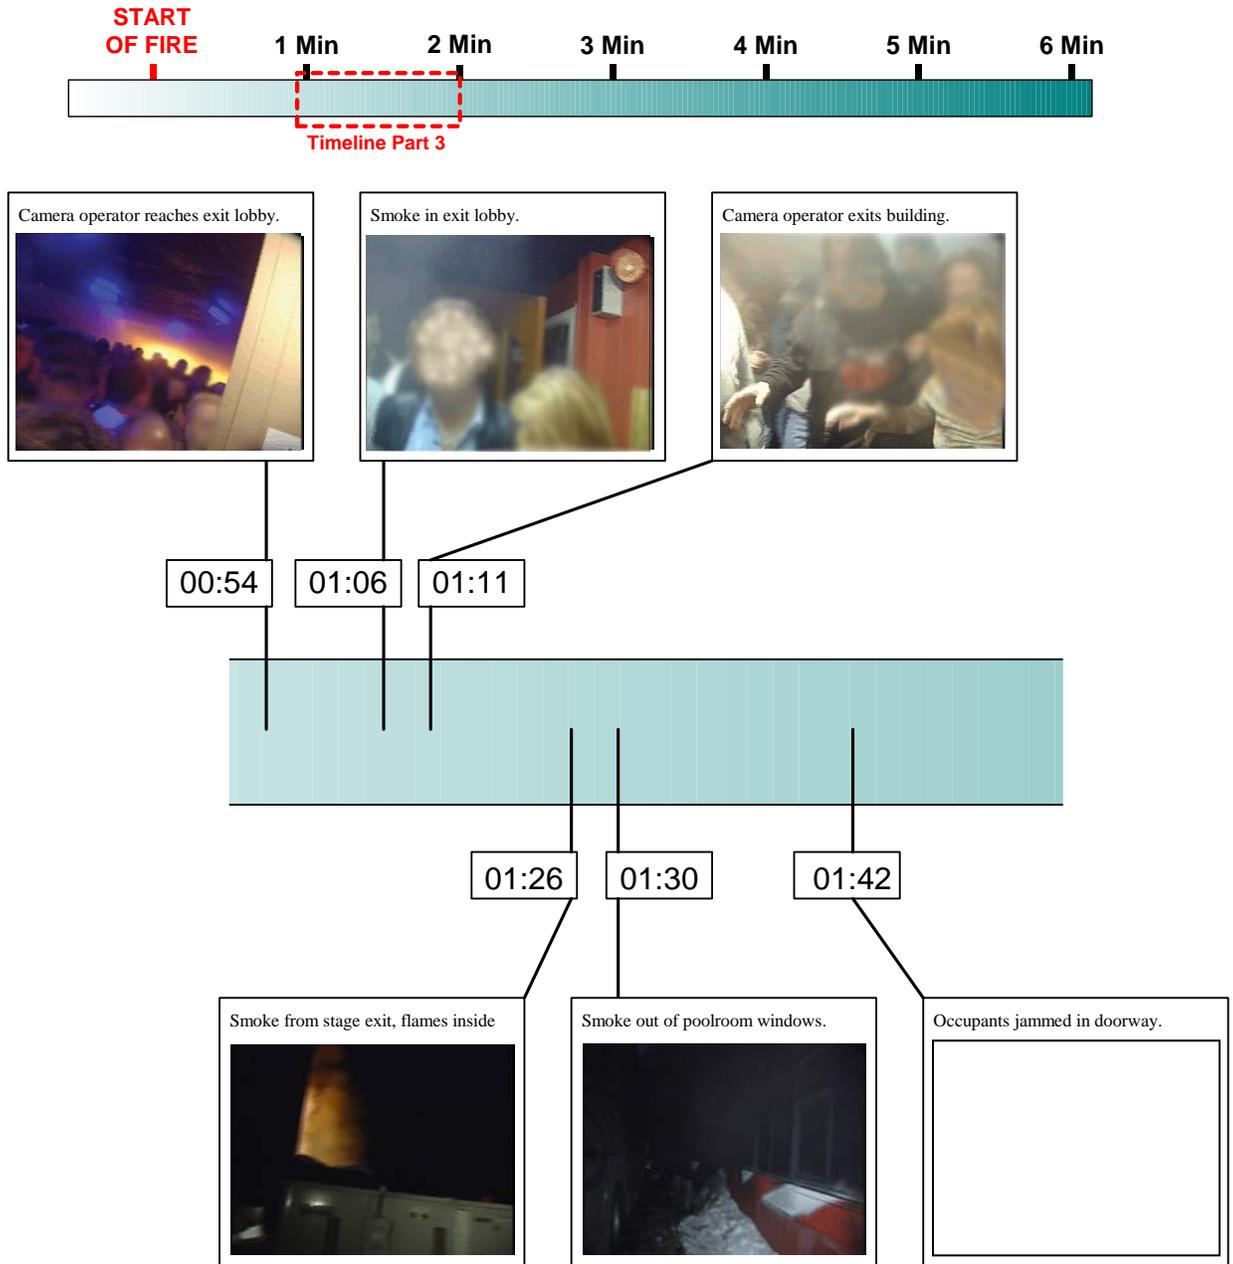
**Figure 2-2c. Incident Timeline (50 seconds to 2 minutes after ignition). Video stills copyright © 2003 TVL Broadcasting, Inc. All rights reserved.**

The videographer made his way to the exit lobby while continuing to capture the movement of the crowd leaving the area around the dance floor. As seen in Fig. 2-2c, he exited the building at 1 minute 11 seconds (fire time) along with a steady stream of occupants. Sometime estimated to be around 1 minute 30 seconds after ignition of the foam, the front exit became blocked with people, and occupants could be seen breaking windows and escaping from the poolroom/sunroom. The result of the crowd crush at the front exit was captured on the video at 1 minute 42 seconds (Fig. 2-2c). The latest time recorded for an occupant escaping from inside the main bar (through a window) was at 4 minutes 8 seconds; however, people stuck in the front entrance are seen in the video to have escaped as late as 5-1/2 minutes into the fire, just before the fire department ran its first hose line (Fig. 2-2d). (One patron claimed to have been pulled from the bottom of the pile by a firefighter considerably later, but this has not been confirmed by the NIST investigation.)

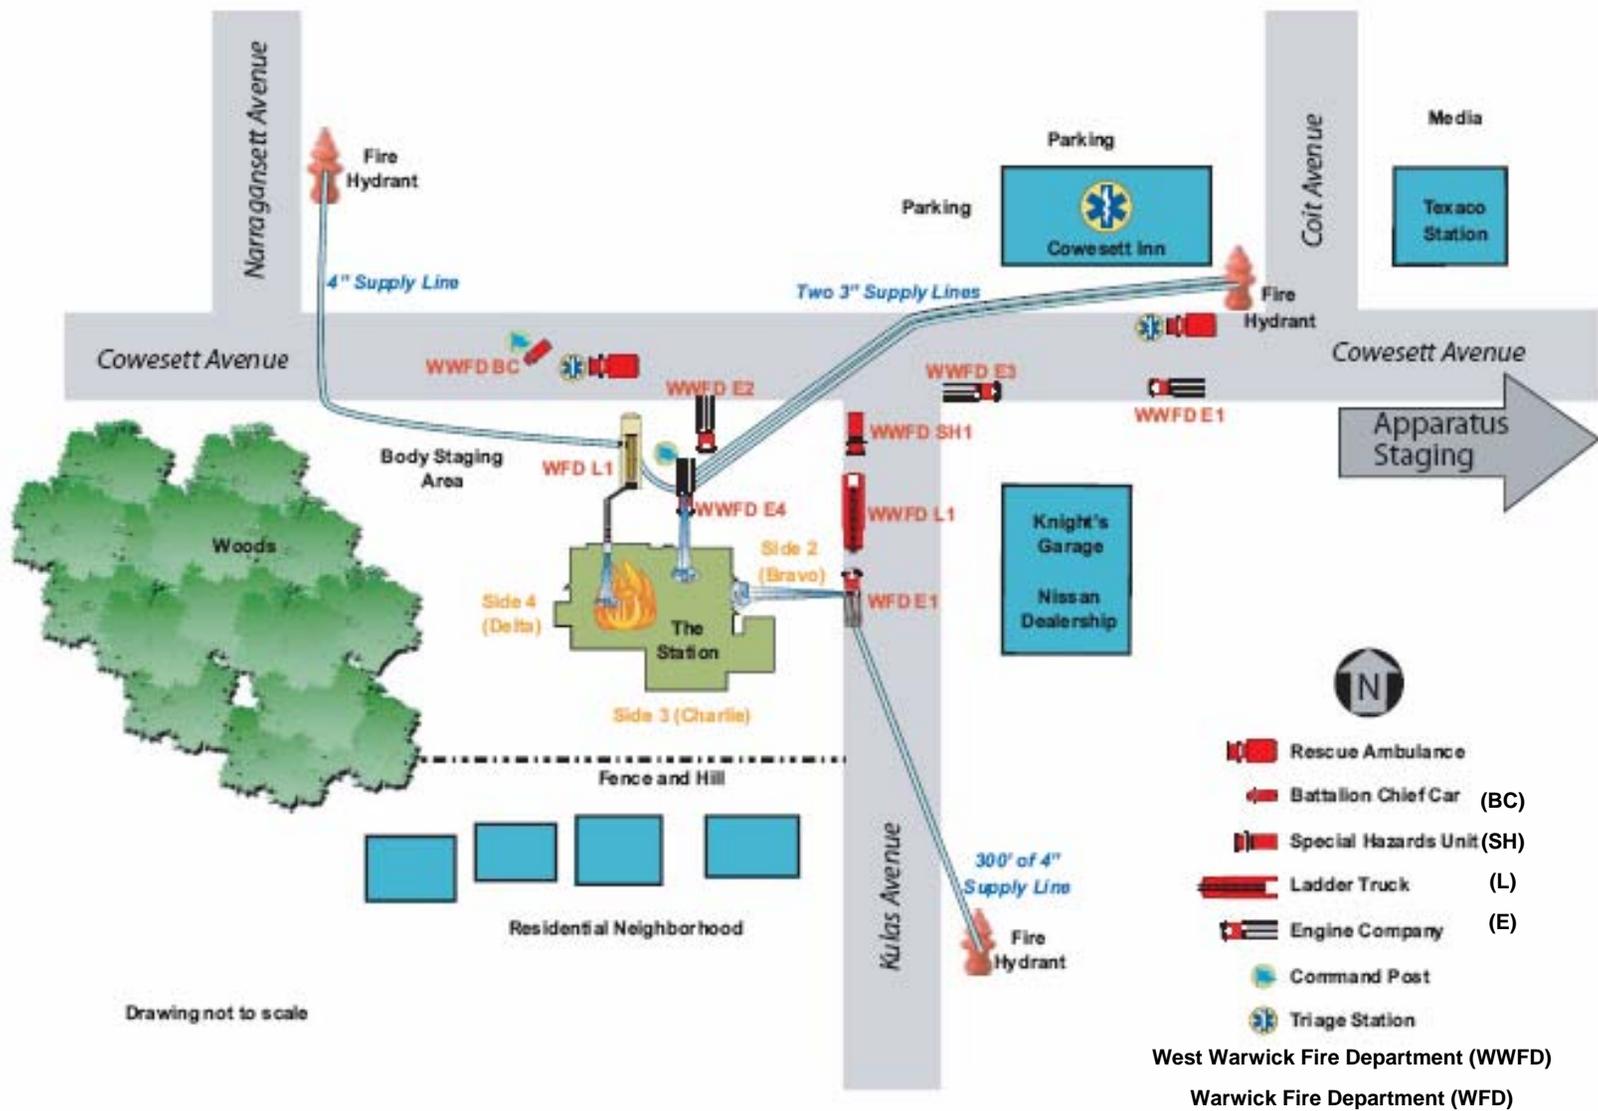
Figure 3-1. Schematic of primary apparatus deployment

Figure 3-1 shows the layout of the fire ground during the fire attack and suppression activities. The initial attack was mounted by WWFD's first unit, Engine 4, approximately 6 ½ minutes into the fire with the advance of a 1 ¾" line to the main entrance of the structure and the primary victim cache, and continued until the unit's on board water supply was exhausted. While the two, 3" supply lines to the front of the structure were being laid and charged, rescue efforts continued along the building's north face, through both the broken windows and exits. However, these efforts were pursued without the benefit of protective hose lines and were substantially hampered by the rapid fire propagation, radiant heat and heavy volumes of smoke discharge from the structure.

The sunroom area at the front of the club included a window-wall approximately 9 m (29 ft) long just to the west of the main entrance facing the parking lot. The roofing and structural support for this element of the building's façade collapsed a little more than an hour into the fire, which prompted the IC to initiate another personnel accountability check.

After this second major element of the structure failed, little remained of the building except sections of the exterior walls at the front (primarily in the area of the main entrance which had been the focus of substantial suppression effort). The west and rear walls were heavily damaged, and elements of the nightclub's storage area, food preparation and office areas to the southeast corner of the structure were

effectively destroyed although some components of interior compartment separations still remained standing at that end of the structure.

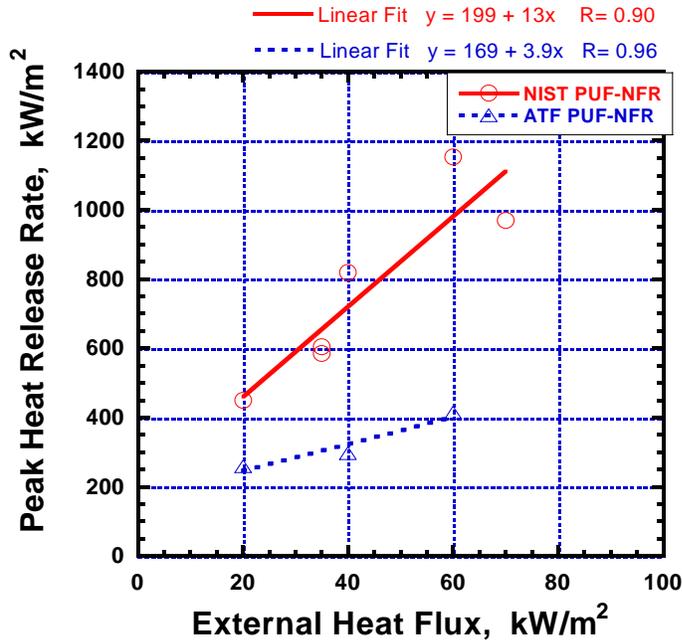
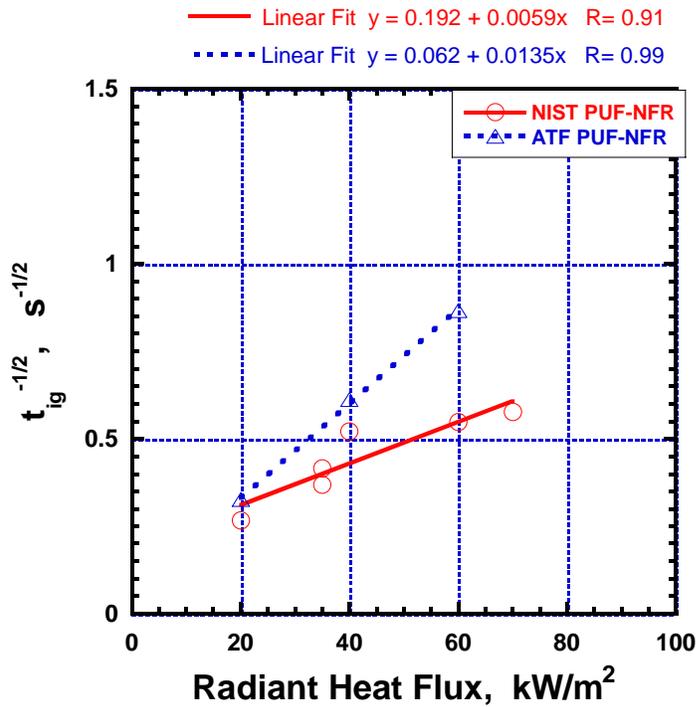
Figure 4-2a. Peak heat release rate versus external heat flux for different polyurethane foams tested at NIST and ATF.

Figure 4-2b. Time to sustained ignition versus external heat flux for different polyurethane foams tested at NIST and ATF.

The precise reasons why the polyether foam tested by ATF differed from the behavior of the foams tested by NIST are not clear. (NIST did not have access to the foam from the fire scene tested by ATF.) However, the shorter time necessary for ignition of the ATF foam suggests that the effective value of  $k_{p,c}$  was less. It is possible that the behaviors were influenced by the different molecular structure, additives, or manufacturing processes. It is also not clear under what conditions the foam had been stored in the basement of the nightclub or whether it had always been stored in the basement, nor what impact aging or water from fire fighting operations may have had on the foam. Using the properties of either foam, the fire is predicted to spread rapidly, with the foam acting as an ignition source for the wood layer underneath. The contribution from the foam to the total heat release in the fire was much less than from the wood, once the wood was ignited by the burning foam.

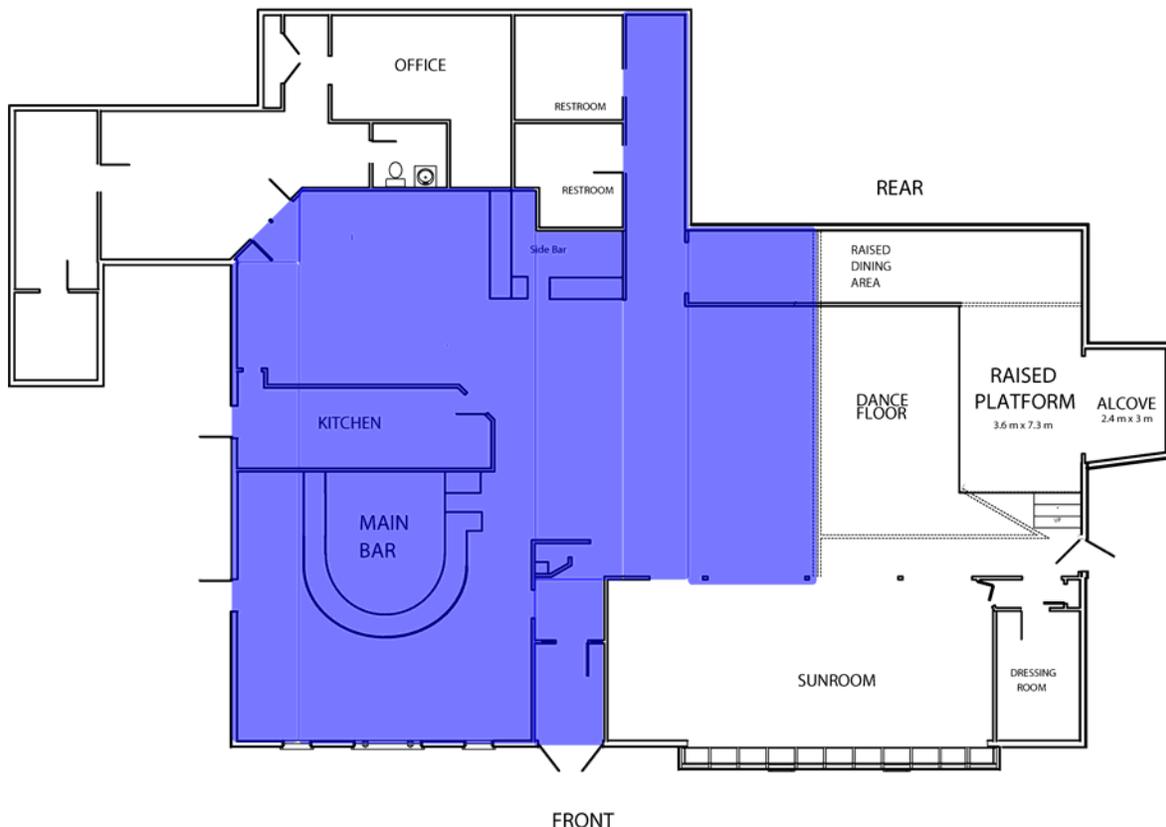
**Figure 4-3. Portion of Nightclub with Acoustical Tile Ceiling (shaded blue section).**

A suspended or dropped ceiling had been installed in the nightclub except for in the sunroom, the platform area, and the dance floor areas (Figure 4-3). Each 0.61 m (2 ft) x 1.22 m (4 ft) x .016 m (0.625 in) panel had been installed or dropped into a metal grid support system. Photographs of the nightclub interior clearly demonstrate that the ceiling tiles had been painted black. It was not clear from the photographs whether the paint had been applied by brush, roller, or spray can. The surface of the tiles also had a glittery appearance that may have been a result of the wet paint being dusted with glitter.

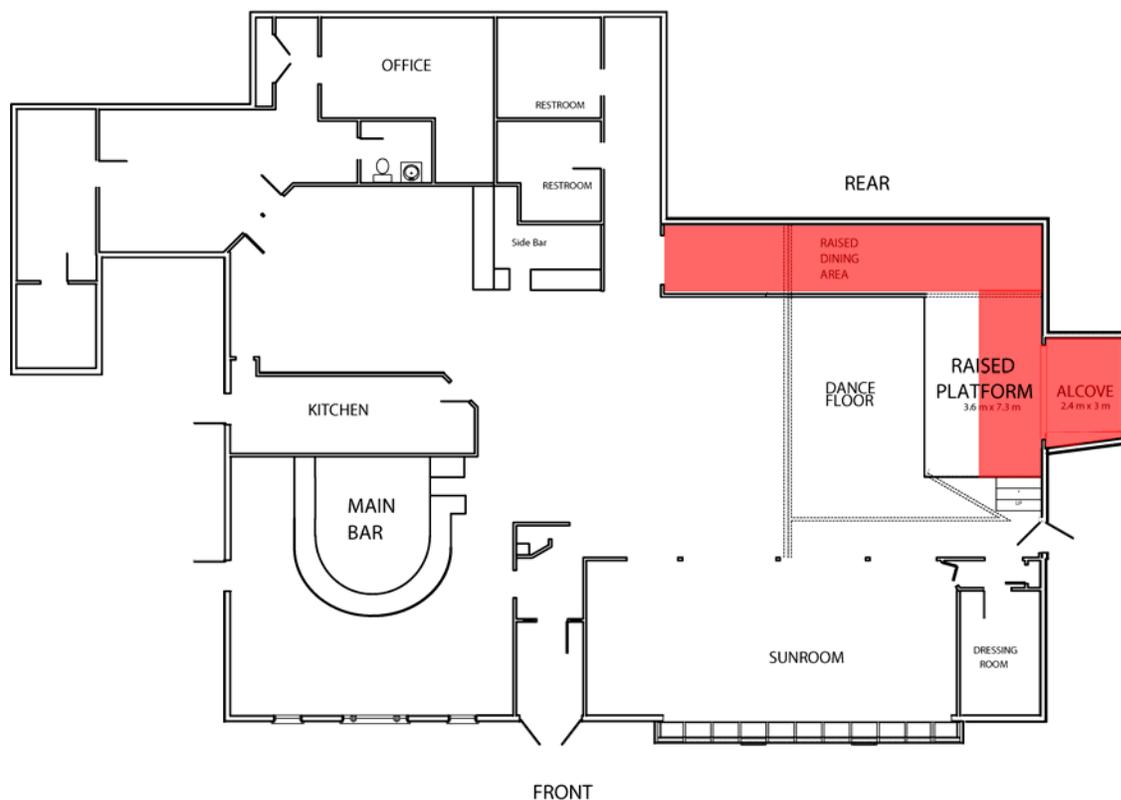
**Figure 4-5. Portion of Nightclub with Carpeting.**

Carpet flooring had been installed in the nightclub on the elevated section along the rear wall and around the platform area. (Figure 4-5). Interior photographs of the nightclub did not provide sufficient information to identify the specific brand or type of carpeting.

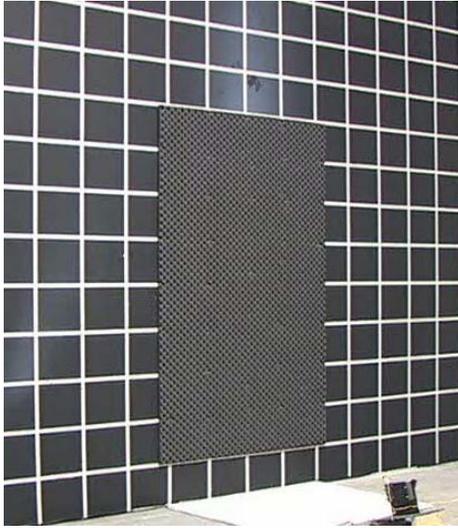
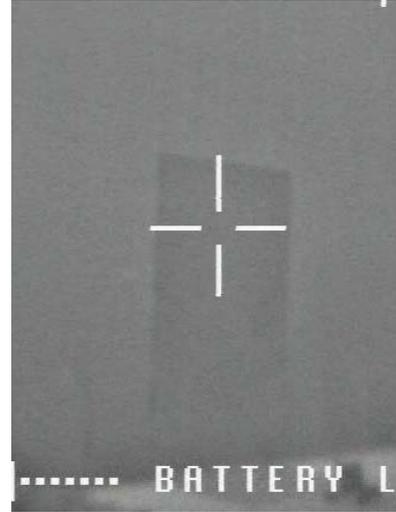
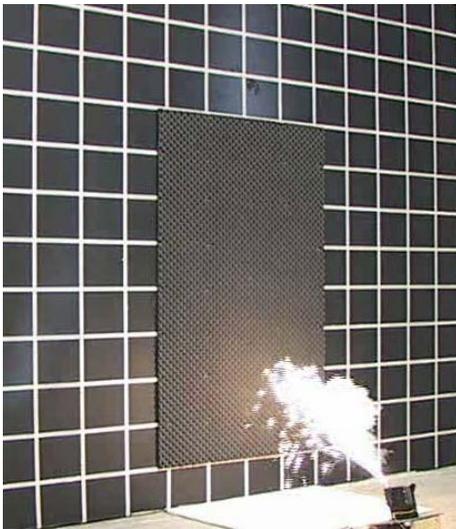
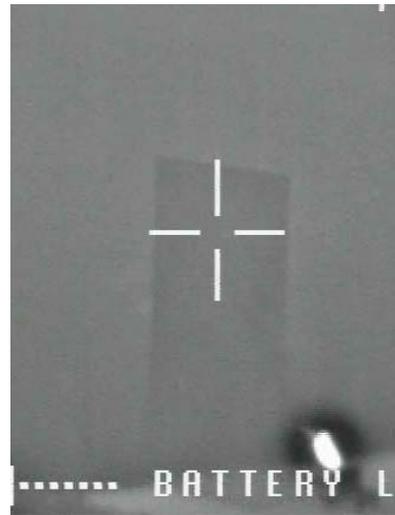
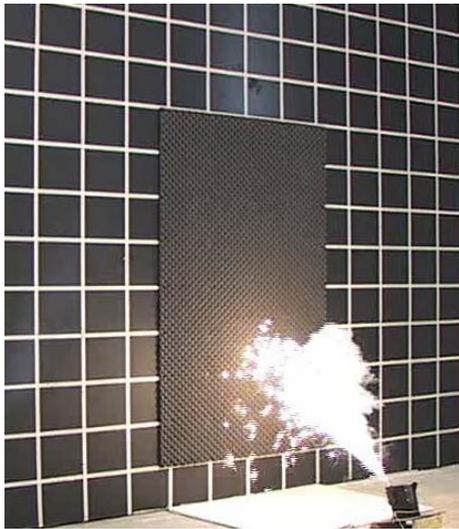
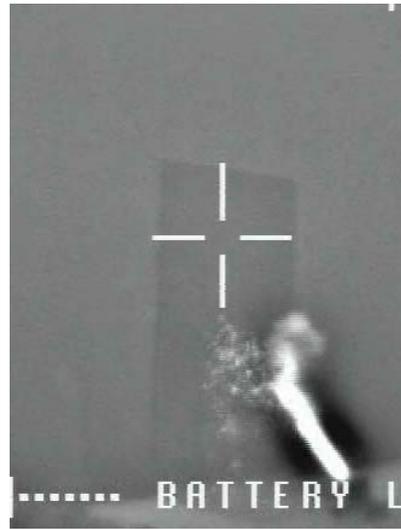
Still images were captured from the video recorded by the standard video and IR camera. For gerbs that were positioned at 45 degrees in a plane parallel to the wall, pairs of visible and infrared images are shown for times from 0 seconds to 30 seconds in Figure 4-13a through 4-13h. The visible images demonstrate that the gerb discharged a spray of white sparks for 15 seconds. The spray of hot sparks impacted the wall between 0.91 m (3 ft) and 1.5 m (5 ft) above the floor. Within 2 seconds after ignition, a thermal pattern (white area in IR image) developed on the wall. This area of increased temperature was oval in shape with a horizontal width of 0.3 m (1 ft) and a vertical dimension of 0.61 m (2ft). A similarly sized and positioned thermal pattern was also seen at 5 seconds into the discharge. The edges of the thermal pattern appeared fuzzy or diffuse. At 10 seconds after ignition, this thermal pattern had sharper edges and a black "haloing" appeared around the pattern. This haloing or shadowing has been observed under laboratory conditions in the presence of a significant thermal gradient. BST detectors measure relative levels of infrared radiation and are AC-coupled. The AC-coupling can cause a "black halo" or shadowing effect that increases as the relative radiation difference between an object and its surroundings increases unless a DC restoration process is included in the signal output circuitry. This would be consistent with the foam burning before  $t = 10$  seconds. Although not clearly seen in the standard video camera, flames were observed on the right hand side of the hot spark pattern at 9 seconds. By 15 seconds a well defined and hot thermal plume was observed in the IR image. Gas temperatures are plotted versus time in Appendix F, Figs. F-16a and F-16b.

The width of the alcove in the nightclub was 3.0 m (10 ft) and the end of each gerbs was offset from the center of the opening by about one foot. The NIST tests demonstrated that a 15 x 15 gerb which was angled at 45 degrees and discharged against (and in a plane perpendicular to) a wall from a distance of 1.22 m (4 ft) could ignite a sheet of polyurethane foam in approximately 10 seconds. This is similar to the ignition sequence observed in the WPRI video.

**Figure 4-13a. Standard and Infrared Video Images of Non-fire Retarded Polyurethane Foam on Gypsum Board Wall just before ignition at  $t = 0$  seconds.**

**Figure 4-13b. Standard and Infrared Video Images of Gerb Discharge onto a Non-fire Retarded Polyurethane Foam Sheet on Gypsum Board Wall at  $t = 0.5$  seconds.**

**Figure 4-13c. Standard and Infrared Video Images of Gerb Discharge onto a Non-fire Retarded Polyurethane Foam Sheet on Gypsum Board Wall at t = 1 second.**

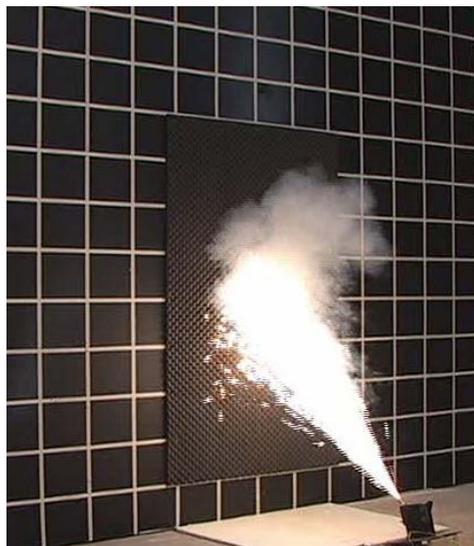
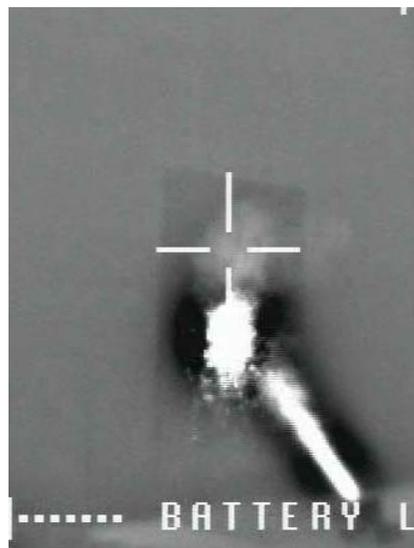
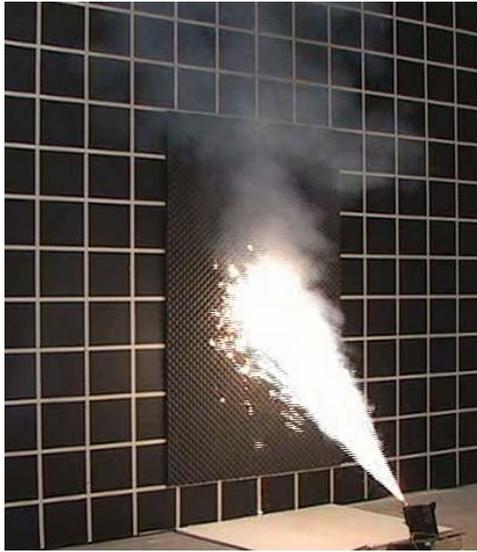
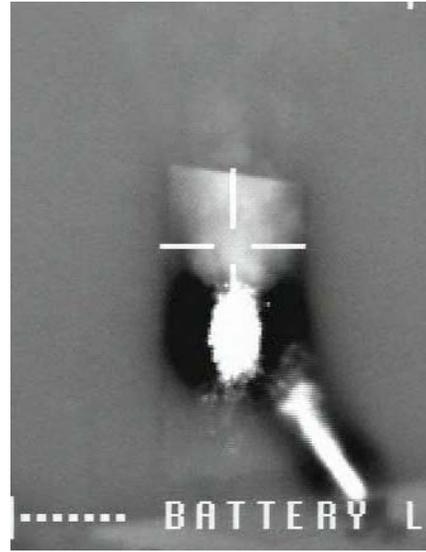
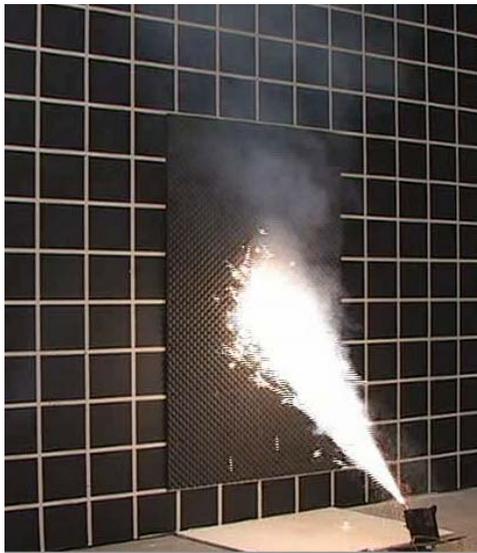
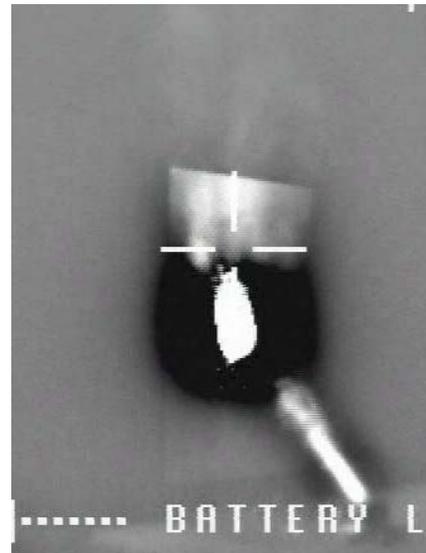
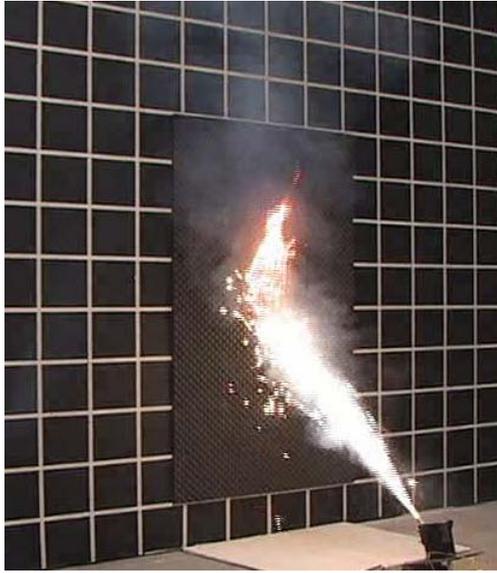
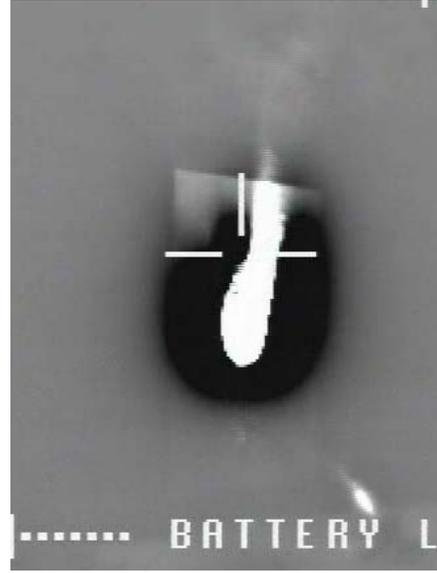
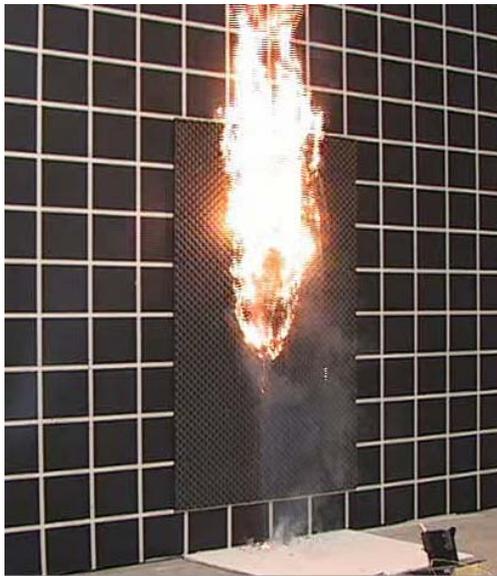
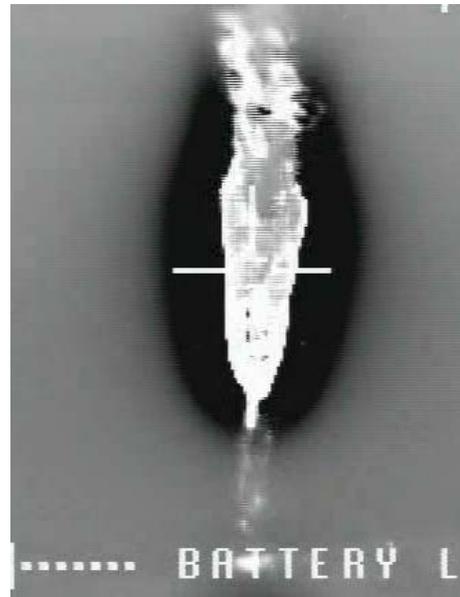
**Figure4-13d. Standard and Infrared Video Images of Gerb Discharge onto a Non-fire Retarded Polyurethane Foam Sheet on Gypsum Board Wall at t = 2 seconds.**

**Figure 4-13e. Standard and Infrared Video Images of Gerb Discharge onto a Non-fire Retarded Polyurethane Foam Sheet on Gypsum Board Wall at  $t = 5$  seconds.**

**Figure 4-13f. Standard and Infrared Video Images of Gerb Discharge onto a Non-fire Retarded Polyurethane Foam Sheet on Gypsum Board Wall at  $t = 10$ seconds.**

**Figure 4-13g. Standard and Infrared Video Images of Gerb Discharge onto a Non-fire Retarded Polyurethane Foam Sheet on Gypsum Board Wall at  $t = 15$  seconds.**

**Figure 4-13h. Standard and Infrared Video Images of Gerb Discharge onto a Non-fire Retarded Polyurethane Foam Sheet on Gypsum Board Wall at  $t = 30$  seconds.**

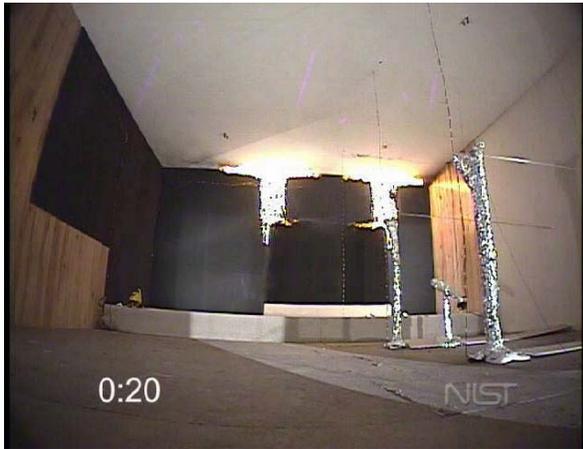
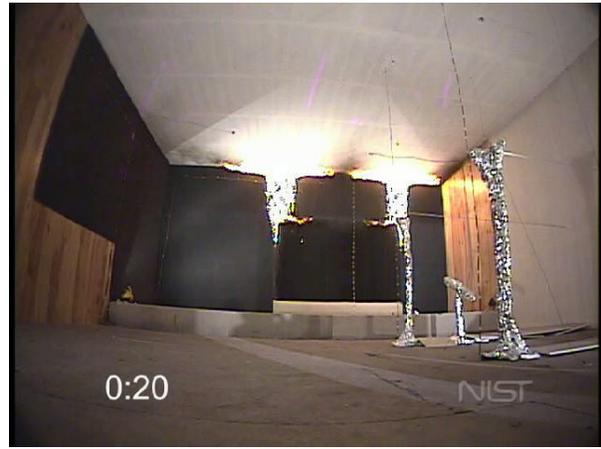
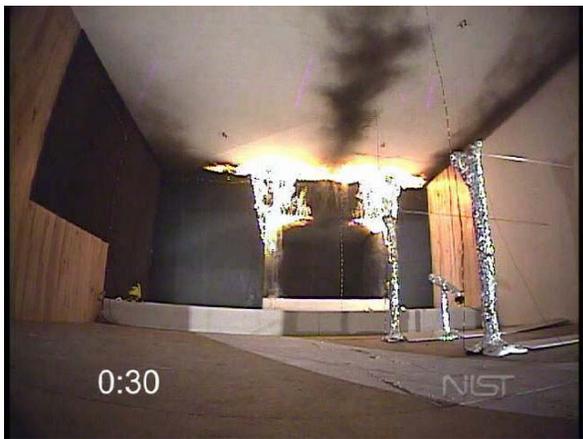
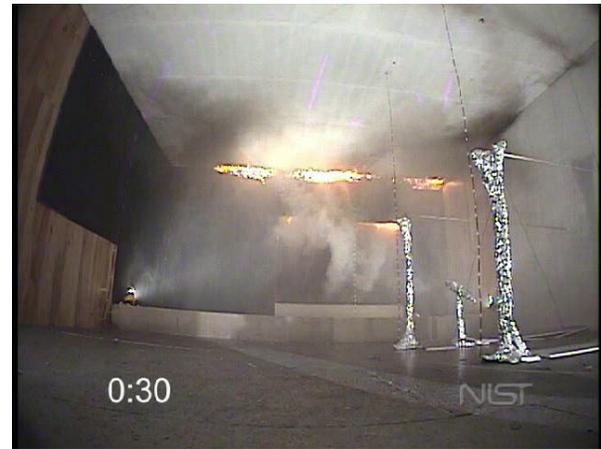
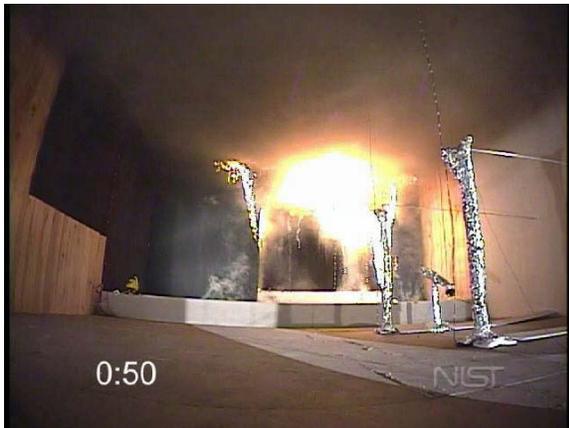
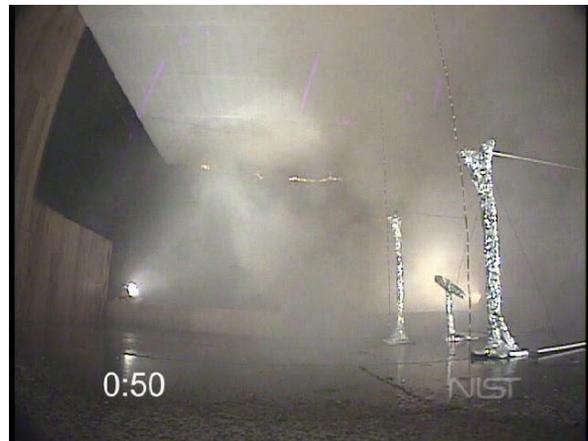
The succession of video frames on the left of Fig. 4-20 show how rapidly the fire spreads during the first 50 seconds, compared to how quickly the fire is controlled with sprinklers in the frames along the right. The first sprinkler activates on the right of the platform 24 seconds after ignition. By 30 seconds the sprinkler above the platform on the left and the sprinkler in the alcove have activated.

**Figure 4-20. Still frames taken from video of full-scale mock-up experiments. Time after ignition is indicated in lower left of each frame. Left column: unsprinklered; right column: sprinklered (first head activates at 24 seconds)**

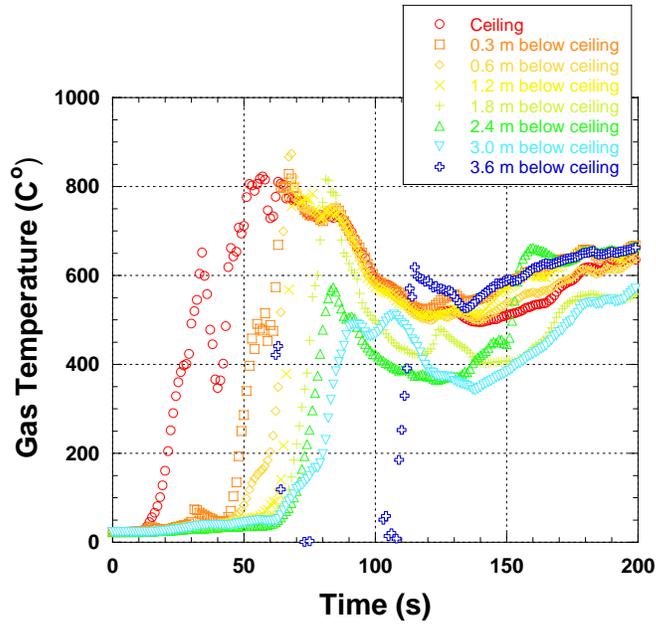
Figure 4-22. Temperatures versus Time for Unsprinklered Mockup Test. Thermocouples positioned on Platform (Location B) from ceiling to platform floor.

For the unsprinklered case, the temperature at the ceiling measured at location B (Fig. 4-22) began to increase within 10 seconds of ignition and continued to increase to over 800 °C in approximately 50 seconds. In less than 60 seconds, the temperature exceeded 50 °C at 1.4 m (4.5 ft) above the floor (2.4 m below the ceiling). The hot gases began to form an upper layer and the layer began to descend; in just over 110 seconds, the temperature at the floor of the platform had increased to over 600 °C.
