NIST NCSTAR 2: Vol. I

# Report of the Technical Investigation of The Station Nightclub Fire

# **Report of the Technical Investigation of The Station Nightclub Fire**

June 2005

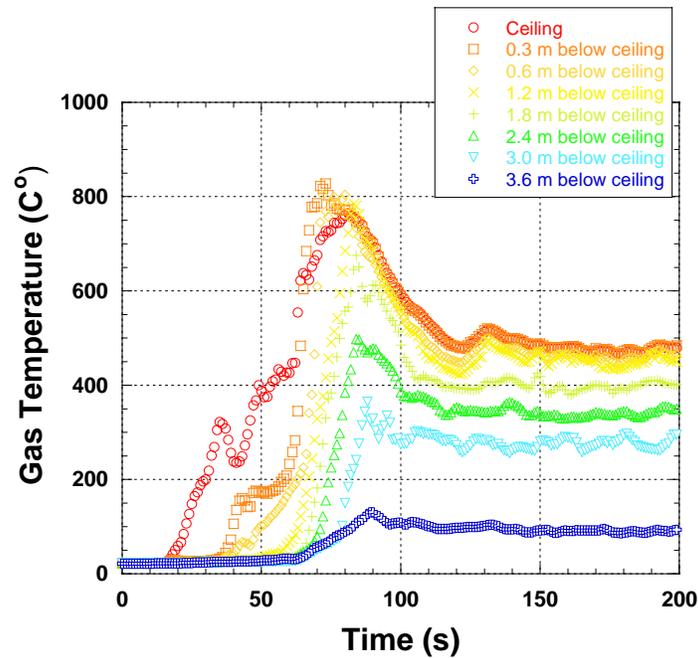
Figure 4-23. Temperatures versus Time for Unsprinklered Mockup Test. Thermocouples positioned on Main Floor (Location C) from ceiling to floor.

The thermocouple array at location C was installed 6.7 m from the foam covered platform wall, 3 m further away from the platform wall than the thermocouples at location B. The temperatures required about 15 seconds longer to begin increasing than those measured at location B, and required approximately 70 seconds to reach peak temperatures of 800 °C. From Fig. 4-23 one can see that the temperatures at 3.6 m below the ceiling did not begin to increase until 60 seconds after ignition and then the temperatures reached peak values of approximately 100 °C in 90 s. The temperatures at location C exceeded 50 °C at the 1.4 m (4.5 ft) above the floor (2.4 m below the ceiling) elevation in less than 70 seconds.

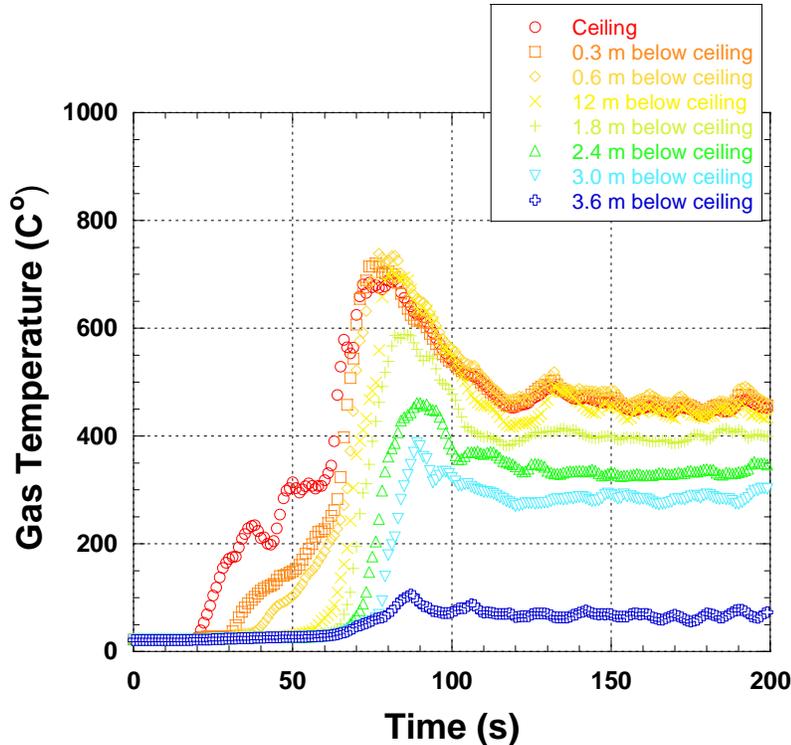
**Figure 4-24. Temperatures versus Time for Unsprinklered Mockup Test. Thermocouples positioned on Main Floor (Location D) from ceiling to floor.**

The thermocouple array at location D was installed 8.5 m from the foam covered platform wall, an additional 1.8 m further away from the platform wall than the thermocouples at location C. The temperatures began to rise in about 20 seconds (see Fig. 4-24), and required approximately 80 seconds to reach peak temperatures of 700 °C. The temperatures at 3.6 m below the ceiling did not begin to increase until 70 seconds after ignition and reached peak values of approximately 100 °C in 90 s. The temperatures near the floor at location D were about the same as the values recorded at the floor on the platform, Location C.

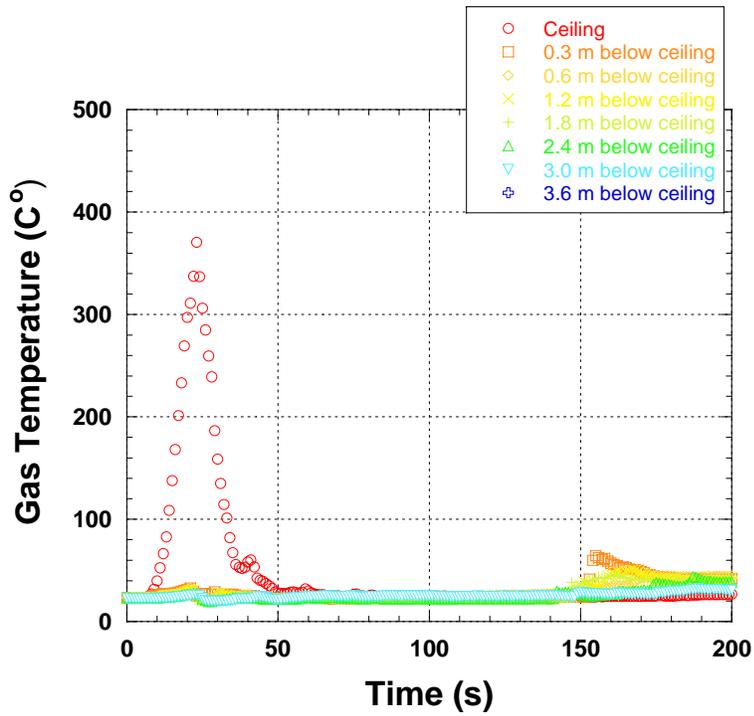
Figure 4-25. Temperatures versus Time for Sprinklered Mockup Test. Thermocouples positioned on Platform (Location B) from ceiling to platform floor.

For the sprinklered test burn, the ceiling thermocouple at location B (on the platform) recorded a peak temperature of 380 °C about 20 seconds after ignition, as can be seen in Fig. 4-25. When the sprinkler activated, the ceiling temperature quickly decreased, dropping to about 20 °C within 40 seconds of ignition. The activation of the sprinklers caused the other thermocouples at lower elevations to record near ambient temperatures throughout the test burn.

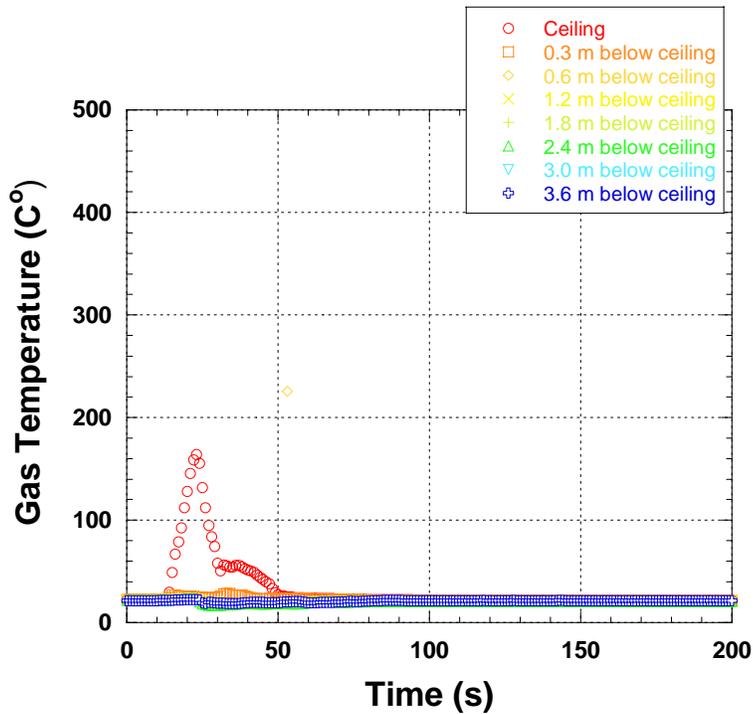
Figure 4- 26. Temperatures versus Time for Sprinklered Mockup Test. Thermocouples positioned on Main Floor (Location C) from ceiling to floor.

At location C (Fig. 4-26), the ceiling temperatures reached a peak temperature of 170 °C in about 20 seconds and declined to near ambient temperatures within 60 seconds. For location D (Fig. 4-27), the ceiling temperatures reached a peak temperature of 130 °C in about 20 seconds and declined to near ambient temperatures within 60 seconds. Thermocouples at lower elevations for both locations appeared to remain at near ambient temperatures throughout the test.

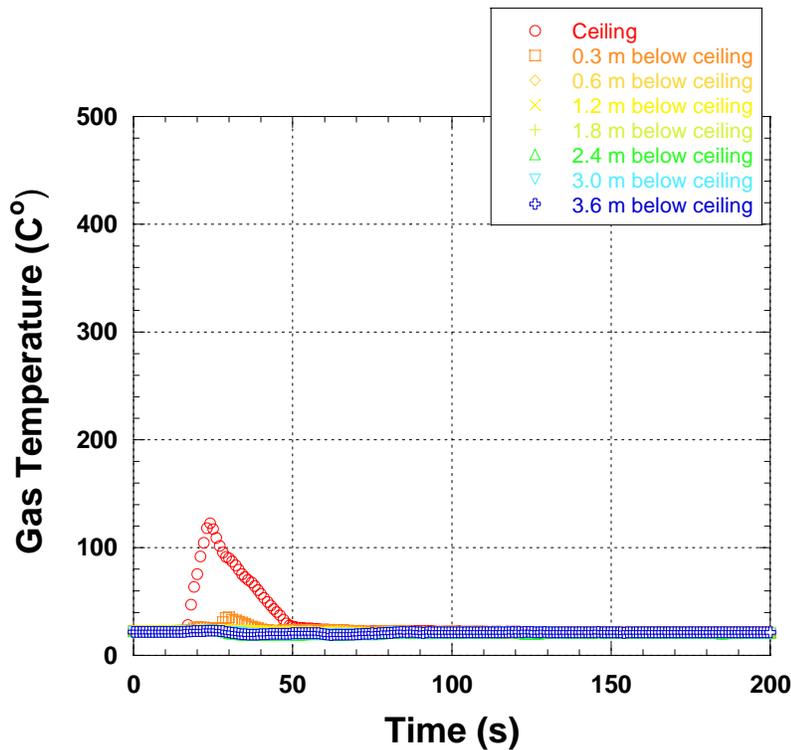
**Figure 4-27. Temperatures versus Time for Sprinklered Mockup Test. Thermocouples positioned on Main Floor (Location D) from ceiling to floor.**

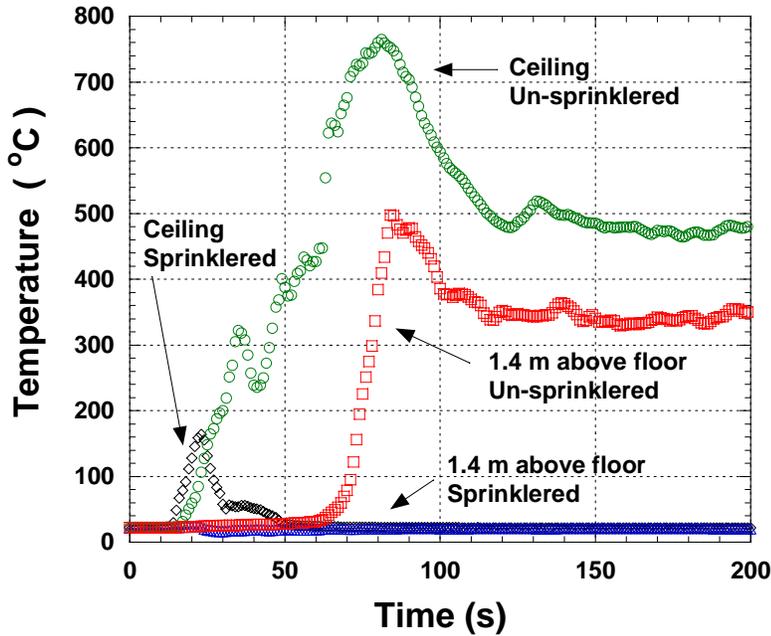
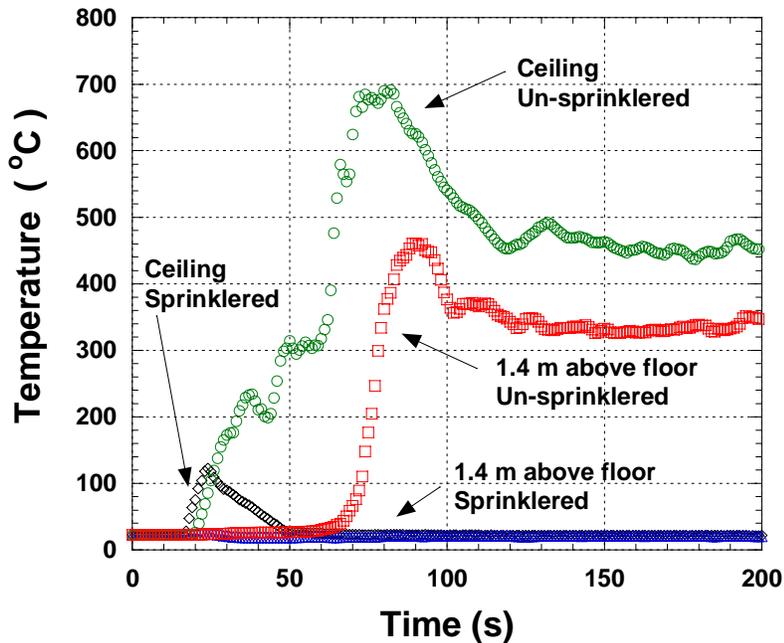
The comparison between the temperatures at the ceiling and 1.4 m above the floor for the sprinklered and unsprinklered experimental data is striking, as demonstrated in Fig. 4-28a for location C and Fig. 4-28b for location D. At 25 seconds, the temperatures at the ceiling were about 175 °C at location C and 125 °C at location D for both experiments, indicative of the fire being properly replicated up to the point when the sprinkler activated. During the next 25 seconds the temperatures throughout the compartment returned to close to ambient conditions in the sprinklered compartment. This compared to a continuing rapid rise in temperatures for the unsprinklered compartment, which reached ceiling temperatures in excess of 300 °C at 50 seconds, and peaks of 700 °C plus in the following 25 seconds. Peak temperatures of 400 °C to 500 °C were reached 1.4 m above the floor for the unsprinklered test; temperatures did not rise at all for the sprinklered compartment at this location.

Figure 4-28a. Temperatures versus Time for Unsprinklered and Sprinklered Mockup Test. Thermocouples positioned on Main Floor (Location C) at ceiling and 1.4 m (4.5 ft) above floor.

Figure 4-28b. Temperatures versus Time for Unsprinklered and Sprinklered Mockup Test. Thermocouples positioned on Main Floor (Location D) at ceiling and 1.4 m (4.5 ft) above floor.

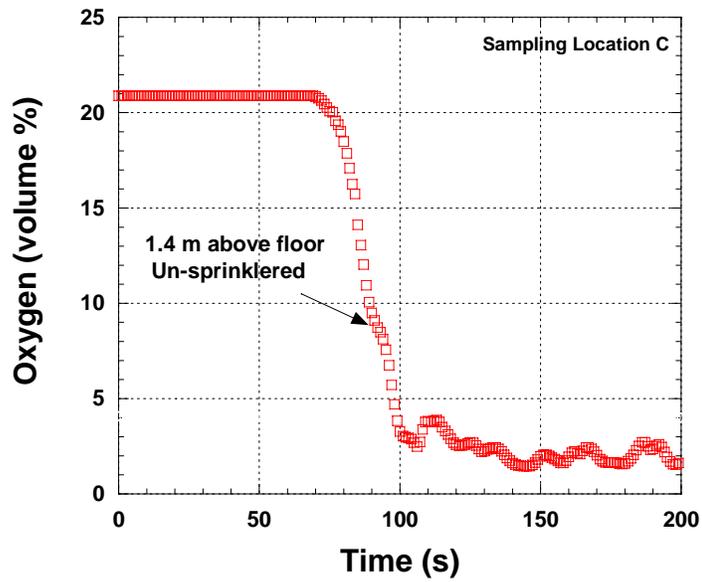
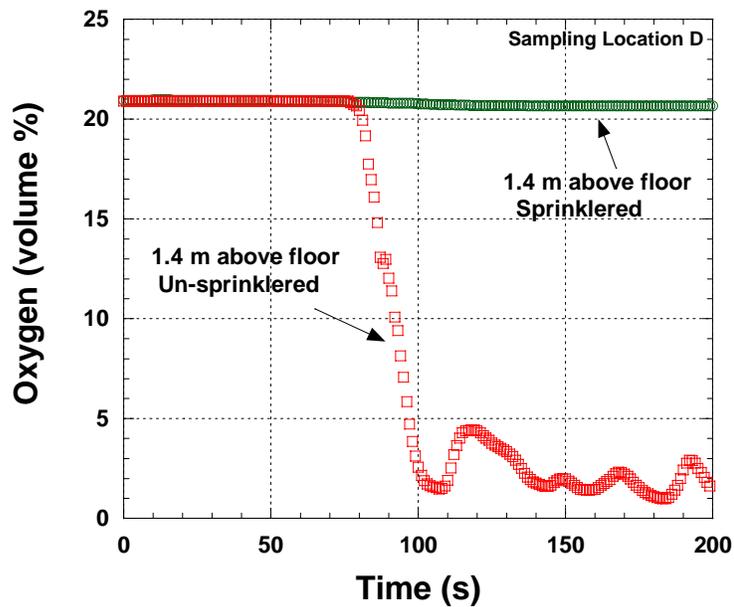
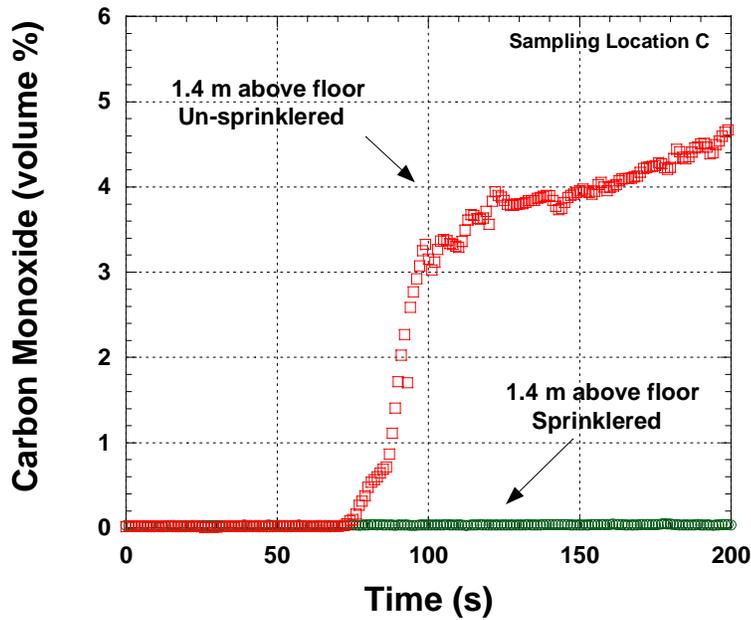
Figure 4- 30. Oxygen Volume Fraction vs Time for Unsprinklered and Sprinklered Mockup Test. Gas Sampling probe positioned on Main Floor (Location C) at 1.4 m (4.5 ft) above floor.

Figure 4-31. Oxygen Volume Fraction vs Time for Unsprinklered Mockup Test. Gas Sampling probe positioned on Main Floor (Location D) at 1.4 m (4.5 ft) above floor.

Figure 4-32. Carbon Monoxide Volume Fraction vs Time for Unsprinklered and Sprinklered Mockup Test. Gas Sampling probe positioned on Main Floor (Location C) at 1.4 m (4.5 ft) above floor.

Gas volume fractions versus time are plotted for the unsprinklered and sprinklered tests in Figures 4-30 through 4-35 for O<sub>2</sub>, CO and HCN. (Additional gas volume fractions measurements are discussed in Appendix G.) At both locations C and D, oxygen volume fractions did not begin to drop at the 1.4 m elevation until 70 seconds to 80 seconds after ignition for the unsprinklered mock-up experiments. At both locations, the oxygen volume fractions descended to less than 4 % in less than 100 seconds, then fluctuated between 1 % and 4 % . During the sprinklered test burns, the oxygen mole fraction at location D did not appear to drop much below ambient oxygen levels. (A malfunctioning oxygen analyzer prevented the oxygen concentrations from being monitored at location D during the sprinklered burns.)

At both locations C and D, volume fractions of carbon monoxide at the 1.4 m elevation did not begin to increase until 70 seconds to 80 seconds after ignition for the unsprinklered mock-up experiments, but then increased to 3 % in the next 20 seconds to 30 seconds and reached 4.5 % by 200 seconds after ignition. During the sprinklered test burns, the carbon monoxide concentration at neither location C nor location D appeared to increase much above ambient levels.

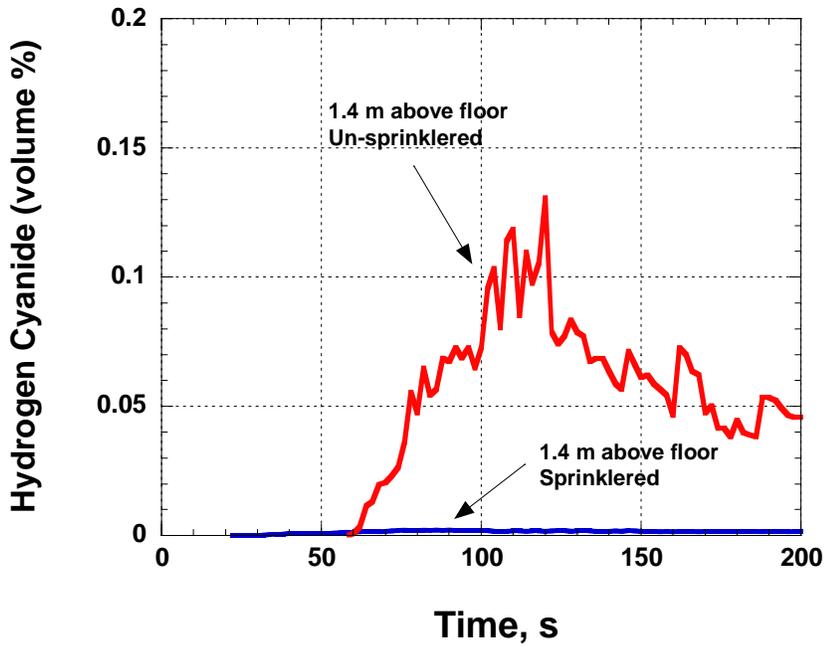
Figure 4-34. Hydrogen Cyanide Volume Fraction vs Time for Unsprinklered and Sprinklered Mockup Test. Gas Sampling probe positioned on Main Floor (Location C) at 1.4 m (4.5 ft) above floor.

The volume fractions of hydrogen cyanide at the 1.4 m elevation began to increase 60 seconds after ignition for the unsprinklered mockup experiments. At location C, the HCN reached its peak value of 0.13 % in 120 seconds. The HCN increased slightly faster at location D, where it reached a peak volume fraction of 0.17 % in about 90 s. During the sprinklered test burns, the hydrogen cyanide concentration at locations C and D were barely above the measurable limit.

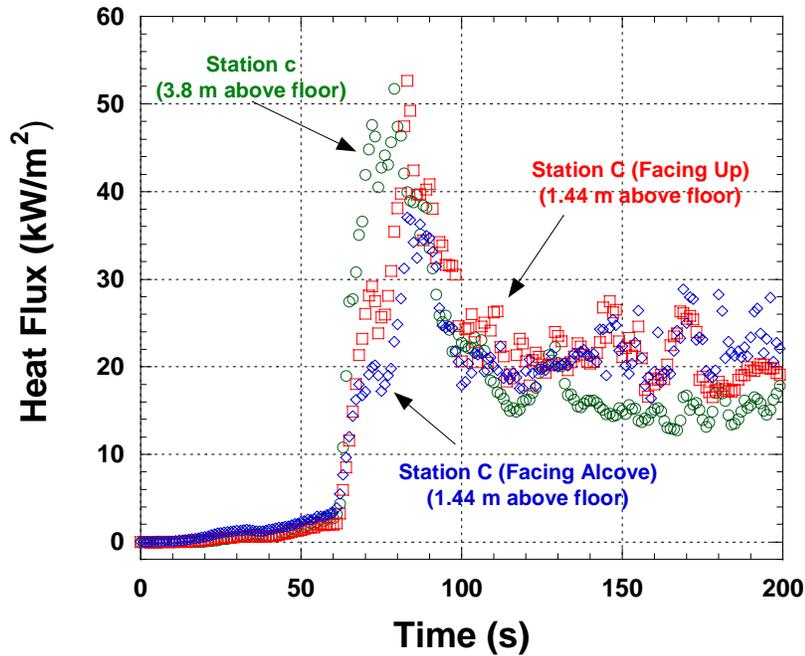
Figure 4- 37. Heat Fluxes versus time for unsprinklered mockup test. Radiometer positioned flush with ceiling (3.8 m above floor); heat flux gauges facing up (1.44 m above floor), and facing alcove (1.44 m above floor) at sampling location C.

For the unsprinklered compartment test, the output of the thermal radiation and total heat fluxes for the radiometer and heat flux gauges at locations C and D are shown in Fig. 4-37 and Fig 4-38. At location C, peak fluxes in excess of 50 kW/m<sup>2</sup> were reached about 70 seconds after ignition. Peak fluxes at location D were about 20 % lower than location C. At 100 seconds after ignition, radiation and heat flux at

location C and the heat flux at location D decreased significantly to  $20 \text{ kW/m}^2$  and appeared to remain relatively constant at both locations. The radiometer in the ceiling at location D dropped to  $10 \text{ kW/m}^2$  before becoming relatively steady. (Additional plots of heat flux are shown and discussed in App. G.)

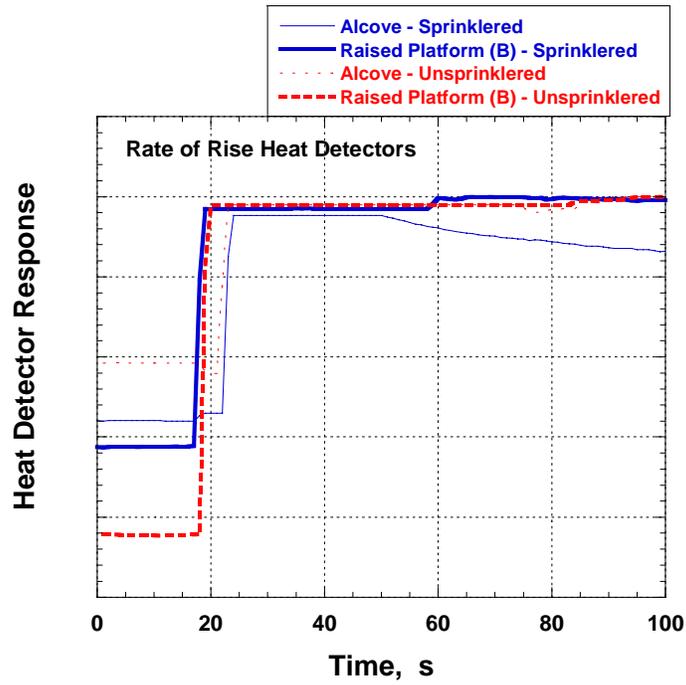
Figure 4- 39. Response of Rate of Rise Heat Detectors versus Time for Unsprinklered and Sprinklered Mockup. Detectors located in Alcove and at Location B.

The responses of rate of rise heat detectors and fixed temperature detectors are plotted in Fig. 4-39 and Fig. 4-40, respectively. For both unsprinklered and sprinklered test burns, each of the rate of rise detectors activated in less than 20 seconds. Only in the unsprinklered experiments did the fixed temperature detectors activate. The fixed temperature detector in the alcove activated in about 20 seconds while the fixed temperature detector above the platform required almost 40 seconds to respond.

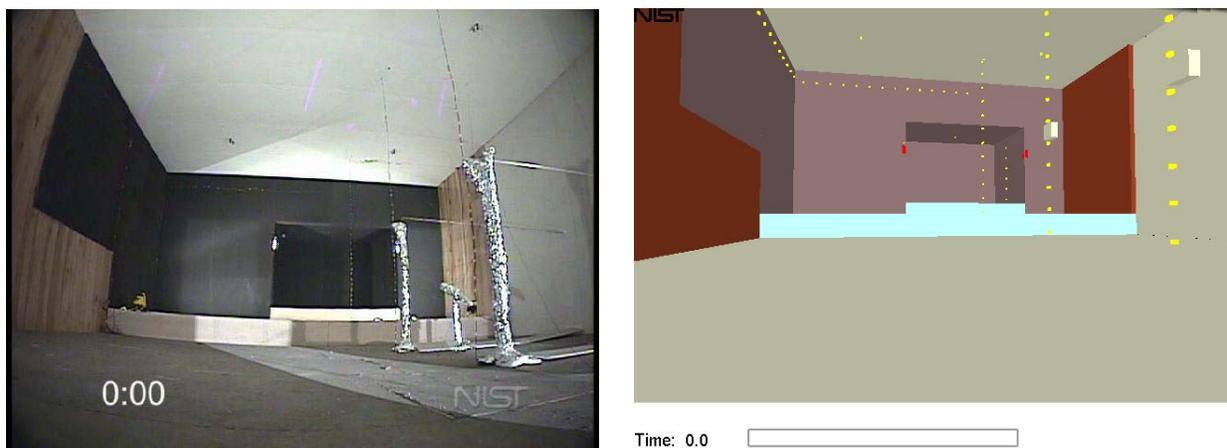
Figure 5-2. Ignition at the corners of the drummer's alcove, t = 0 second.

Figure 5-2 shows the experiment and the simulation at the time of ignition. The video frame on the left shows the foam covered walls, the wood paneling, and the carpeted platform. Gypsum board covered the ceiling, floor and the remaining wall areas that were not covered with wood paneling or foam. Some of the instrumentation can be seen in the foreground of the video frame. In the image from the simulation, on the right, the comparable interior finishes can be seen. The instrumentation in the right figures is represented by colored dots. The thermocouples appear as yellow dots in evenly spaced arrays. The light gray blocks represent the locations of the heat flux sensors and the gas sampling locations, which were installed at approximately 1.5 m (5 ft) above the floor.

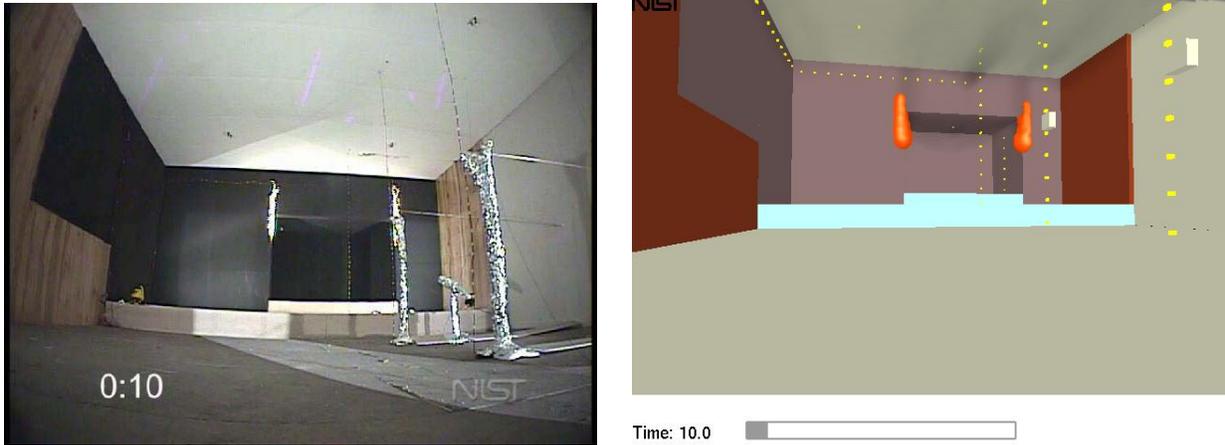
**Figure 5-3. Flames spreading toward ceiling,  $t = 10$  seconds after ignition.**

Figure 5-3 compares the fire development at 10 seconds after ignition. A flame is shown on both corners where the platform wall intersects with the drummer’s alcove. In the case of FDS, the area that appears to be involved with flames is based on the stoichiometric mixture fraction, where there is the ideal mixture of fuel and oxygen for a robust flame to exist. The heat release rate per unit volume represented by the simulated flames is  $285.5 \text{ kW/m}^3$ . The flames in the simulation appear wider due to the grid resolution, which is 100 mm (4 in) throughout the room.

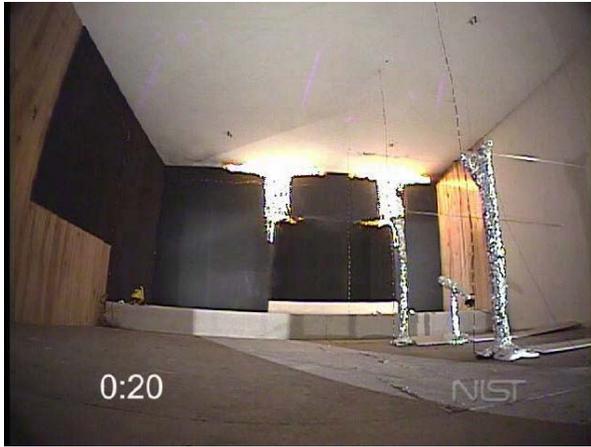
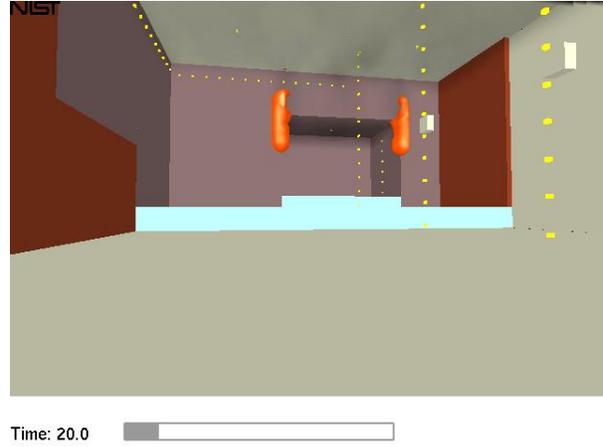
The video frame to the left in Figure 5-4 shows flames 20 seconds after ignition growing vertically and impinging on the ceiling. The simulated flames on the right, however, have not yet reached the ceiling. As noted above, the simulated flame is constrained to grow in 100 mm (4 in) increments, both vertically and laterally. This may account for the wider flame and the accompanying redistribution of energy that would reduce the propensity for rapid vertical flame spread. Light smoke can be seen in both images along the ceiling of the alcove, with light wisps of smoke along the ceiling above the platform.

**Figure 5-4. Flames impinging on ceiling, t = 20 seconds after ignition.**

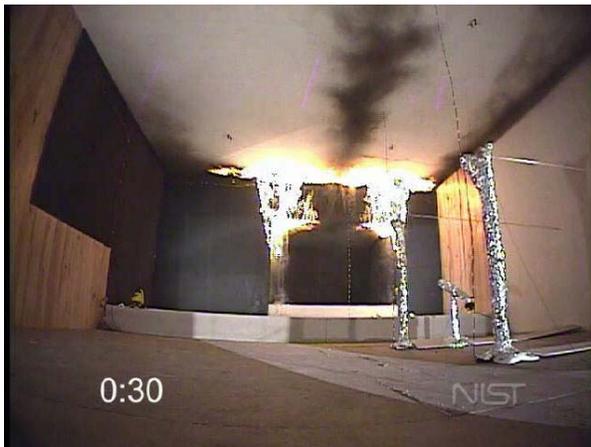
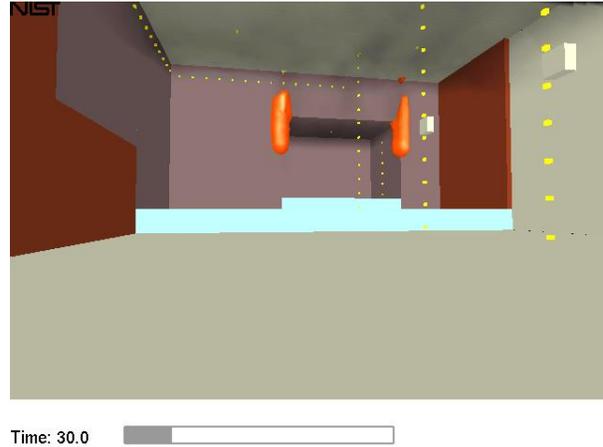
**Figure 5-5. Visible smoke spreading across ceiling, t = 30 seconds after ignition.**

Figure 5-5 shows an increased amount of smoke flow across the ceiling at 30 seconds after ignition. The actual fire continues to grow at a faster rate than the simulated flames. In the video frame on the left the flames have formed twin V-patterns on each side of the alcove and the flames are spreading across the alcove ceiling. Notice the light smoke that is coming up from the carpeting below the two fire plumes. This is the result of foam melting and the burning foam droplets falling to the floor. This mode of flame spread is not accounted for within the FDS model. At 40 seconds after ignition, the video frame in Figure 5-6 shows areas of the foam on the platform wall have burned out (note the dark area directly above the point of ignition on the left side of the alcove). The actual flame fronts have continued to spread and into the alcove, where fire is visible on portions of the side walls and the ceiling of the alcove. The flames simulated with FDS have also grown, although at a slower rate. Both of the simulated flames have impinged on the ceiling.

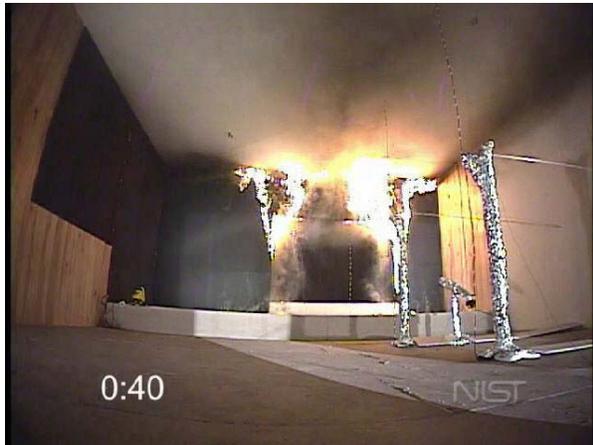
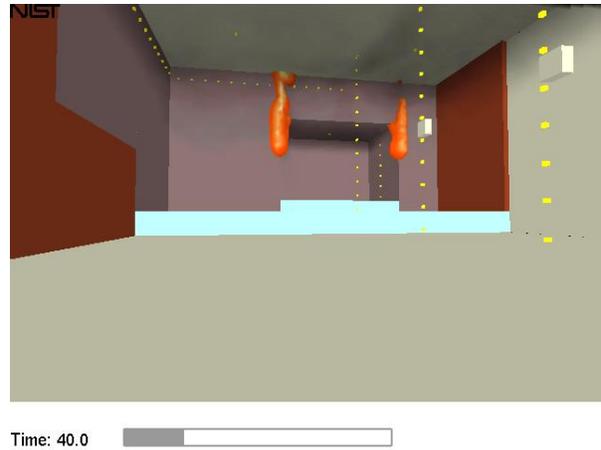
**Figure 5-6. Flames continue to spread into alcove, t = 40 seconds after ignition.**

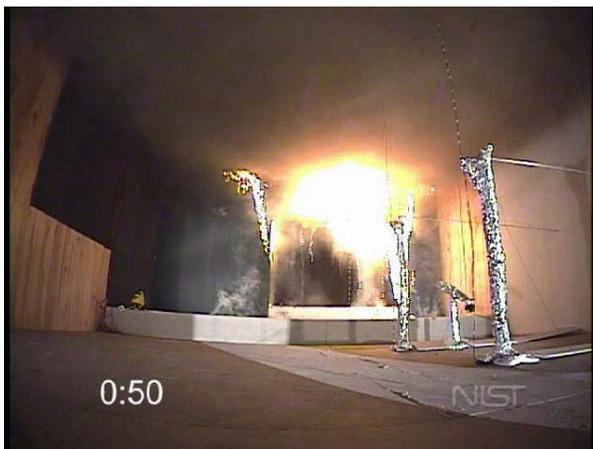
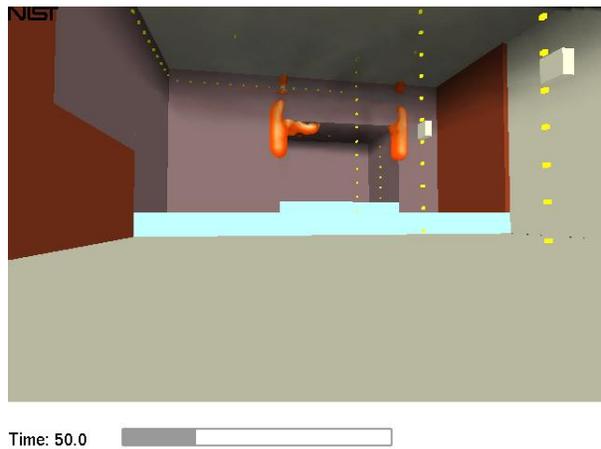
**Figure 5-7. Ceiling of alcove fully involved in fire, t = 50 seconds after ignition.**

Figure 5-7, has images captured at 50 seconds after ignition. In the experiment, it appears that the entire ceiling of the alcove is burning, as well as the area of the platform wall above the opening to the alcove. There is also more smoke from drop-down of the burning foam onto the carpet, both in the alcove and on the platform. In the simulation, the flames have moved into the alcove and are spreading across the ceiling. In both images, the smoke or hot gas layer has developed across the ceiling of the enclosure.

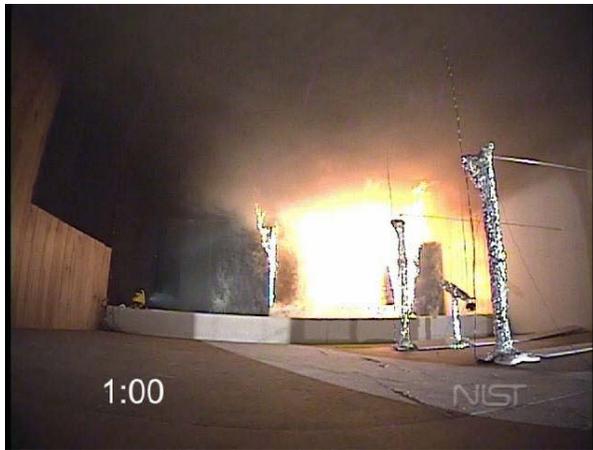
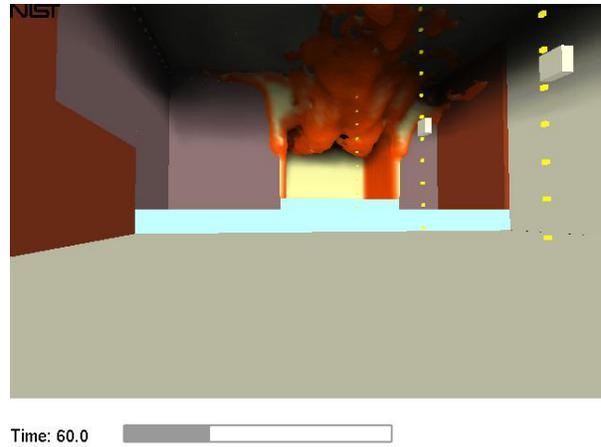
In Figure 5-8, the ceiling and the walls of the alcove have become fully involved with fire in both of the images. At 60 seconds after ignition, flashover has already occurred in the experiment and flashover is about to occur in the simulation. In both cases, flames are extending out of the alcove across the ceiling and the smoke layer has become thicker and darker.

**Figure 5-8. Flashover has occurred in alcove area,  $t = 60$  seconds after ignition.**

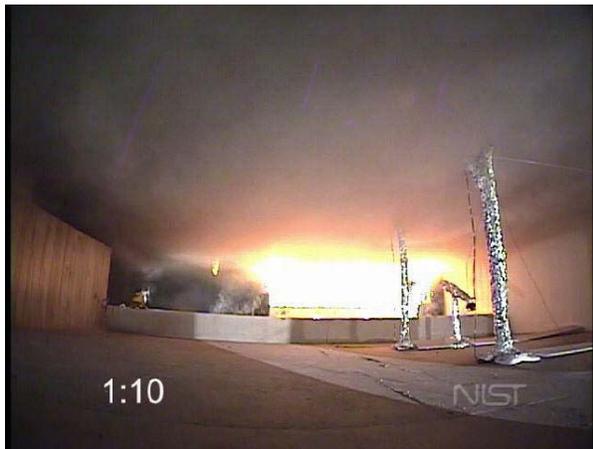
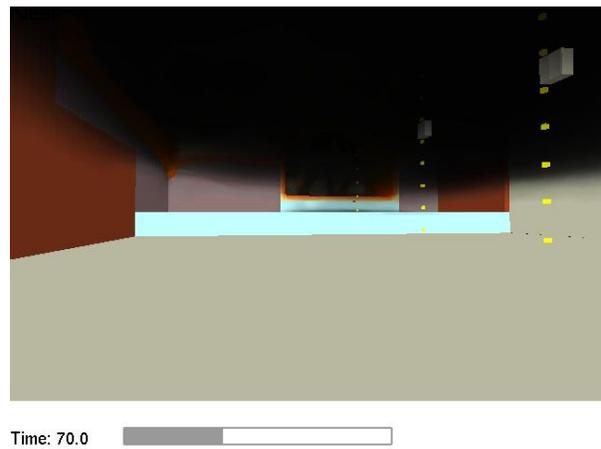
**Figure 5-9. Smoke layer has dropped to 1.5 m above floor,  $t = 70$  seconds after ignition.**

The images in Figure 5-9 show a significant increase in the amount of the smoke in the enclosure. The smoke layer has descended to within 1.5 m (5 ft) of the floor. The flames have spread along the wall behind the platform and can be seen at the lower edge of the smoke layer in both the video frame and the image from the simulation. The smoke in the experiment appears lighter in color than it actually is due to light that is being reflected from floor level halogen lights that were used to improve the visibility for the video cameras.

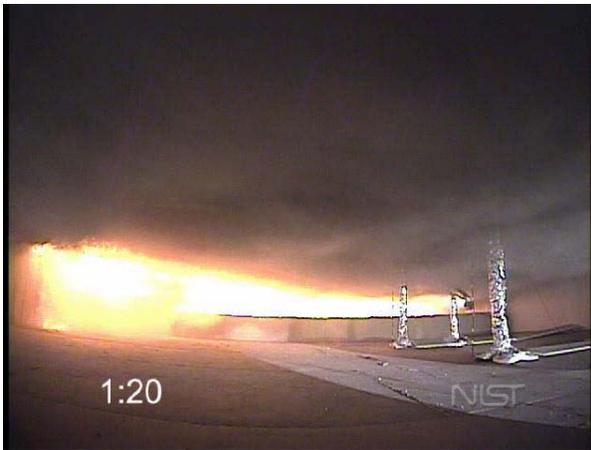
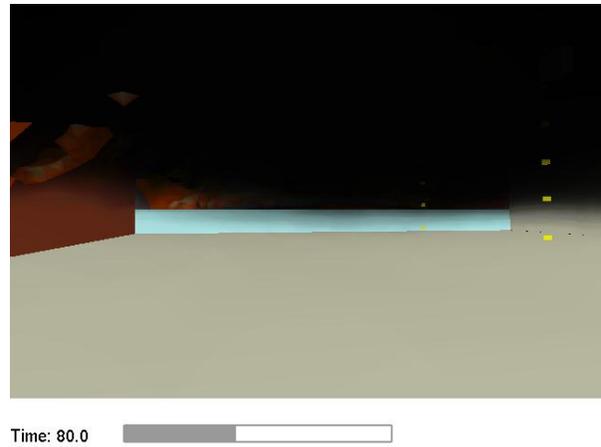
The fire continues to grow in both the experiment and the simulation as shown in Figure 5-10. The smoke layer has continued to descend. The interface height of the smoke layer is approximately 0.75 m (2.5 ft) above the floor at 80 seconds after ignition for both the experiment and the simulation. Both images also show the flame extension on the left wall of the enclosure. The upper portion of the left wall near the platform had foam installed over the paneling.

**Figure 5-10. Fire continues to spread,  $t = 80$  seconds after ignition.**

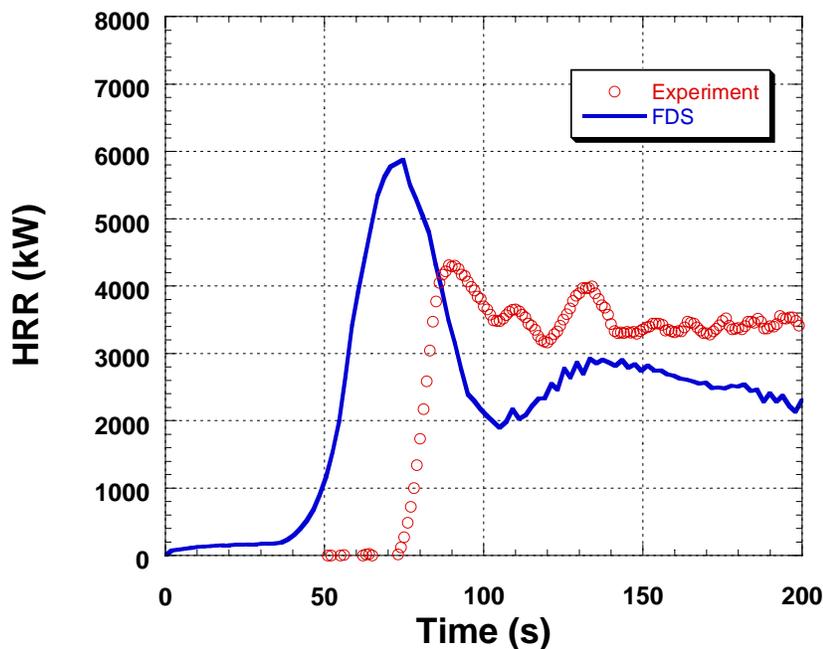
Figure 5-12. Power generated in experiment as measured outside of doorway, compared to FDS simulation of heat release rate from fire within compartment.

Figure 5-12 compares the measured heat release rate leaving the door of the experiment (based upon oxygen consumption) to the heat release rate from the fire within the compartment as predicted by FDS. For fires burning in the open under the laboratory hood, the thermal power measured by the oxygen depletion calorimeter is equal to the heat release rate from the fire. However, for a fire within an enclosure, the effluent from the room is a mixed average of the upper layer gases, and does not represent the instantaneous heat release rate of the fire. Smoke did not exit the compartment doorway until approximately 60 seconds after ignition. This means that a direct comparison between the experimental measurements and the numerical predictions cannot be made because the oxygen depletion calorimeter does not respond to a fire within an enclosure until the combustion products have had time to exit the door and become entrained into the hood. The heat release rate predicted by FDS in Fig. 5-12 represents the instantaneous heat release throughout the room. The heat release rate reaches a peak of

approximately 6 MW about 70 seconds into the simulation, 20 seconds prior to the peak in thermal power measured in the oxygen depletion calorimeter. Both curves approach 3000 kW  $\pm$  300 kW approximately 150 seconds into the fire, again consistent with a ventilation-limited condition. The heat release rates diverge at longer times as the model consumes the remaining interior finish fuels while the physical fire continues to burn at a reduced rate into the wood supporting the platform and walls. When the areas under the heat release rate curves were integrated, the resulting energies were found to agree within 10 %.

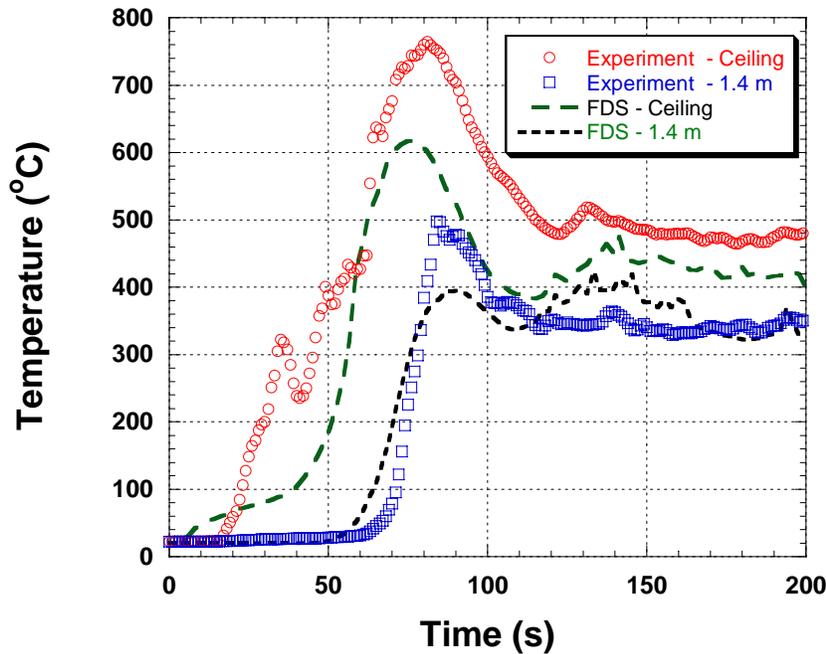
**Figure 5-13. Temperature comparison between the un-sprinklered fire experiment and the FDS simulation at Station C.**

Figure 5-13 is a comparison of the temperatures predicted and measured 25 mm below the ceiling and 1.4 m above the floor at the thermocouple array located at Station C (4.25 m west of the door opening or 1.7 m from the platform). The FDS output has been smoothed by applying a Stineman function (a geometric weight applied to the current point  $\pm$ 10 % of the data range). The temperature data show reasonable agreement with the predictions, including an overshoot followed by a leveling off as the fire reaches a ventilation limit. The temperatures near the ceiling increase faster in the test; conversely, the lower level temperatures increase at a slower rate in the test.

Note that, unlike the heat release rate, the temperature measurements respond to the local environment within a second; hence, the experimental temperatures and FDS predictions can be compared directly. Initially, the experimental measurements near the ceiling increase more rapidly than predicted. This is probably due to the strong transverse temperature gradients associated with the ceiling jets created early in the fire (see Fig. 5-5), where small differences in position between the experiment and simulation can have a large change in temperature. The simulated thermocouple temperatures are temperatures averaged over the grid cell volume(s) that they are associated with, which results in differences in positions between the experimental point measurement and the FDS output. The peak temperatures for the experiment and the simulation occur within 5 seconds of each other.

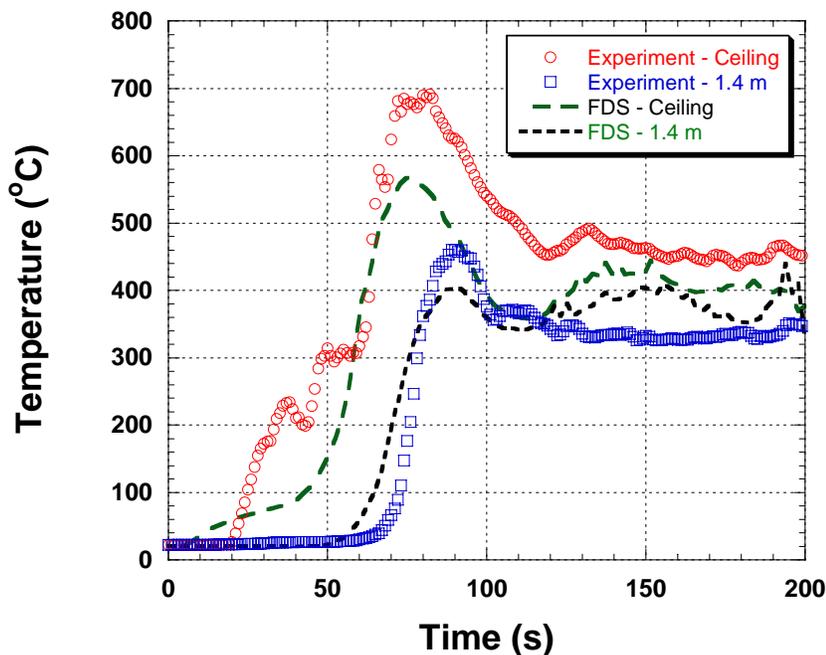
**Figure 5-14. Temperature comparison between the un-sprinklered fire experiment and the FDS simulation at Station D.**

Figure 5-14 is a comparison of the temperatures predicted and measured 25 mm below the ceiling and 1.4 m above the floor at the thermocouple array located at Station D (2.35 m west of the door opening). Similar to the previous figure, the temperature data show reasonable agreement with the predictions. The trends are also similar and both of the measured temperatures and the predictions exhibit a reduction in peak temperatures relative to the values from Station C that is located approximately 2 m closer to the platform.

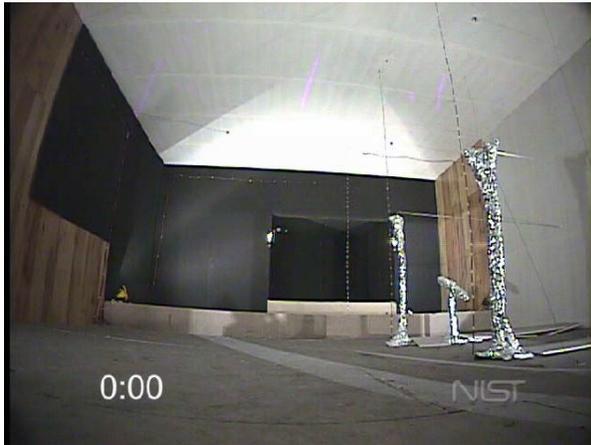
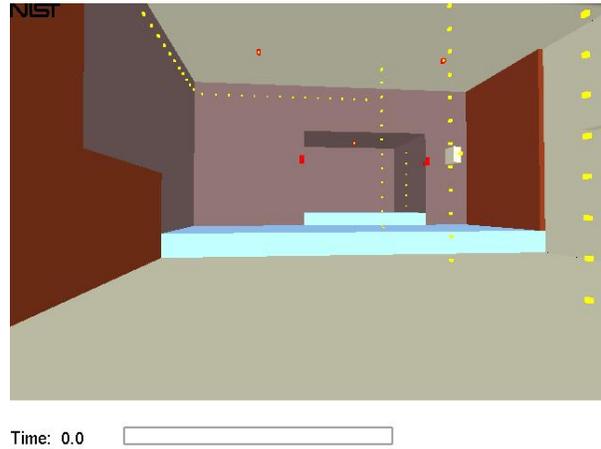
**Figure 5-19. Ignition at the corners of the alcove, t = 0 seconds.**

sprinkler activation. Figures 5-19 through 5-21 show a very similar progression in fire growth as the unsprinklered case for both the experiment and the FDS simulation between ignition and 20 seconds after ignition. Figure 5-22 was captured at 25 seconds after ignition, approximately 1 second after the first sprinkler activated in both the experiment and the simulation. With the experiment, the impact of the sprinkler can be seen as the fire on the right side of the platform wall is suppressed. In FDS the flame height on the right side of the alcove can be seen to be reduced.

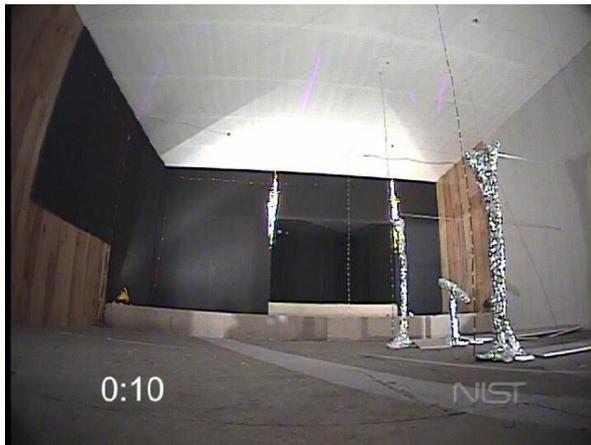
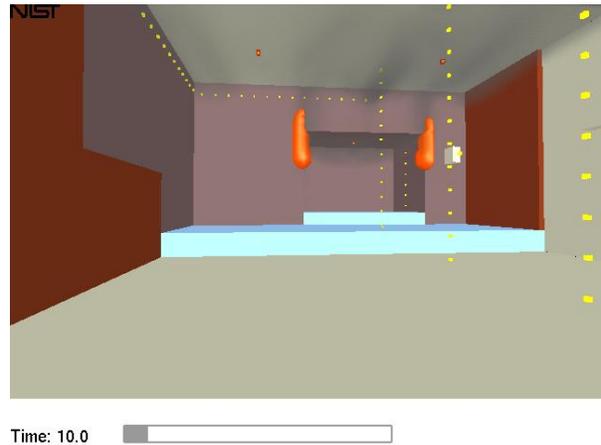
**Figure 5-20. Flames spreading toward ceiling, t = 10 seconds after ignition.**

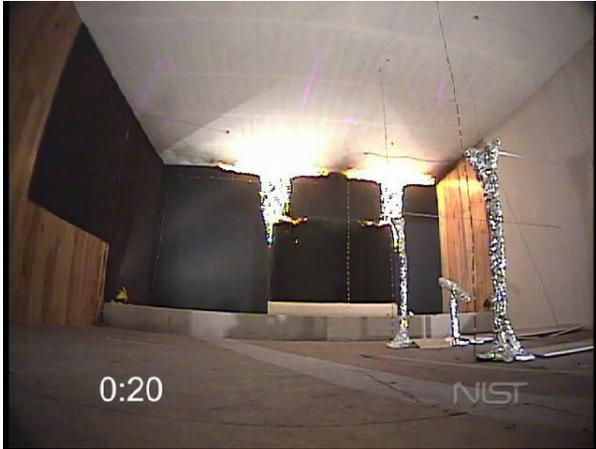
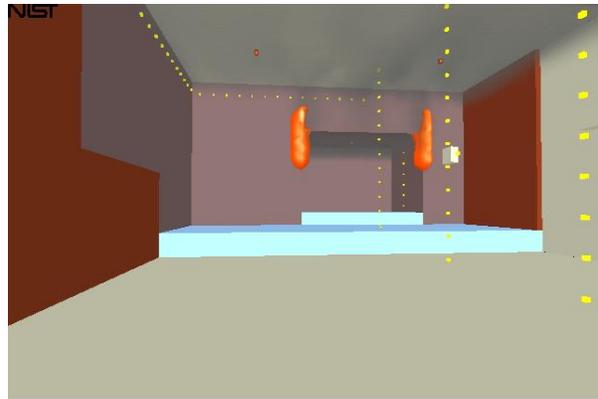
Figure 5-21. Flames impinging on ceiling,  $t = 20$  seconds after ignition.

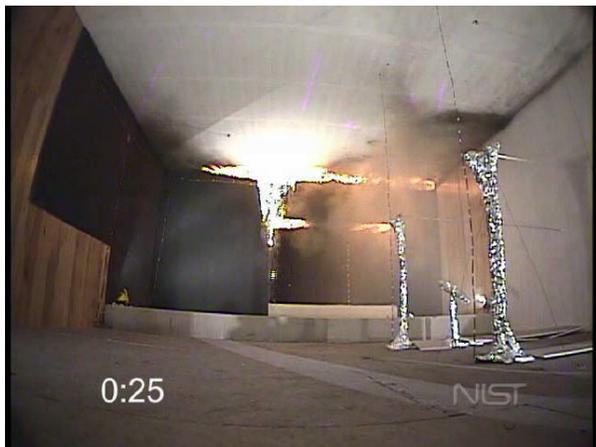
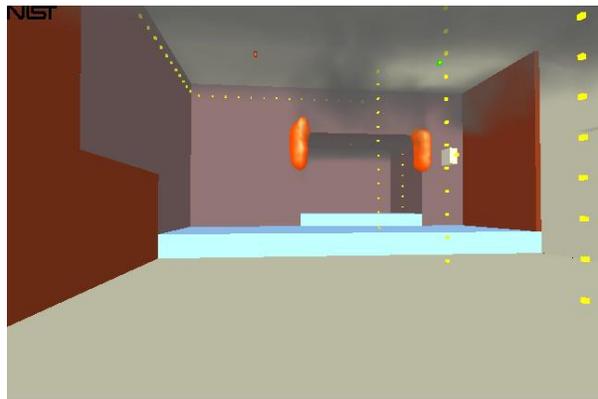
Figure 5-22. Initial sprinkler operating,  $t = 25$  seconds after ignition.

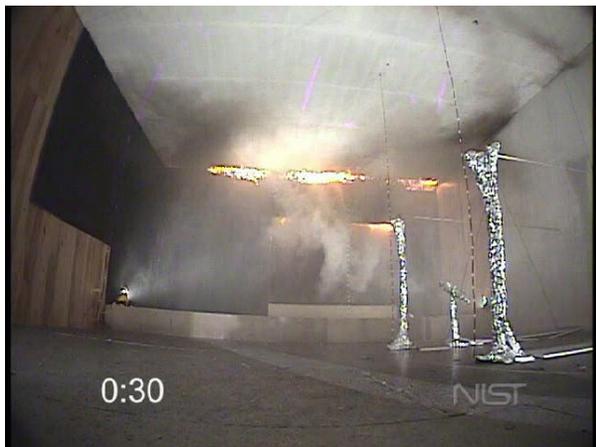
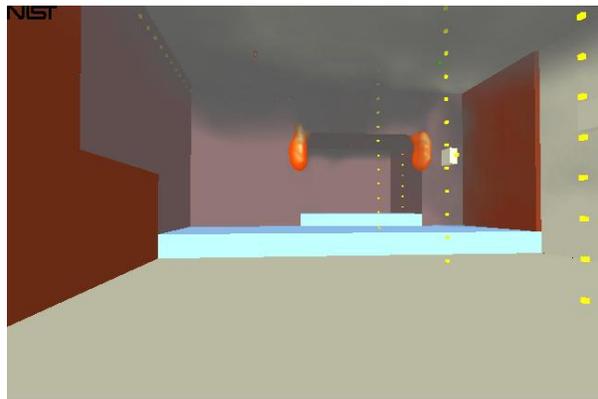
Figure 5-23. Third sprinkler operating in experiment,  $t = 30$  seconds after ignition.

By 30 seconds (see Fig. 5-23) the effect of both of the sprinklers above the platform operating as well as the sprinkler in the alcove is apparent. Burning continues at the intersection of the platform wall and the ceiling. This area is above where the water spray is hitting the wall. Also notice the flames on the ceiling of the alcove. This area is shielded from the water spray of the two sprinklers. The smoke being pushed out of the alcove is due to the activation of the sprinkler on the ceiling of the alcove. In the simulation, only one sprinkler is operating at this time. The fire growth on the right side of the alcove has been limited by the single sprinkler.

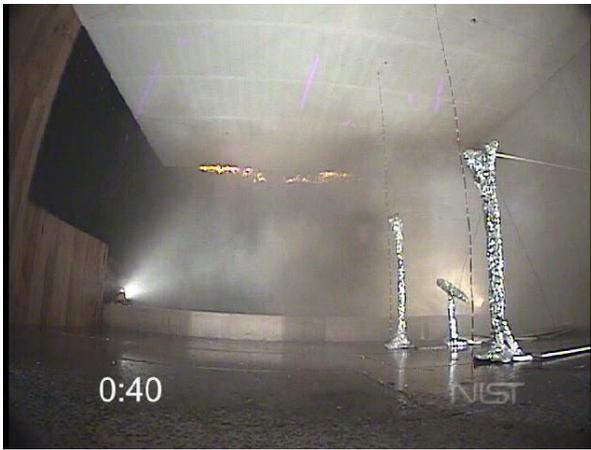
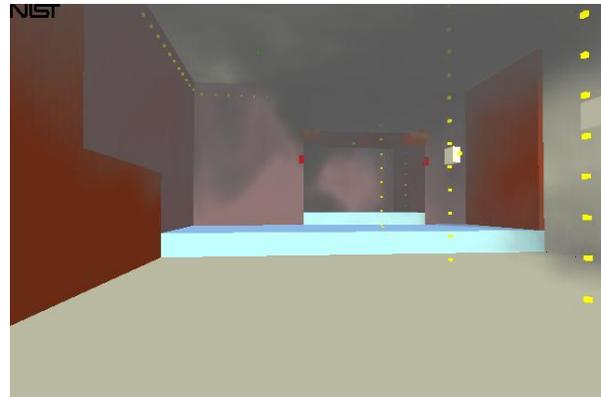
**Figure 5-24. Suppression with three sprinklers operating in each case, t = 40 seconds after ignition.**

By 40 seconds after ignition, three sprinklers in the experiment and in the simulation have activated. The video frame in Figure 5-24 shows that the fire in the alcove has been suppressed and that the burning above the water line on the platform wall continues. With three sprinklers operating in FDS, the water spray is significantly reducing the visible flames. The flames on the platform wall have been suppressed. However, there are still flames visible at the intersections of the alcove ceiling and the alcove walls on both sides of the alcove. These areas are shielded from the water spray of the sprinklers over the platform and they are above the water impact line from the sprinkler in the alcove.

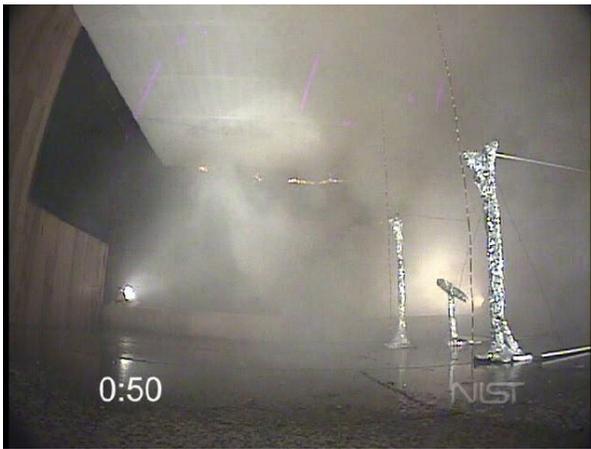
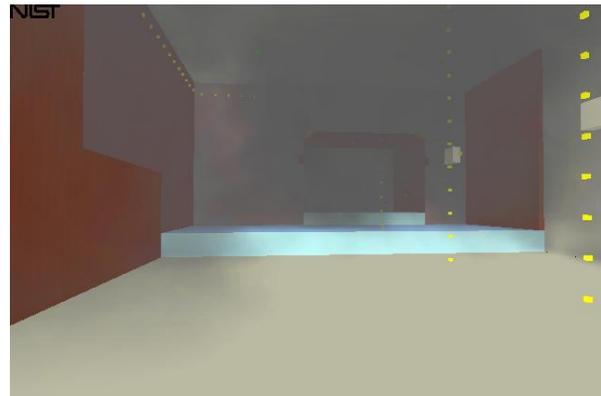
**Figure 5-25. Fire suppression continues in both the experiment and the simulation, t = 50 seconds after ignition.**

Figures 5-25 through 5-27 show continued fire suppression for both the experiment and the simulation. In both cases some flames exist in the ceiling area of the alcove. But clearly the rate of fire growth and the resulting hazard development has been reduced significantly when compared with the unsprinklered case.
