NIST NCSTAR 2: Vol. I

# Report of the Technical Investigation of The Station Nightclub Fire

# **Report of the Technical Investigation of The Station Nightclub Fire**

June 2005

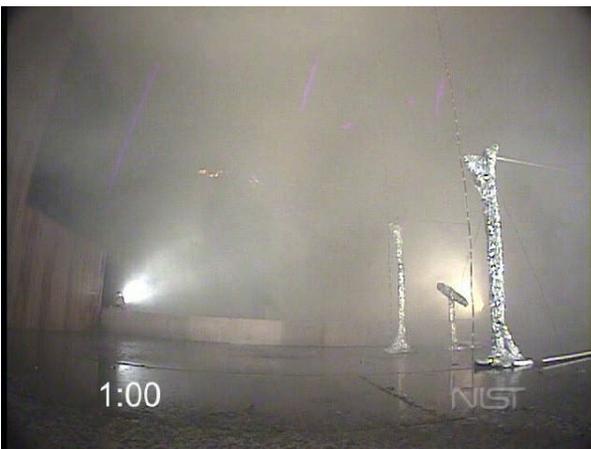
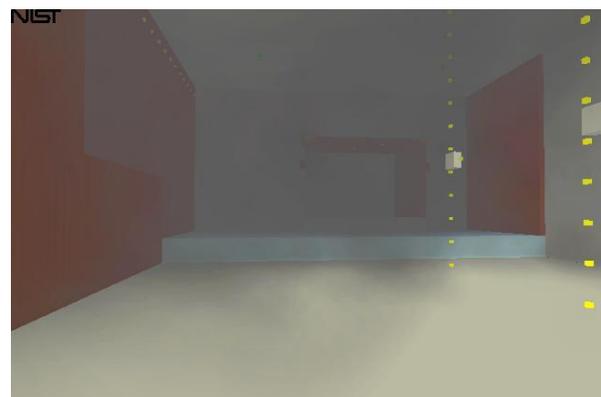
**Figure 5-26. Fire controlled in both cases, t = 60 seconds after ignition.**

Figures 5-25 through 5-27 show continued fire suppression for both the experiment and the simulation. In both cases some flames exist in the ceiling area of the alcove. But clearly the rate of fire growth and the resulting hazard development has been reduced significantly when compared with the unsprinklered case.

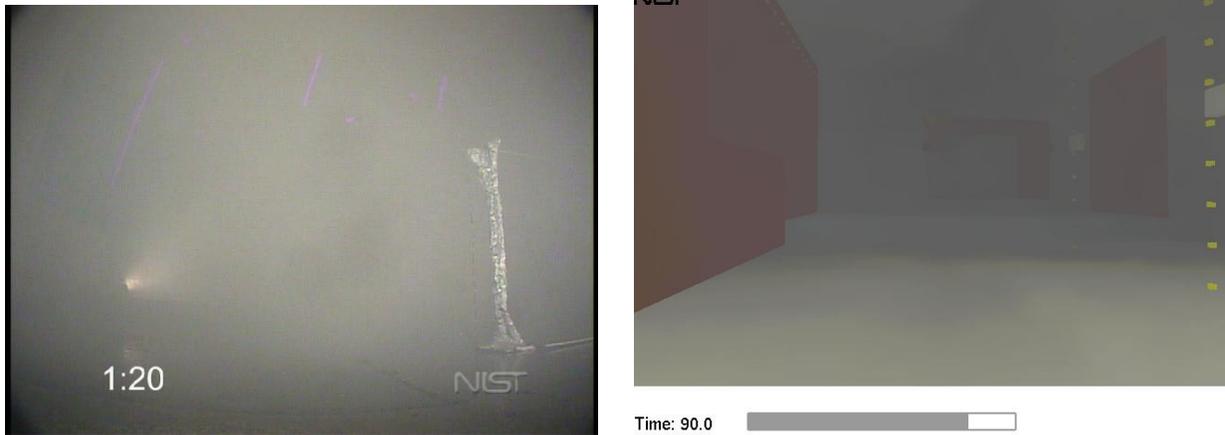
**Figure 5-27. Fire controlled in both cases,  $t = 90$  seconds after ignition.**

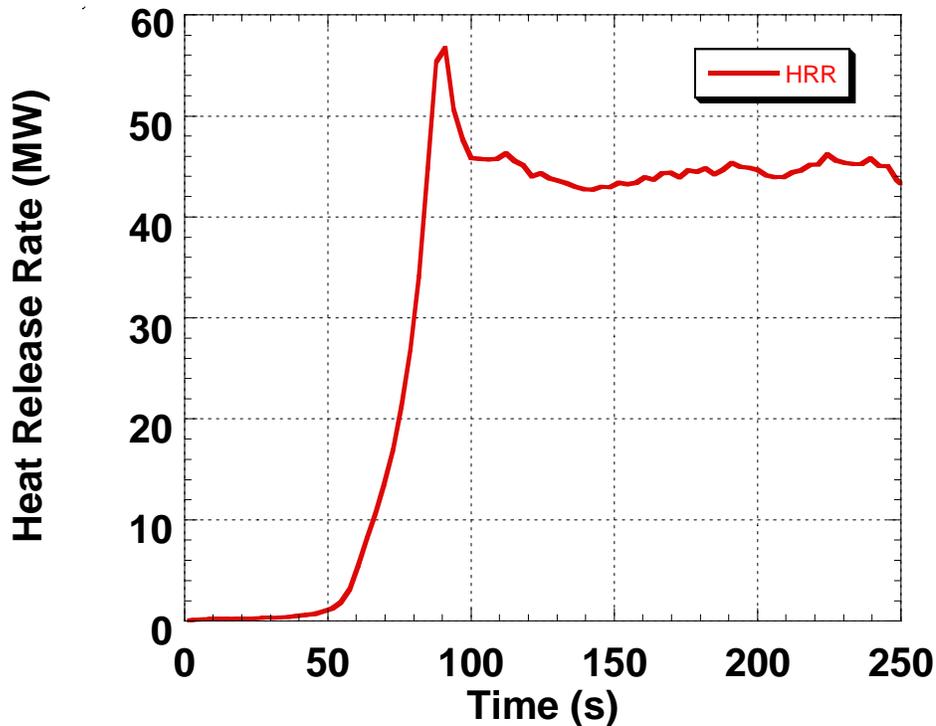
The total heat released in the fire is plotted in Figure 5-42. The graph shows that after the alcove became fully involved with fire, at approximately 50 to 60 seconds, the heat release rate increased from approximately 2 MW to 54 MW in less than 50 seconds. Hence the rate of increase was more than 1 MW per second. As the fire spread throughout the structure and the fire became oxygen limited the heat release rate became steady at approximately 45 MW for approximately 150 seconds. After that time, the simulation began to deplete the fuel contained in the interior finish materials. The fire in the actual nightclub had spread into the structure and burned in and through areas of the roof and walls by this time. The simulation only provided fuel based on the interior finish and did not account for fuel being provided by structural elements and materials in building outer envelope.

**Figure 5-42. Total Heat Released in Building Fire Simulation as a Function of Time**

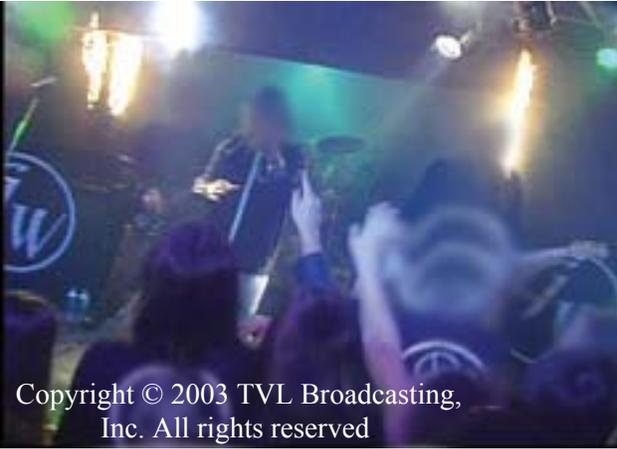
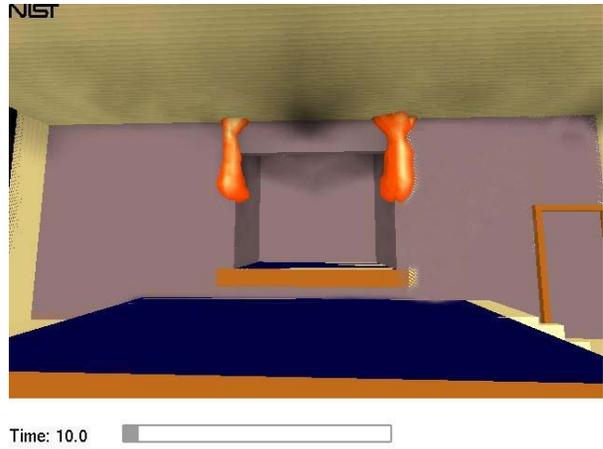
The images from the video in Figures 5-43 and 5-44 capture the initial state of the fires on each side of the platform shortly after the gerb discharge had stopped. At 10 seconds after ignition, the fire can be seen burning on two surfaces at each of the corners; this is also considered in the simulation with the placement of the ignition vents on both sides of the corner. In both the simulation and the actual incident the flames impinge on the ceiling within 20 seconds after ignition.

**Figure 5-43. Initial growth of fire on foam at corner of the alcove (10 seconds)**

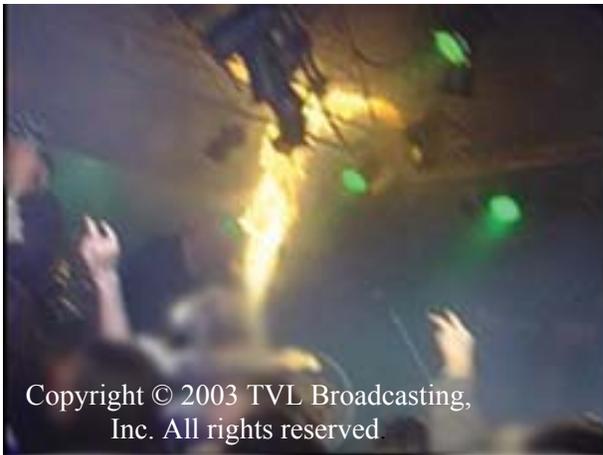
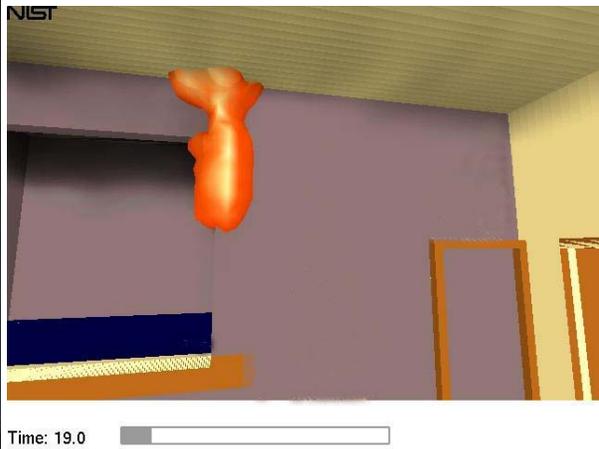
**Figure 5-44. Flames impinging on ceiling (19 seconds)**

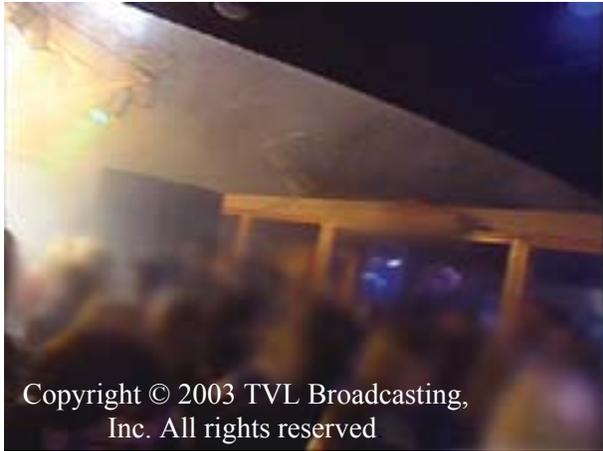
At 23 seconds after ignition, Figure 5-45, the videographer has begun to move toward the exit as have many in the crowd. Notice that many people are still facing the platform. The fire continued to grow and smoke has collected in the raised ceiling area over the dance floor. The smoke filling can be seen in the image from the simulation. (Note the black rectangular image on the floor is representative of the speaker cabinet, whereas the boundaries of the smoke layer are irregular.) At 53 seconds after ignition, the flames have grown and spread along the platform wall and into the alcove as shown in video image in Figure 5-46. In addition, the smoke is spreading across the lower level ceiling area toward the main exit. The flames have spread in the simulation as well and smoke is beginning to spill over from the dance floor area towards the exits and the main bar room, although it takes a few more seconds into the simulation for this to occur. Again the black rectangular objects on the floor are representative of speaker cabinets (near the platform) and the sound and lighting board (left side).

**Figure 5-45. Videographer backing away from platform (23 seconds)**

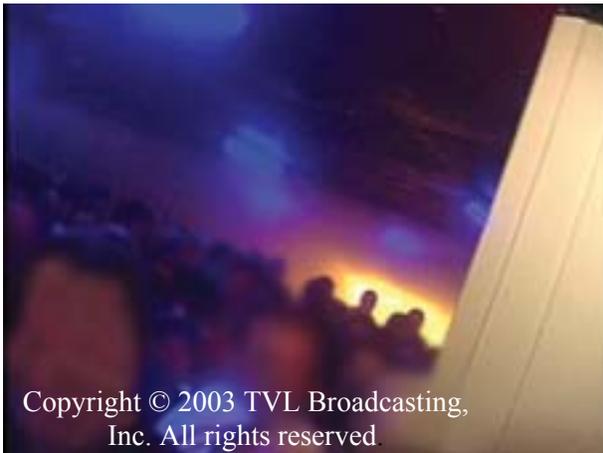
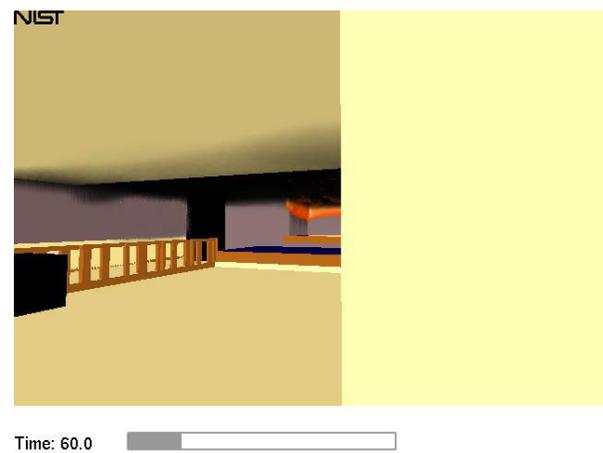
**Figure 5-46. Smoke beginning to roll across ceiling (video 53 seconds, simulation 60 seconds)**

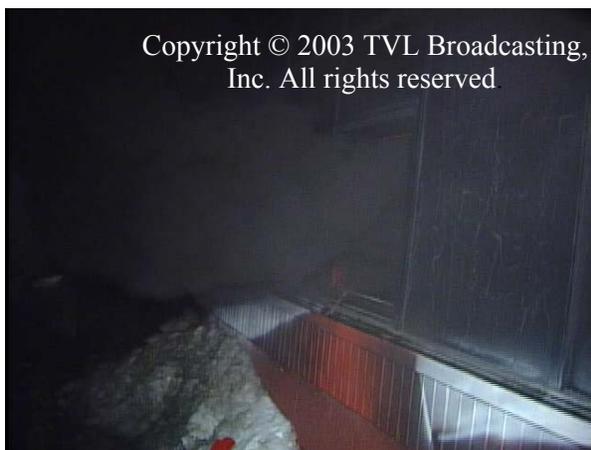
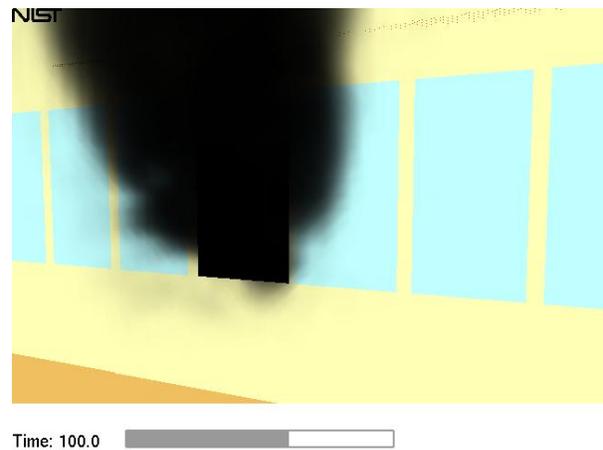
The videographer had exited the nightclub at approximately 70 seconds and headed toward the stage door. He then returns toward the main entrance and attempts to pass between the nightclub and the bus when he encounters a plume of black smoke pushing out of one of the window vents in the sunroom. The image from the simulation also shows a similar view. At approximately 110 seconds after ignition, smoke is flowing from the main entrance; the image from the simulation is given in Figure 5-48. The model did not account for people blocking the air flow into the doorway.

**Figure 5-47. Smoke billowing outside from broken sunroom window (100 seconds)**

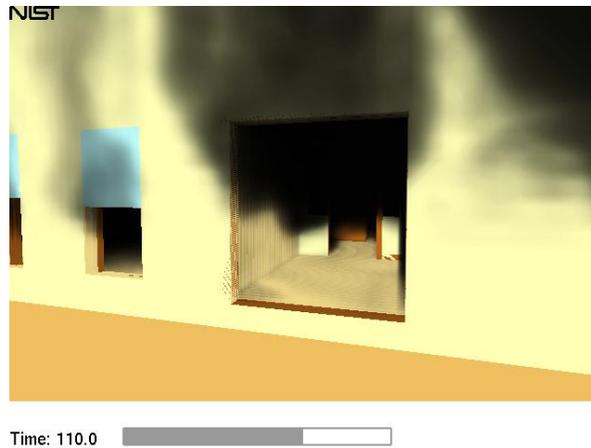
**Figure 5-48. Light smoke emanating from front door of nightclub (110 seconds)**

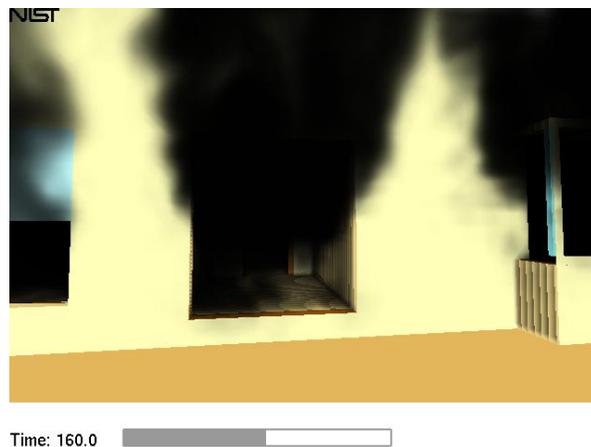
The Smokeview image in Figure 5-49 shows the smoke flow from the front door at 160 seconds after ignition in the simulation. In Figure 5-50, the simulated smoke flow from the main bar room windows is shown. More smoke is coming from the center window than the two side windows because the upper and lower portions of the center window have been removed while only the lower portion of the side windows are open in the simulation.

**Figure 5-49. Heavy smoke leaving front door and open main bar window (160 seconds)**

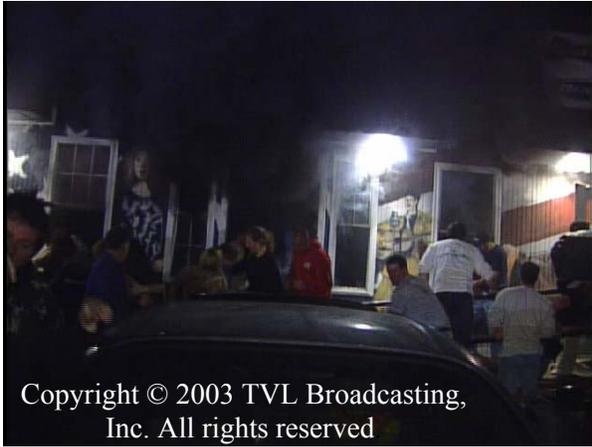
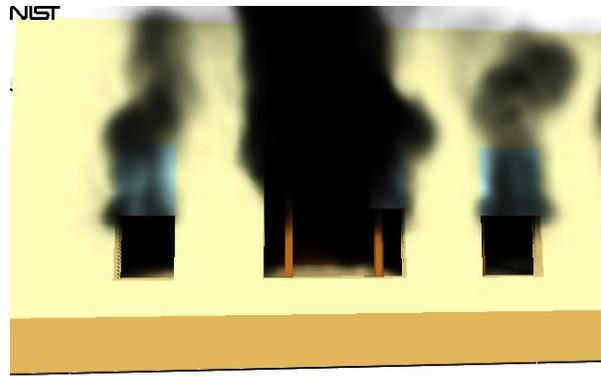
**Figure 5-50. View of smoke plumes from front windows of horseshoe bar area (176 seconds)**

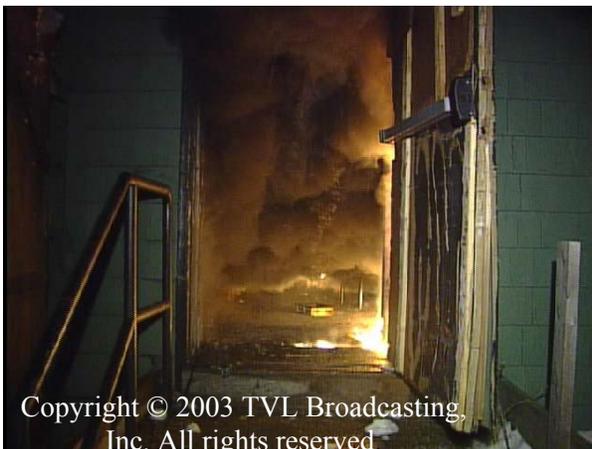
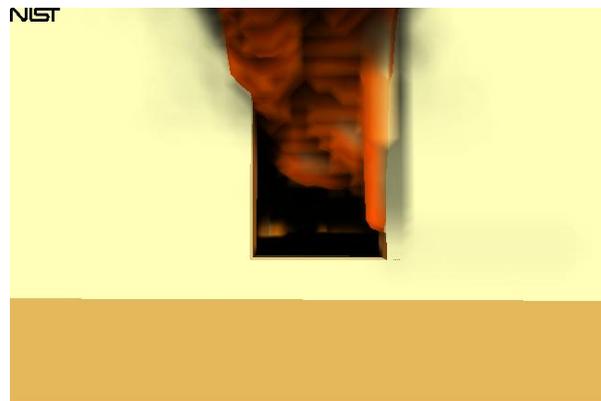
The videographer moves around to the stage door again. The view inside the open door at approximately 289 seconds after ignition is shown in Figure 5-51. The image from the simulation agrees with the video image on the level of combustion products in the doorway. However without a comparison to the temperature in the doorway, the mixture fraction alone would indicate that more flames are in the area of the stage doorway than can be seen in the video image. The videographer continues around to the backside of the nightclub, at 300 seconds after ignition flames are coming through a small portion of the back wall (south wall) of the dance floor area and smoke is leaking from the bathroom hallway wall. The videographer moved toward the front of the nightclub again, at 309 seconds flames can be seen in the area of the front door. It takes another 25 seconds before he is in a position to record the images of the flames coming from the sunroom windows and the main door. The simulation stops at 300 seconds after ignition, short of the time that the entire nightclub reaches flashover conditions.

**Figure 5-51. Looking into stage door exit (289 seconds)**

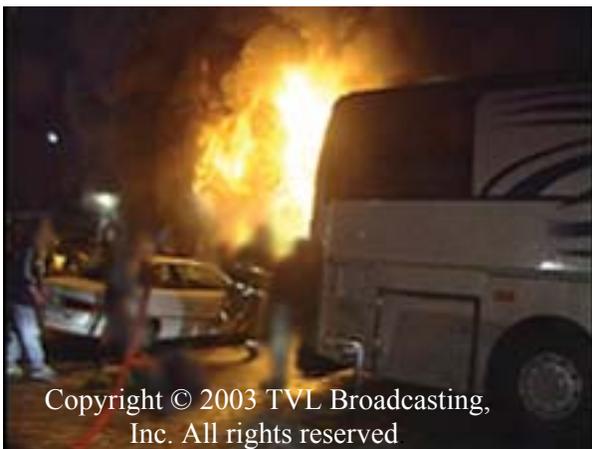
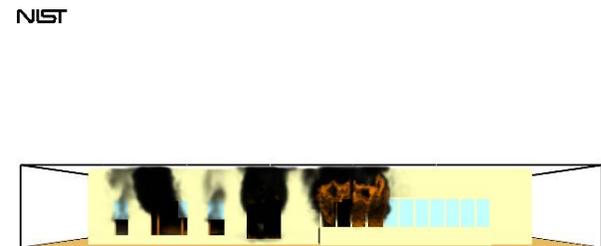
**Figure 5-52. Flames breaking through front door and sunroom windows (337 seconds video, 300 seconds simulation)**

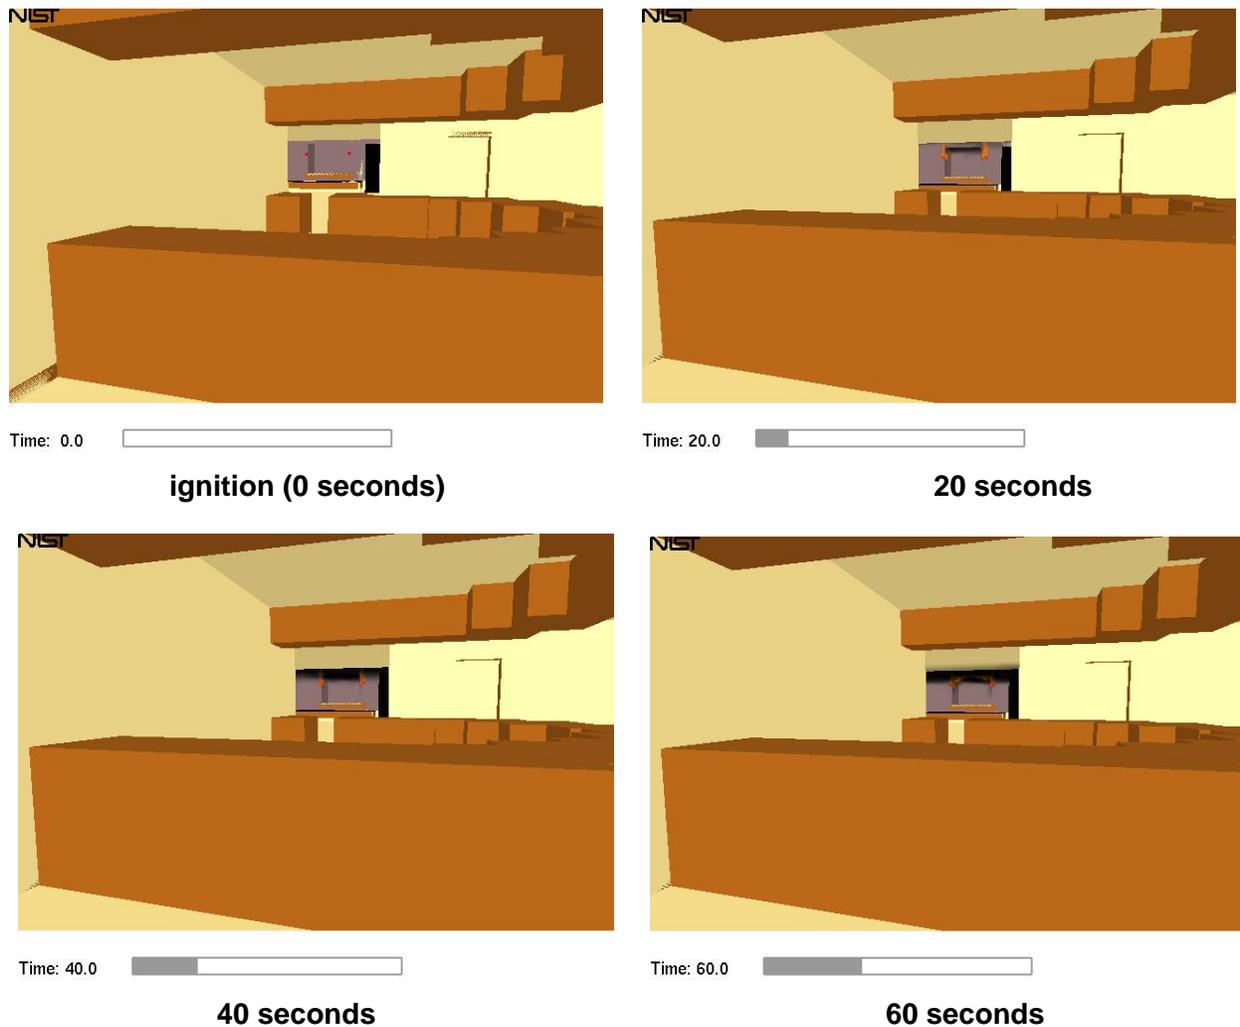
Smokeview images were rendered at certain time intervals from the view looking through the far side of the main bar to the platform area. (See Figures 5-53a,b.) This allowed for the conditions to be observed at several key locations: the platform area, the entrance to the main exit way and the main bar area. Many of the occupants traveled this path as either they were able to exit or were overcome by the conditions prior to being able to do so. The fire developed quickly in the platform area as the foam burned and resulted in the alcove becoming fully developed with fire. Once that occurred the flames involved the entire rear wall and spread toward the main entrance, generating large amounts of smoke. At 70 seconds after ignition, the smoke can be seen in the area of the main entrance to the nightclub. This is consistent with the WPRI video. As the videographer leaves the nightclub, at approximately 70 seconds after ignition, smoke is flowing over the heads of people in the main entry foyer. However, even 80 seconds after ignition visibility remained high in the main bar room. This changed suddenly as the smoke and hot gases that were spilling out of the now-filled raised ceiling above the dance floor quickly spread to the main bar room. Based on the FDS simulation, within another 20 seconds, 100 seconds after ignition visibility was impaired, and remained so throughout the rest of the 300 seconds simulation. Flames can be seen in the last three images of Figure 5-53b as the surfaces in the main bar area began to burn.

**Figure 5-53a. View of fire from beyond horseshoe bar, looking at platform (0 - 60 seconds)**

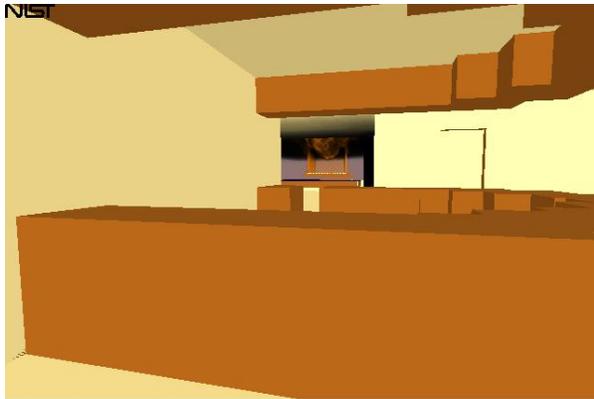
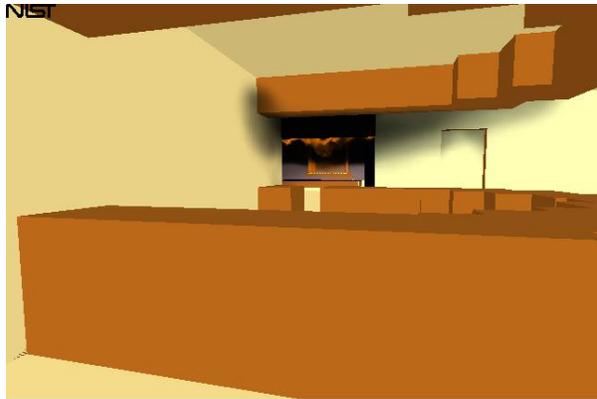
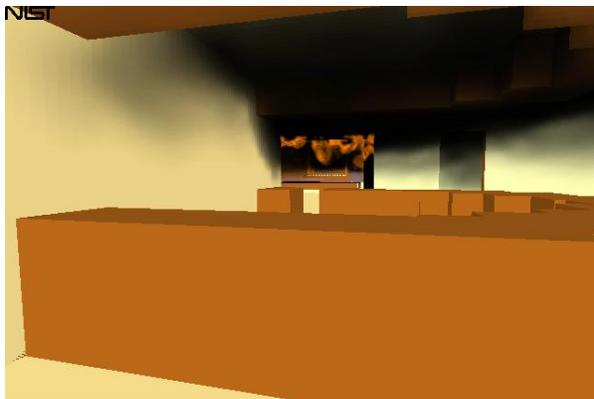
Figure 5-53b. View of fire from beyond horseshoe bar, looking at platform (85 - 250 seconds)

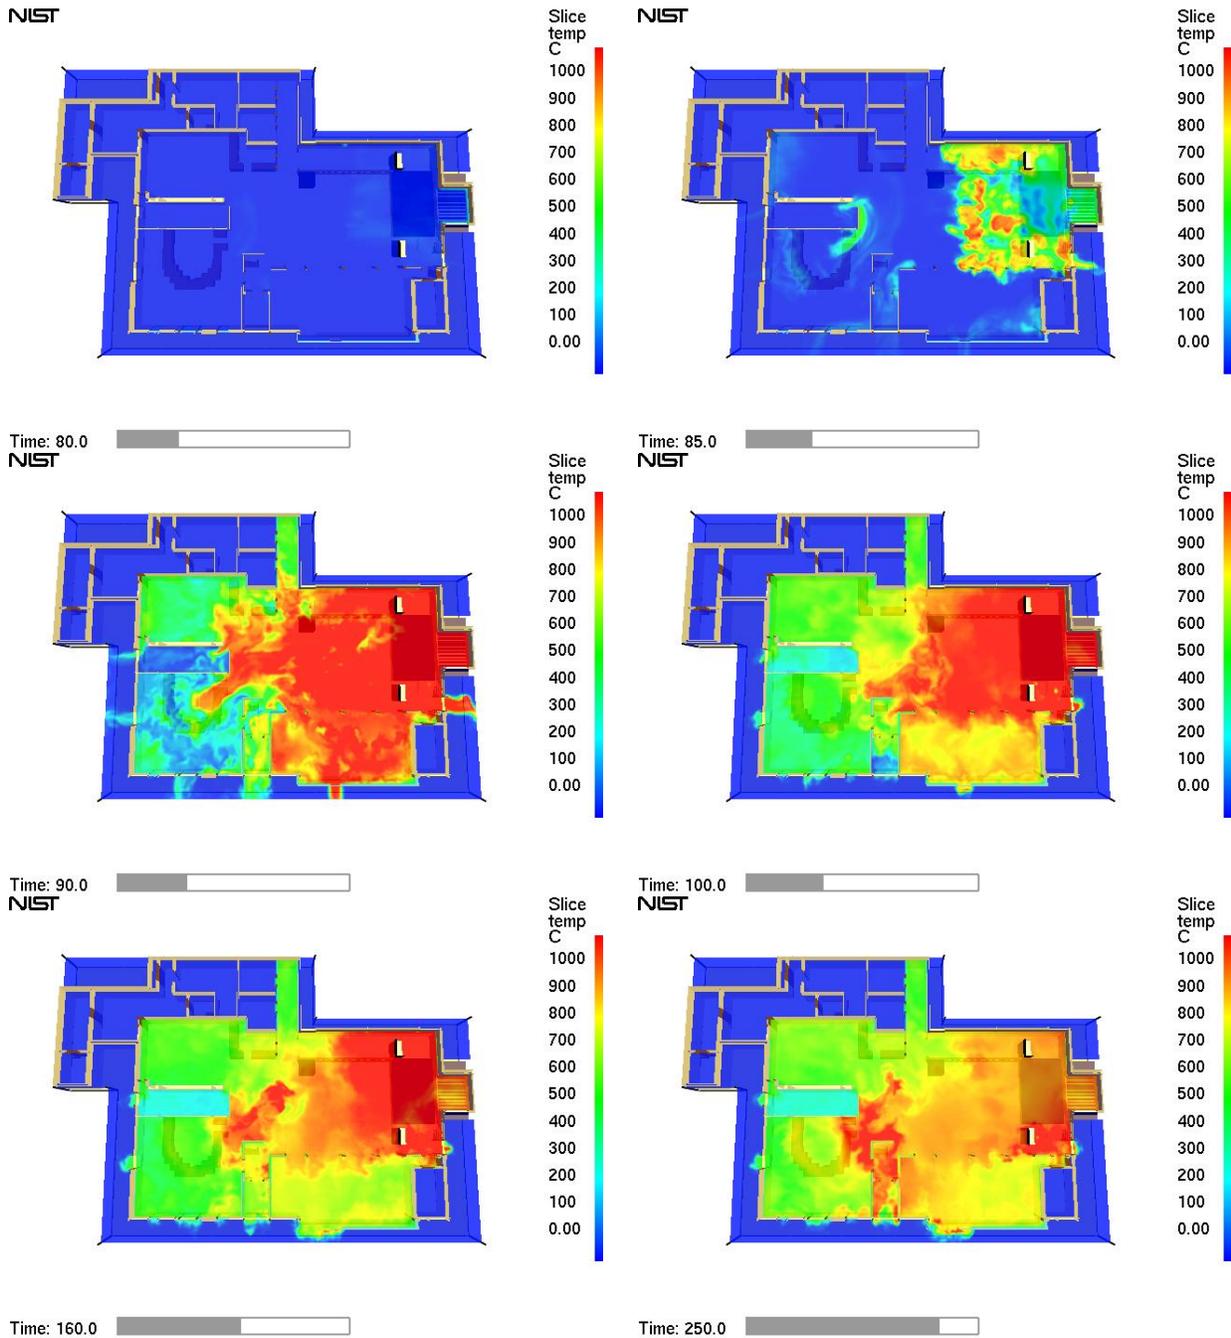
Figure 5-55. Temperatures at 1.5 m (5 ft) above the floor, 80 seconds to 250 seconds

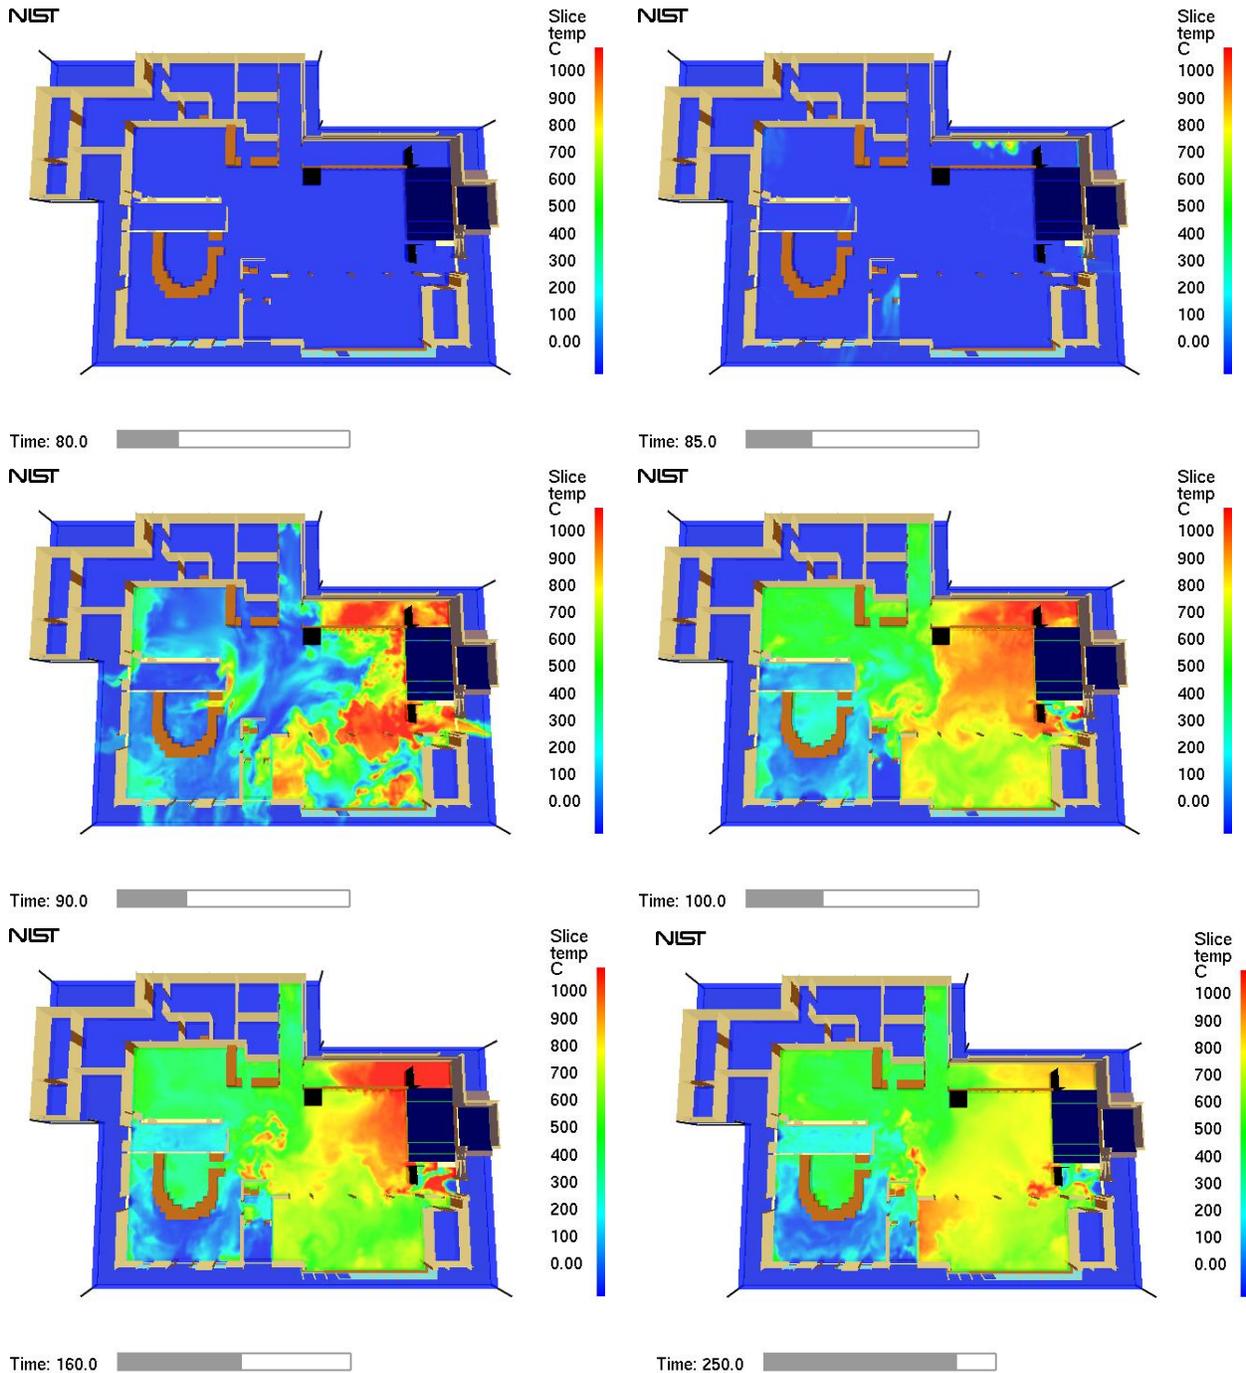
At the 0.6 m (2 ft) height above the floor conditions remain tenable for a longer period of time than at the higher elevation. Figure 5-56 contains images captured at the same time intervals as in the previous figure. One can see that the dance floor and adjacent areas reach untenable temperatures in the simulation within 90 seconds after ignition. The sunroom and dart room areas are predicted to reach untenable temperatures within another 10 seconds.

Figure 5-56. Temperatures at 0.6 m (2 ft) above the floor, 80 seconds to 250 seconds

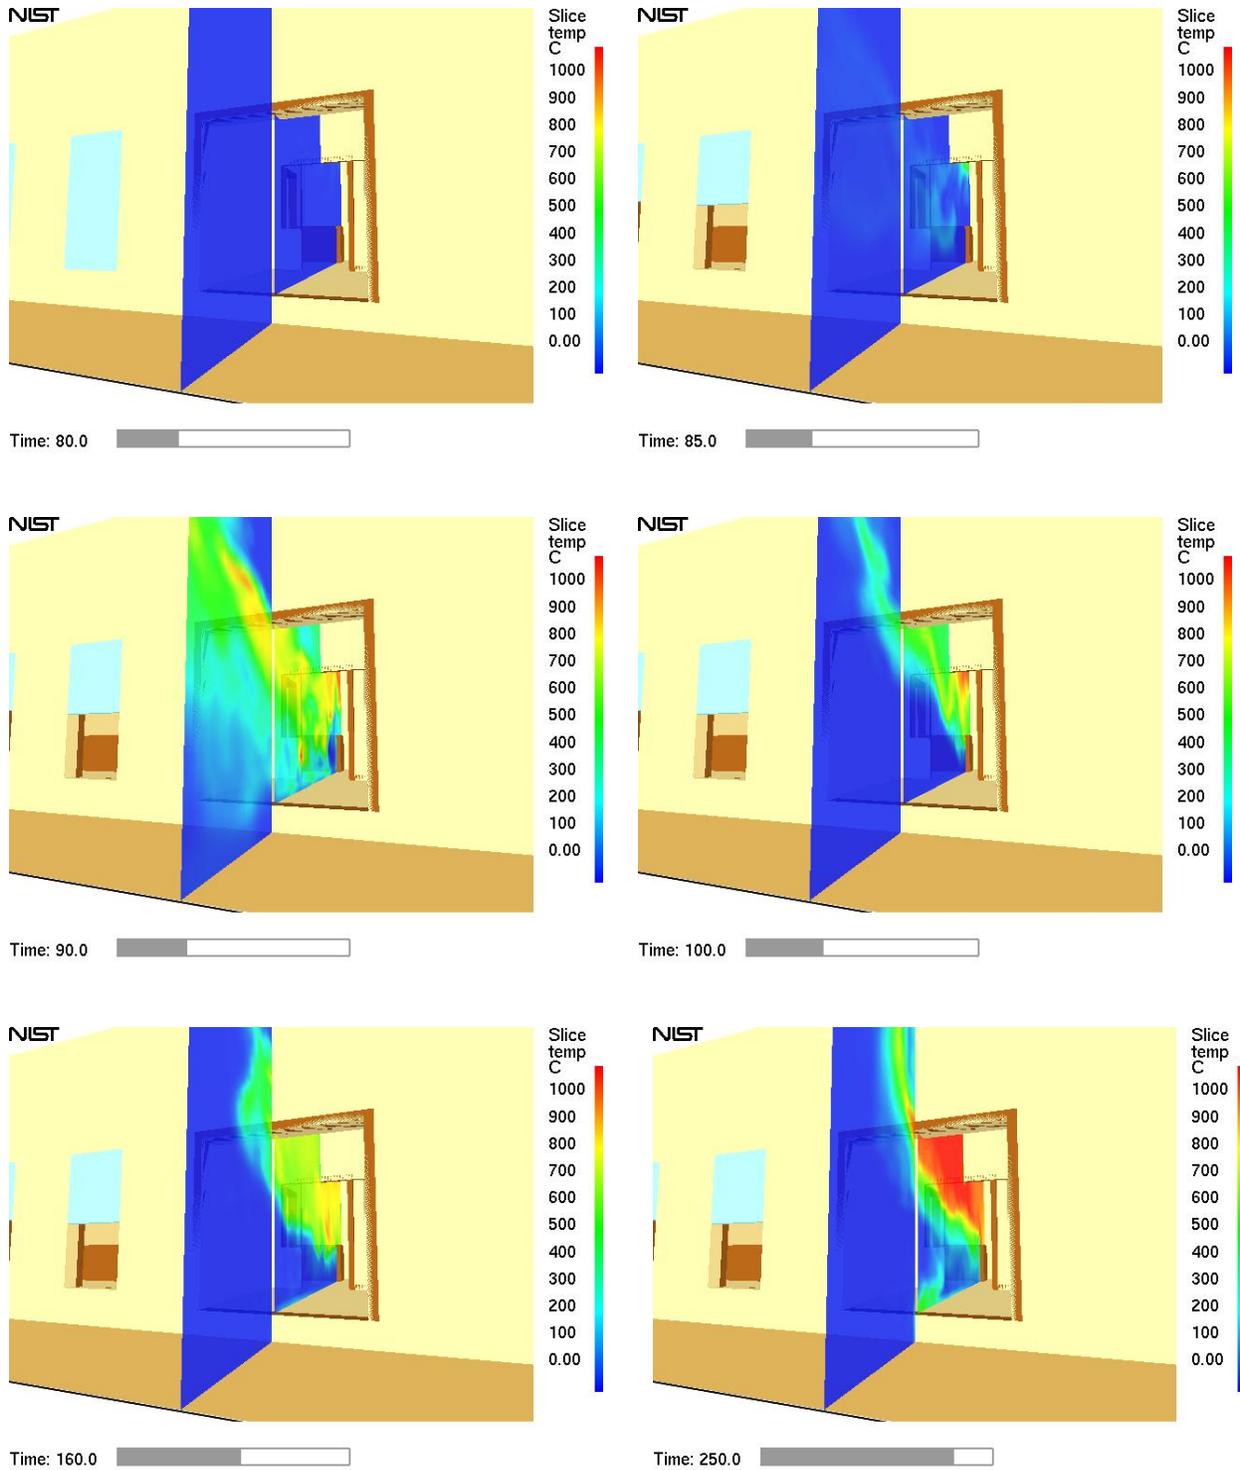
Figure 5-57 shows the temperature predictions for the plane of data that is centered along the axis of the entry foyer. Temperatures just inside the front door, near the floor remain below the tenable limit because of the fresh air being drawn in through the doorway. This region of tenability decreases in a triangular orientation as the entranceway goes into the structure and gets smaller as the simulation continues. This simulation does not account for the occupants that accumulated in the doorway. Thirty-one victims were located in this area.

**Figure 5-57. Temperature profile through the center of the entry foyer, 80 seconds to 250 seconds**

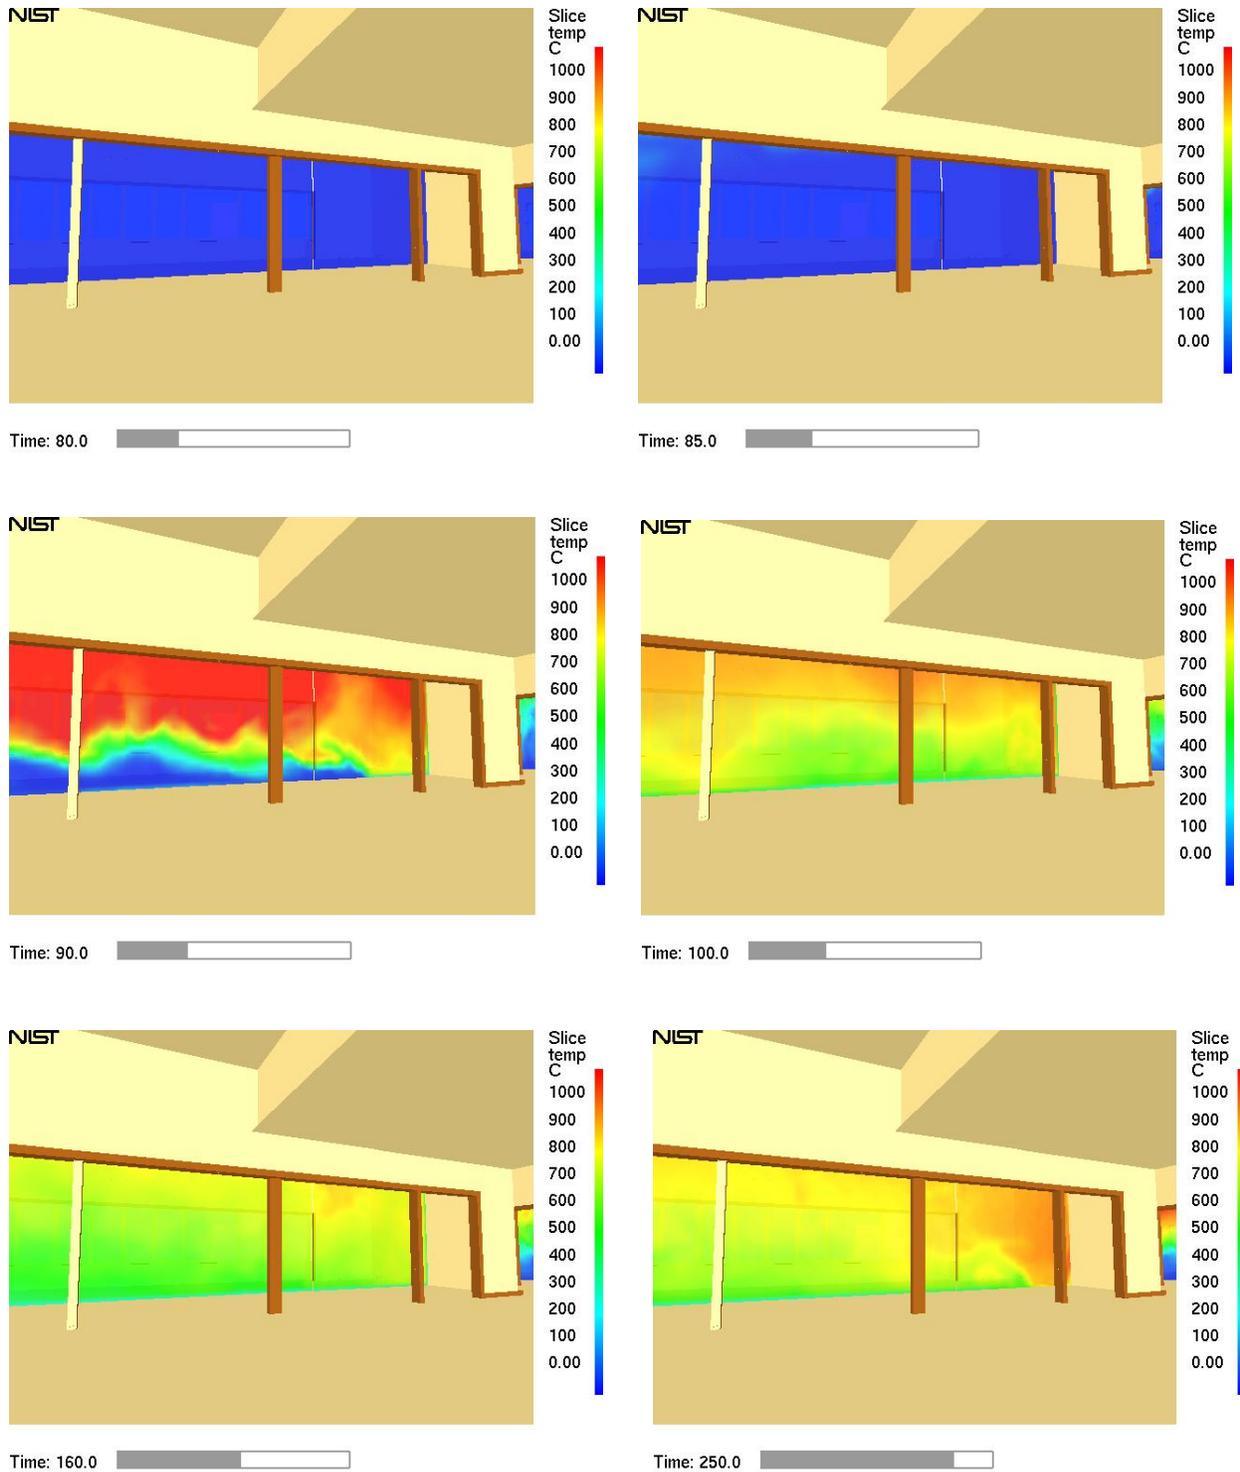
The area in the end of the sunroom adjacent to the entranceway was also a location that many victims were found. A vertical temperature slice through this area, shown Figures 5-58a and 5-58b, suggests that these victims did not have much time before the heat overcame them. Temperatures exceeded the 120 °C (248 °F) tenable threshold within 90 seconds after ignition. The simulation indicates that this change was rapid and extreme with temperatures in the upper portion of the space increasing from ambient conditions to flame temperatures on the order of 1000 °C (1830 °F) within 10 seconds. After the initial energy release due to the burning polyurethane foam (90 seconds), the predicted temperature decreased, but remained in the untenable range throughout the remainder of the simulation. Figure 5-58b shows that the temperatures increased again to 900 °C (1650 °F) at 250 seconds after ignition. The opening of portions of the bay windows between 78 seconds and 120 seconds after ignition had a minimal impact on reducing the temperatures in this part of the building. Eighteen victims were located in this area.

**Figure 5-58. Temperature profile through the center of the sunroom, 80 seconds to 250 seconds**

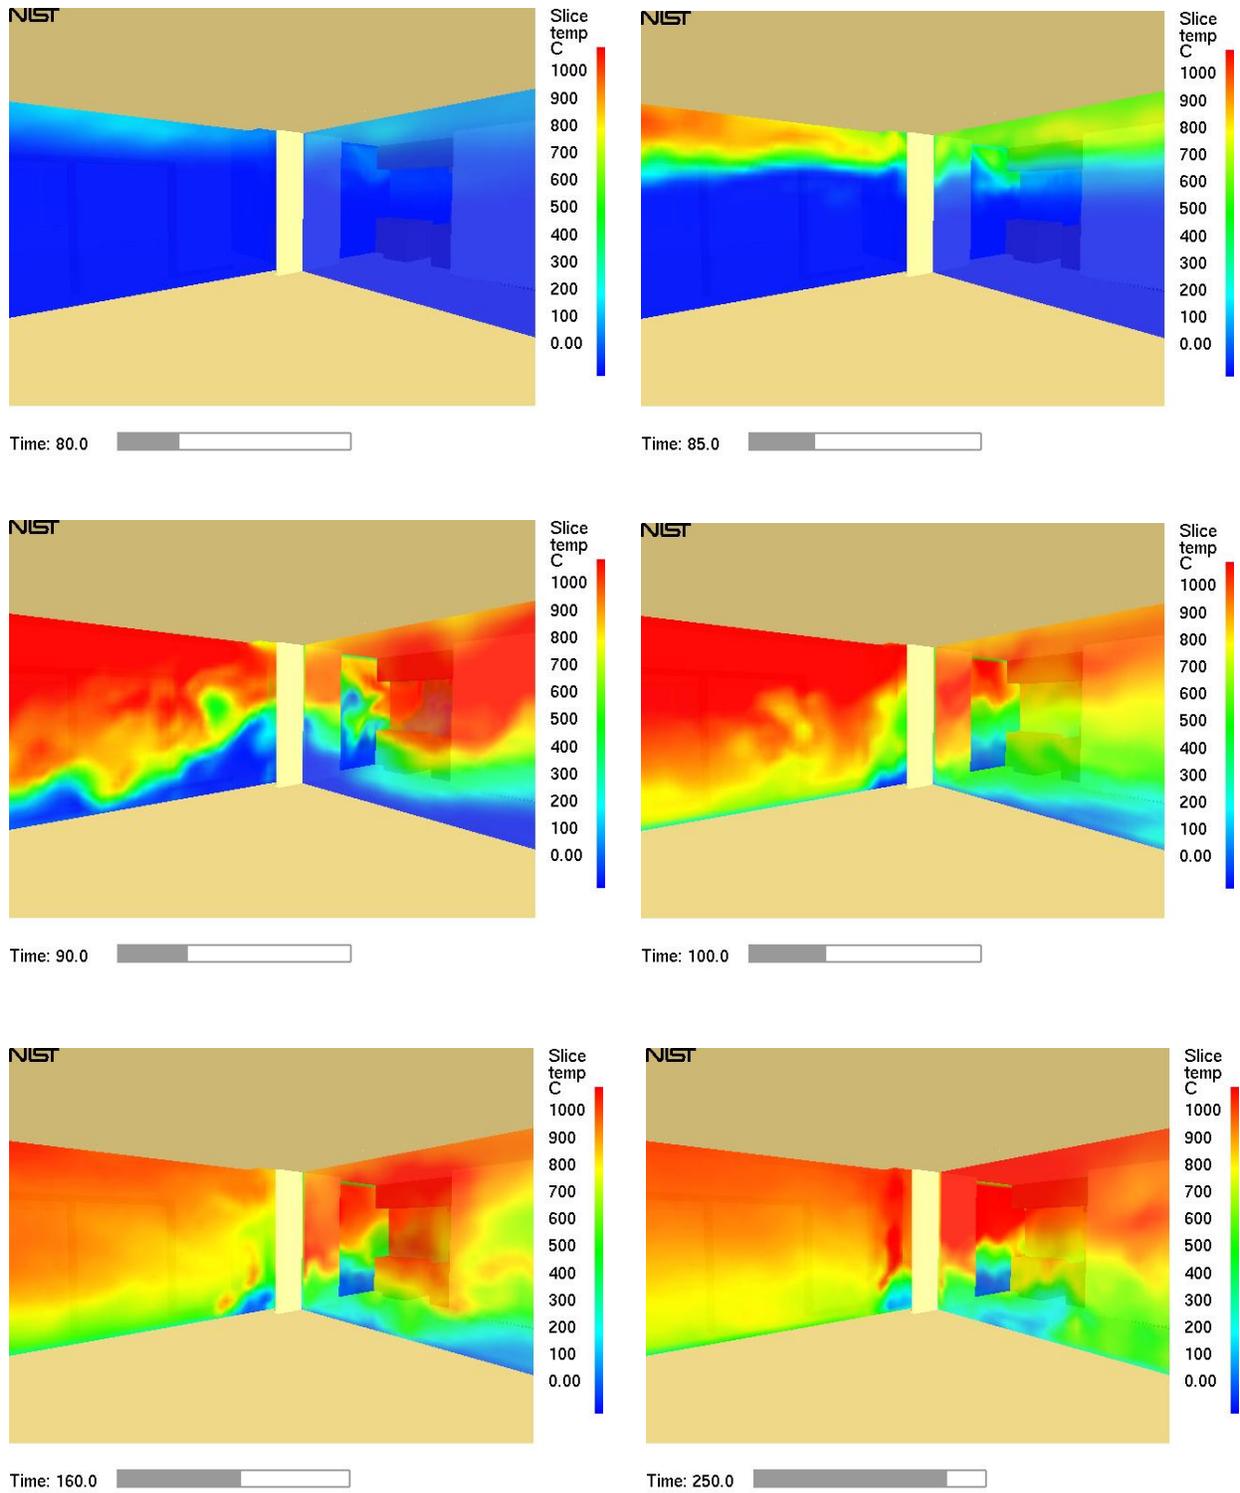
Figure 5-59 depicts the temperatures in the approaches to the main entry foyer. The vertical temperature slices cover the area at the end of the entrance foyer and next to the ticket booth. The view is from the dance floor area looking toward the main entrance (front door). What appears to be a pillar in between the intersection of the two vertical slices is a portion of the wall that separates the sunroom from the main entry foyer. The images demonstrate that temperatures were untenable outside of the entranceway and that if the occupants were not able to make it into the area of cool air coming in from the front doorway, they did not have a chance of survival. Temperatures near the floor exceeded 400 °C (750 °F) within 100 seconds of ignition. Nine victims were located in this area.

**Figure 5-59. Temperature profiles approaching main entry foyer, 80 seconds to 250 seconds**

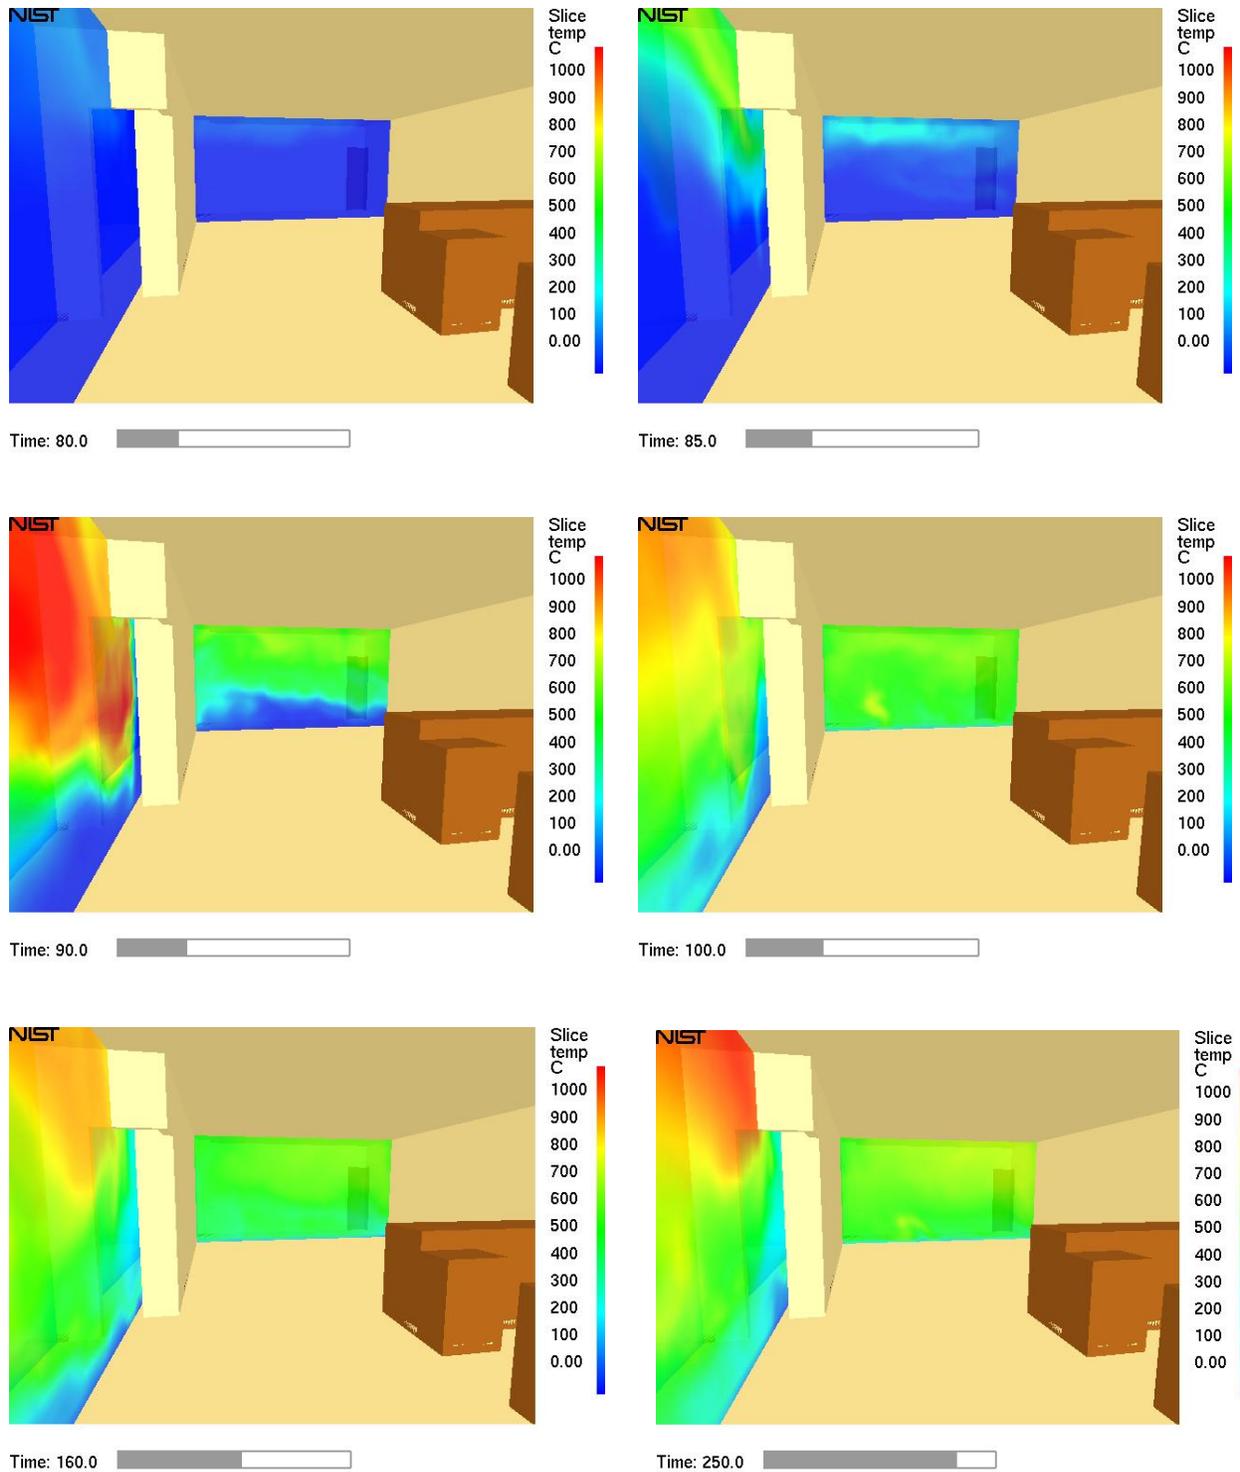
The area of the nightclub with the side bar and the dart room is shown in the simulated images with vertical temperature slices bounding the area to the north (toward the main entrance) and to the east (toward the storage/office area entrance). Figure 5-60 shows the rapid change in thermal conditions between 80 seconds and 90 seconds after ignition. As in other parts of the nightclub simulation this significant increase in temperature was due to the burning of the polyurethane foam. Temperatures near the floor ranged from 200 °C (390 °F) to 600 °C (1110 °F) at 100 seconds. The figure indicates that the temperatures remained in the untenable range throughout the rest of the simulation. In the incident, nine victims were found in this area.

Figure 5-60. Temperature profiles in the dart room, 80 seconds to 250 seconds
