NIST NCSTAR 2: Vol. I

# Report of the Technical Investigation of The Station Nightclub Fire

# **Report of the Technical Investigation of The Station Nightclub Fire**

June 2005

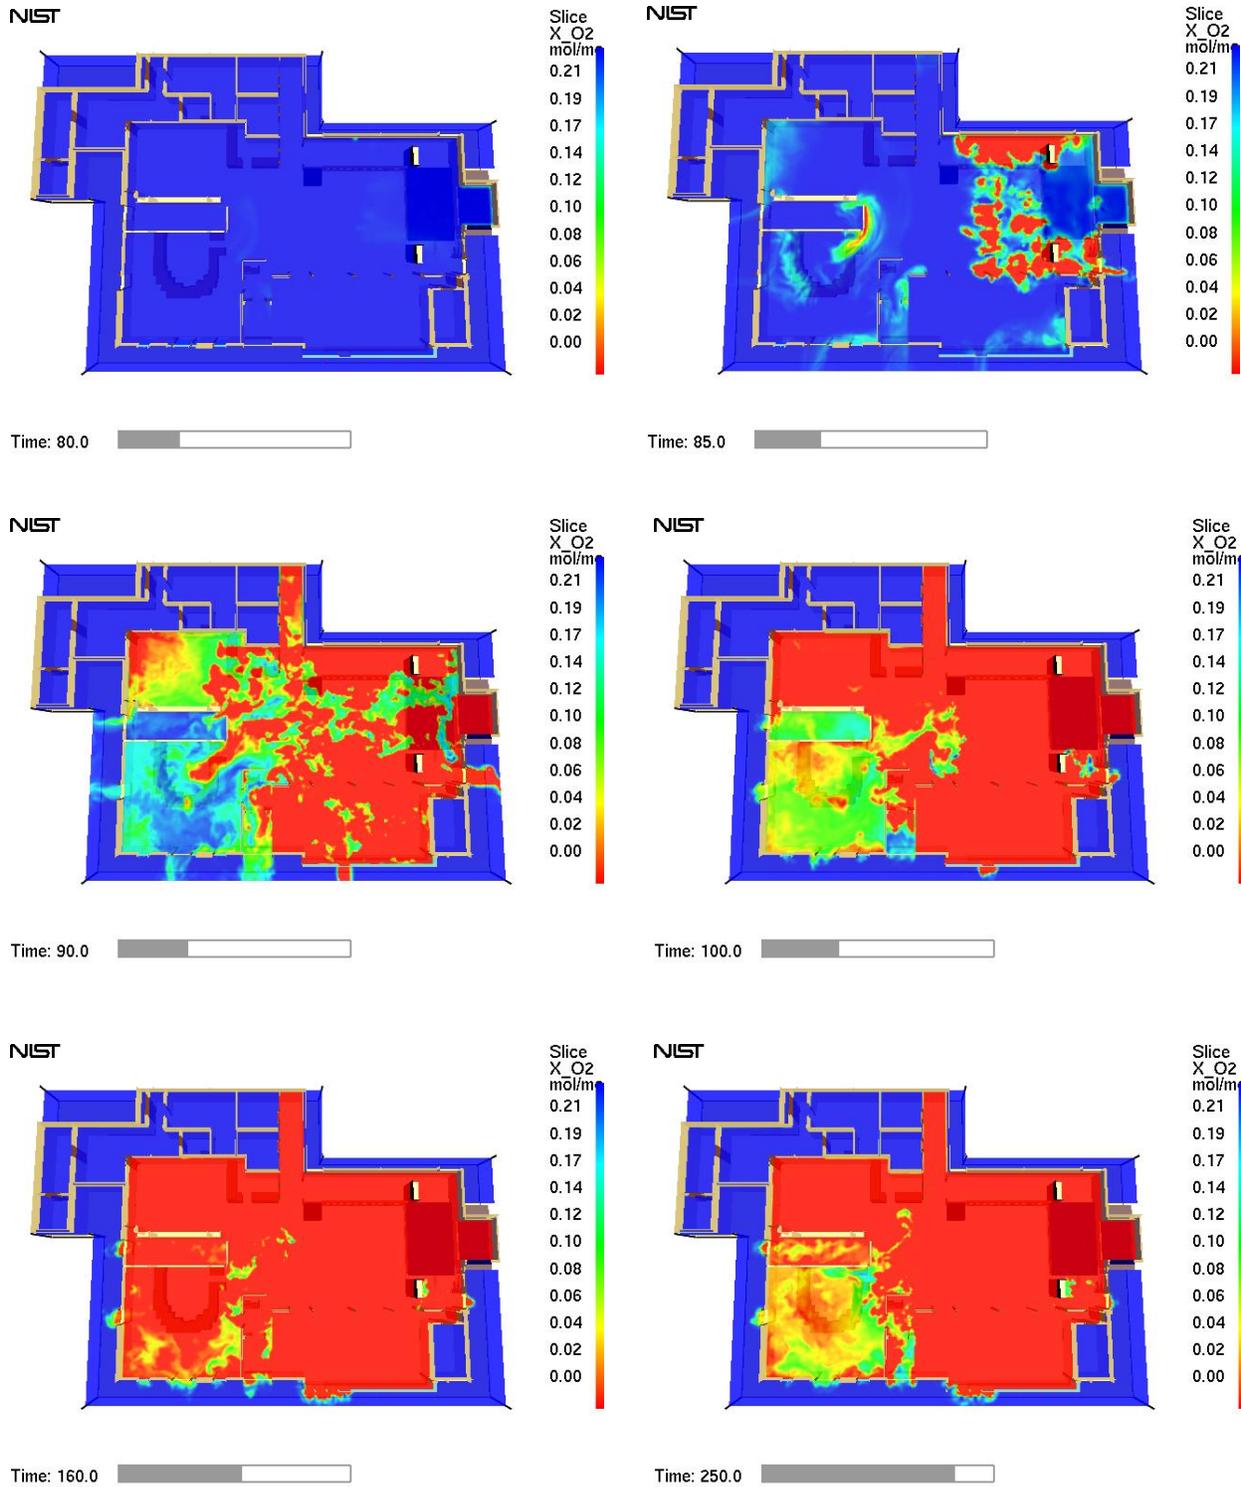
Just as the temperature levels rose rapidly after the platform area became fully involved in flames, the oxygen levels drop proportionally. As shown by the three dimensional smoke output in the previous section, the smoke spreads quickly through the structure. The first four images in Figure 5-61 range from 80 seconds after ignition to 100 seconds after ignition. This sequence has the most dramatic changes in oxygen concentration. Beyond 100 seconds the entire structure is untenable at the 1.5 m (5 ft) height. Tenability exists for the longest duration in the main bar area. Most of the building, including the platform and dance floor areas, the dart room, the main entry foyer and the main bar room, is shown by the simulation to be significantly depleted of oxygen to less than two percent.

Figure 5-61. Oxygen volume fractions at 1.5 m (5 ft) above the floor, 80 seconds to 250 seconds

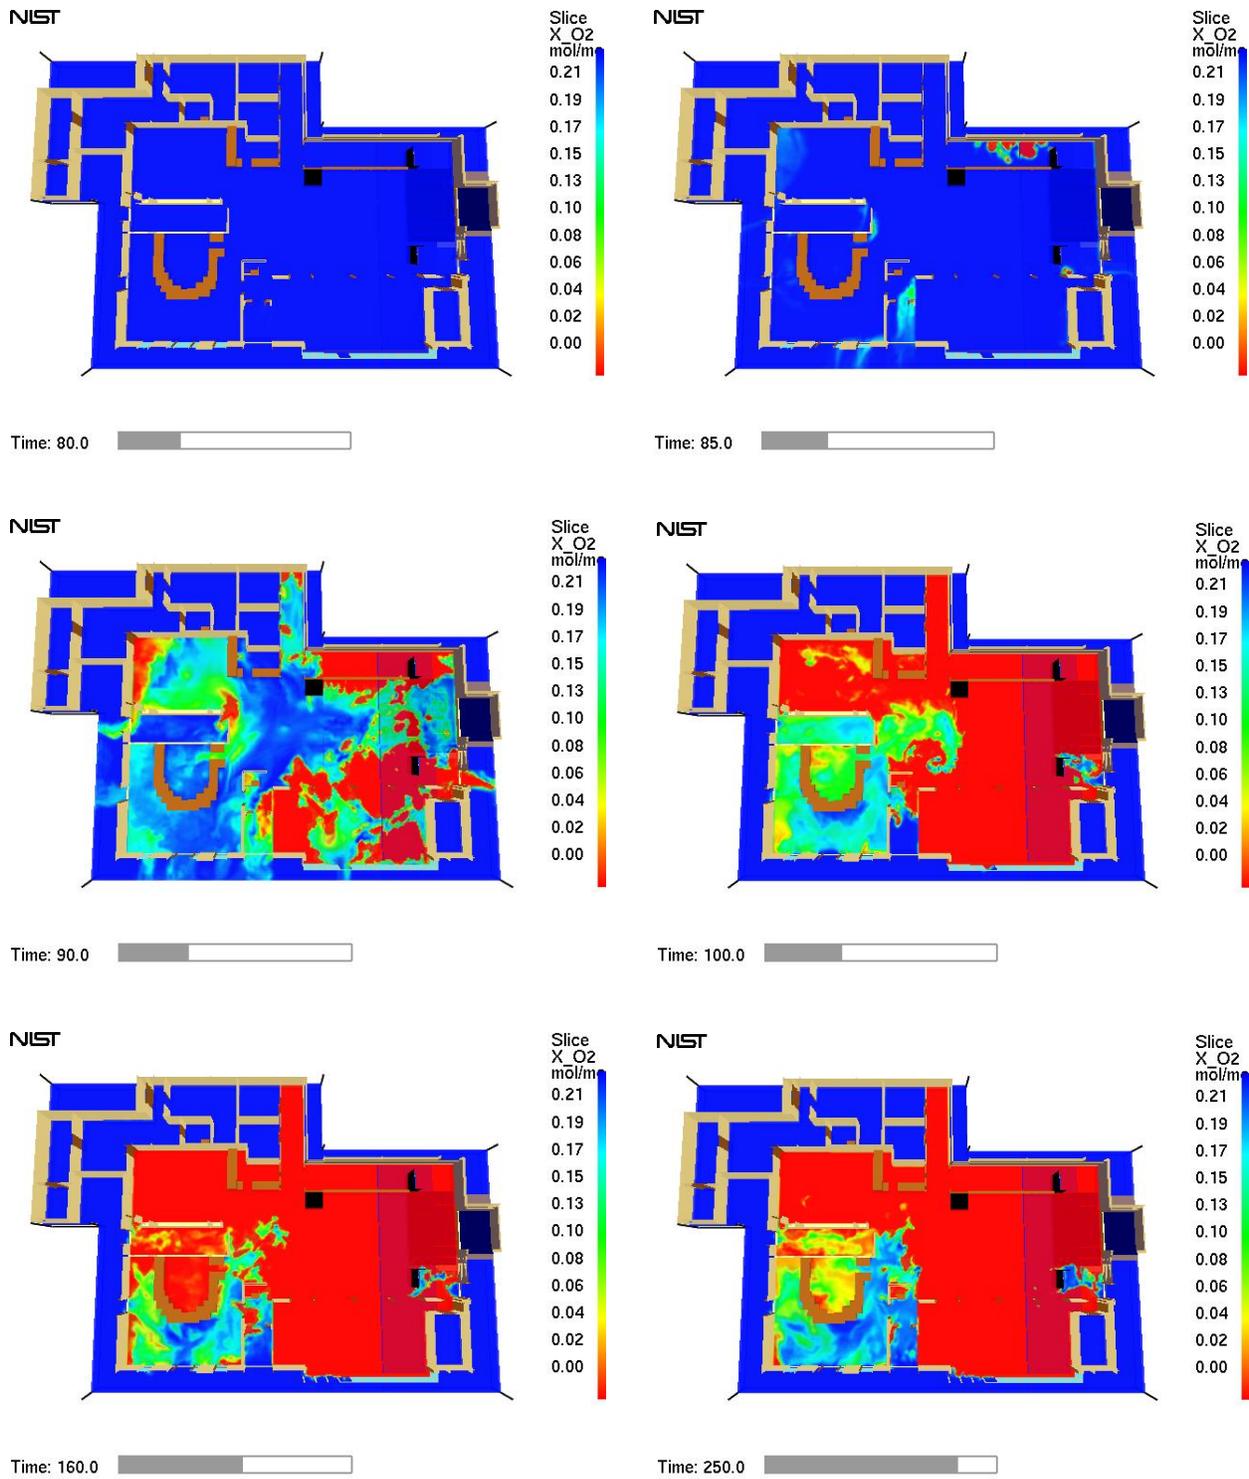
Figure 5-62 shows the predicted oxygen volume fraction 0.6 m (2 ft) above the floor, beginning at 80 seconds after ignition through 250 seconds after ignition. At this lower level it is apparent that tenability is also not likely in any area other than the main bar area and the entranceway right inside the front door. The opening of the windows at the front of the main bar room creates a more tenable atmosphere, probably saving the lives of occupants as they can be seen being pulled from the windows in the WPRI video. Occupants that stayed low in the main bar area had a better chance of survival.

The images in later in Figure 5-62, once again, show a rapid decrease in tenable conditions due to oxygen depletion throughout most of the simulated nightclub with the exception of the main bar room and the main entry foyer. Due to the open doors and windows in these areas, the simulation indicates that sufficient fresh air was drawn in to maintain a level of tenability with respect to oxygen in the areas adjacent to the open windows and the main entry way. This trend is shown to continue through the end of the simulation. In the WPRI video, the last person recorded being assisted through a window from the main bar room occurs at 250 seconds after ignition. This is consistent with the predicted oxygen concentrations near the windows.

Figure 5-62. Oxygen volume fractions at 0.6 m (2 ft) above the floor, 80 seconds to 250 seconds

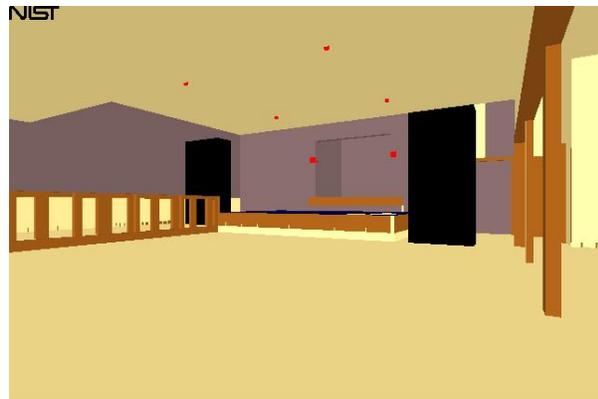
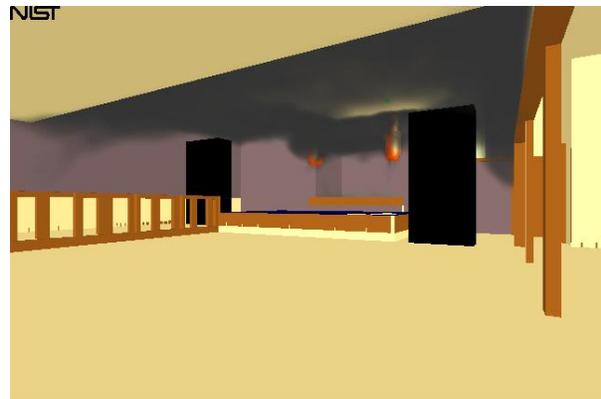
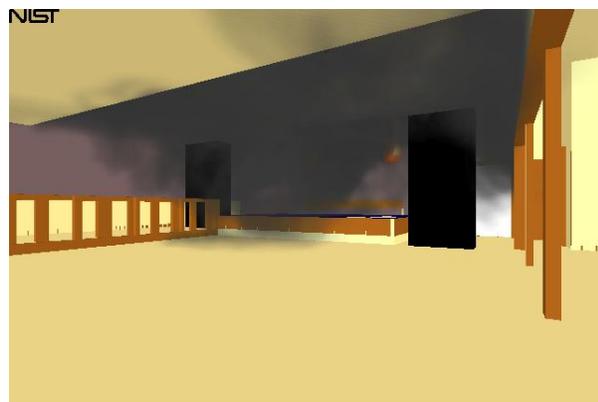
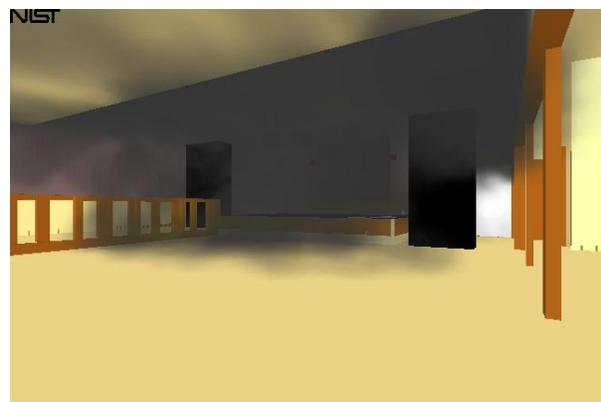
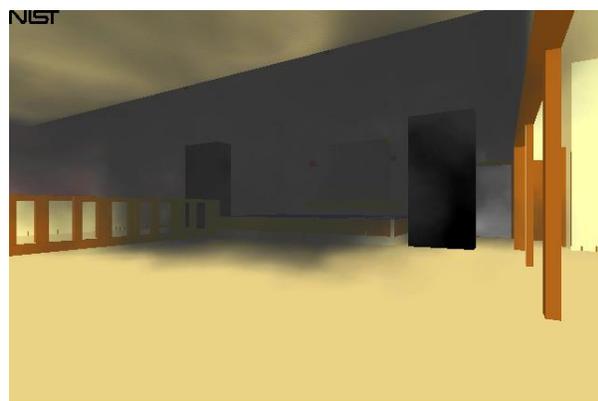
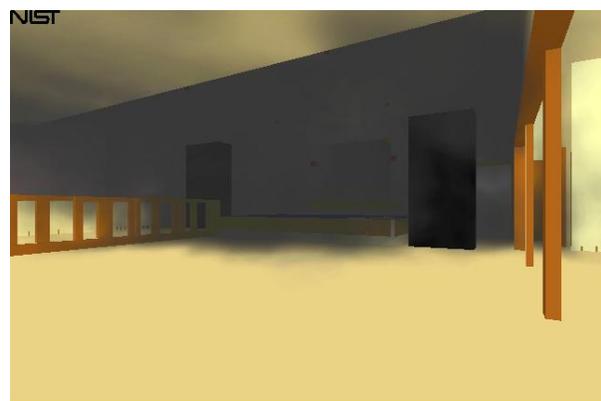
Figures 5-63a and 5-63b are rendered from Smokeview to examine the flame and smoke spread and the effect of the sprinklers. The images begin at ignition or  $t = 0$  seconds and continue until 100 seconds after ignition. The first image in Figure 5-63a shows the two sprinklers over the platform area and the two sprinklers over the dance floor as small red dots along the ceiling. The larger red areas on the platform walls represent the location of the ignition burners. The sprinkler located on the ceiling of the alcove is hidden from view. The second image rendered at 20 seconds shows smoke being pushed away at the first sprinkler, which activated at 16 seconds after ignition. By 30 seconds after ignition, three of the sprinklers had been activated. This caused some of the smoke to be pushed down to the floor. The two sprinklers over the dance floor area did not activate during the simulation. Figure 5-63b has images from 70 seconds to 150 seconds after ignition. During this period the fire was significantly suppressed. The series of images show the smoke dispersing. The fire was extinguished fully at approximately 114 seconds. The smoke continued to spread and is diluted by fresh air entering the area.

**Figure 5-63a. Simulation of nightclub with sprinklers, 0 seconds to 60 seconds**

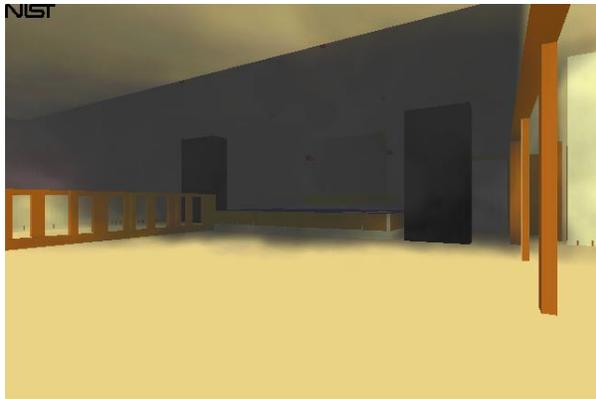
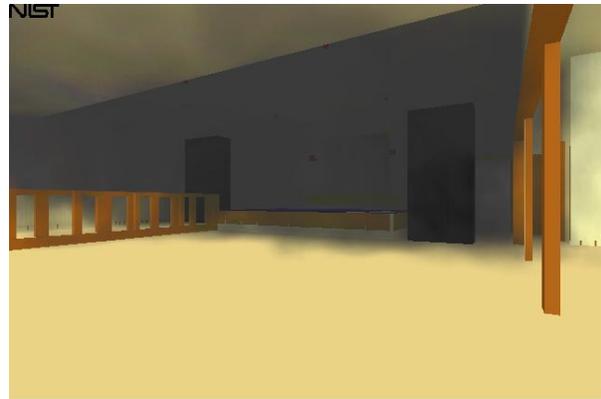
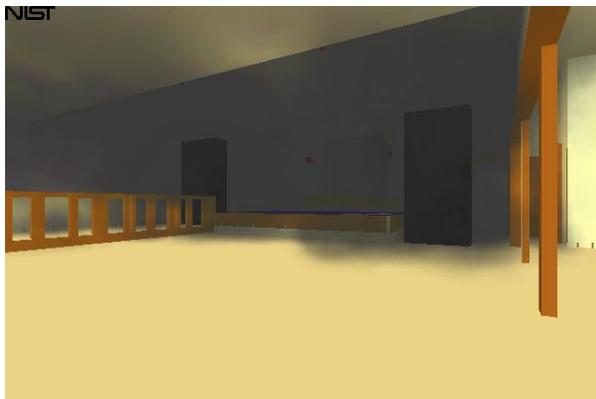
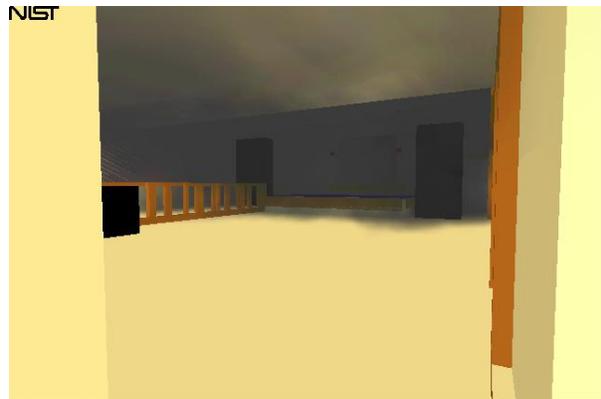
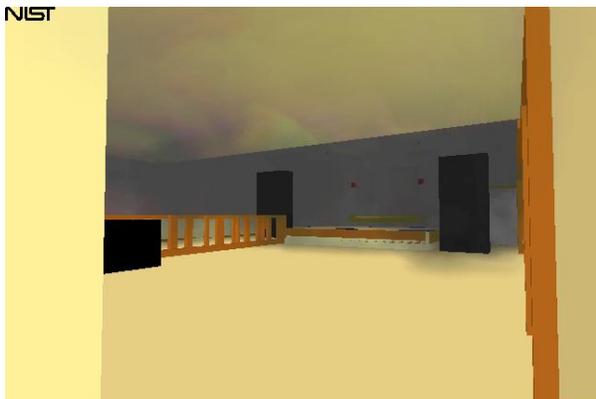
Figure 5-63b. Simulation of nightclub with sprinklers, 70 seconds to 150 seconds

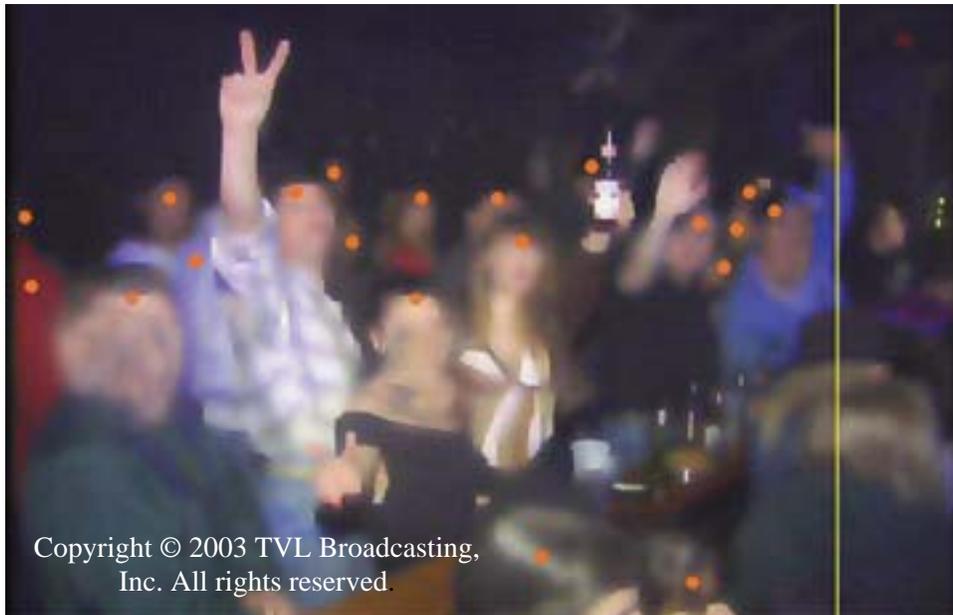
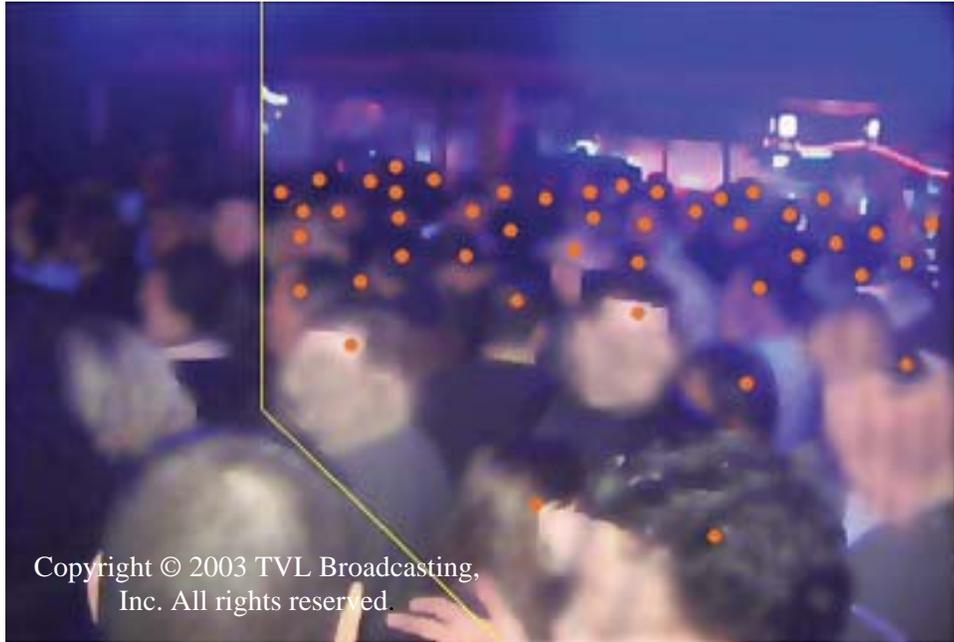
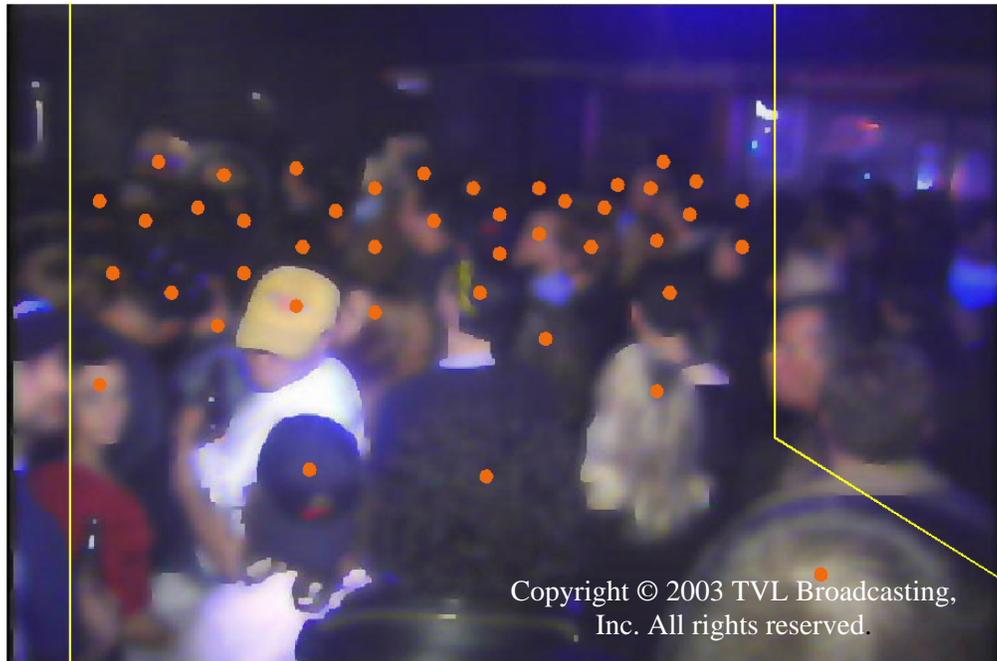
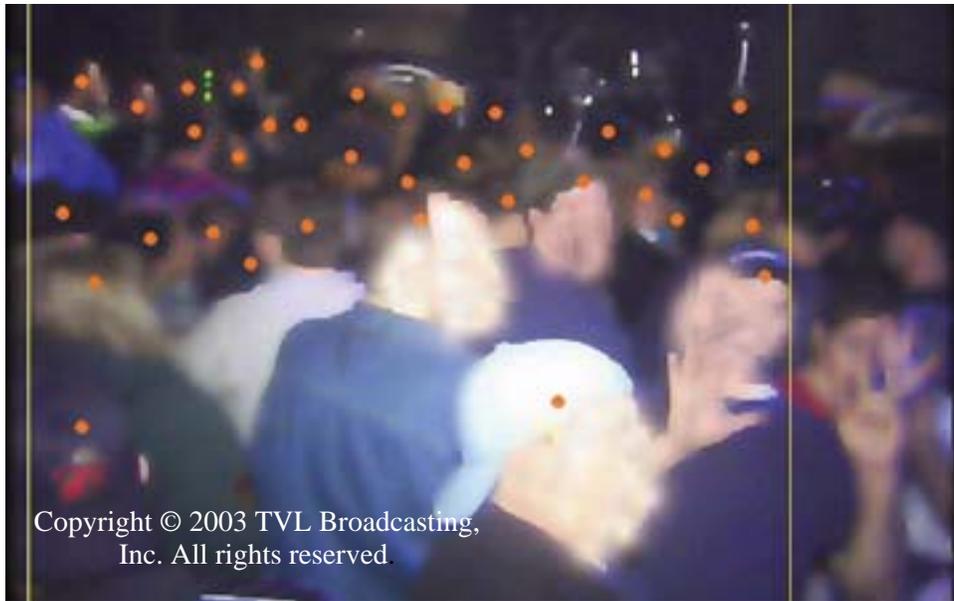
sequence in Figures 6-5 through 6-8 as the camera pans from right to left. The occupants shown in these still frames were counted in an effort to derive an approximate occupant load for the area shown. Orange dots have been used to represent counted occupants. The yellow lines in these Figures represent the boundaries where the frames overlap. A total of 144 occupants can be seen in these four figures. It is not clear at what time in relation to the start of the concert this video sequence was recorded. If it was recorded well before the main musical act, then it is likely that many occupants were located outside of the main platform viewing area at this time (i.e., many occupants may have been near one of the bars, in the pool room, or in the restrooms). Conversely, if this sequence was recorded immediately prior to the start of the primary musical act, then it is likely that the majority of the club's occupants would have moved towards the platform and into the performance assembly area. For these reasons it is not possible to extrapolate to a total building occupant load from this analysis. However, these figures can be helpful in estimating possible ranges of the number of occupants that may have been within the main platform viewing area.

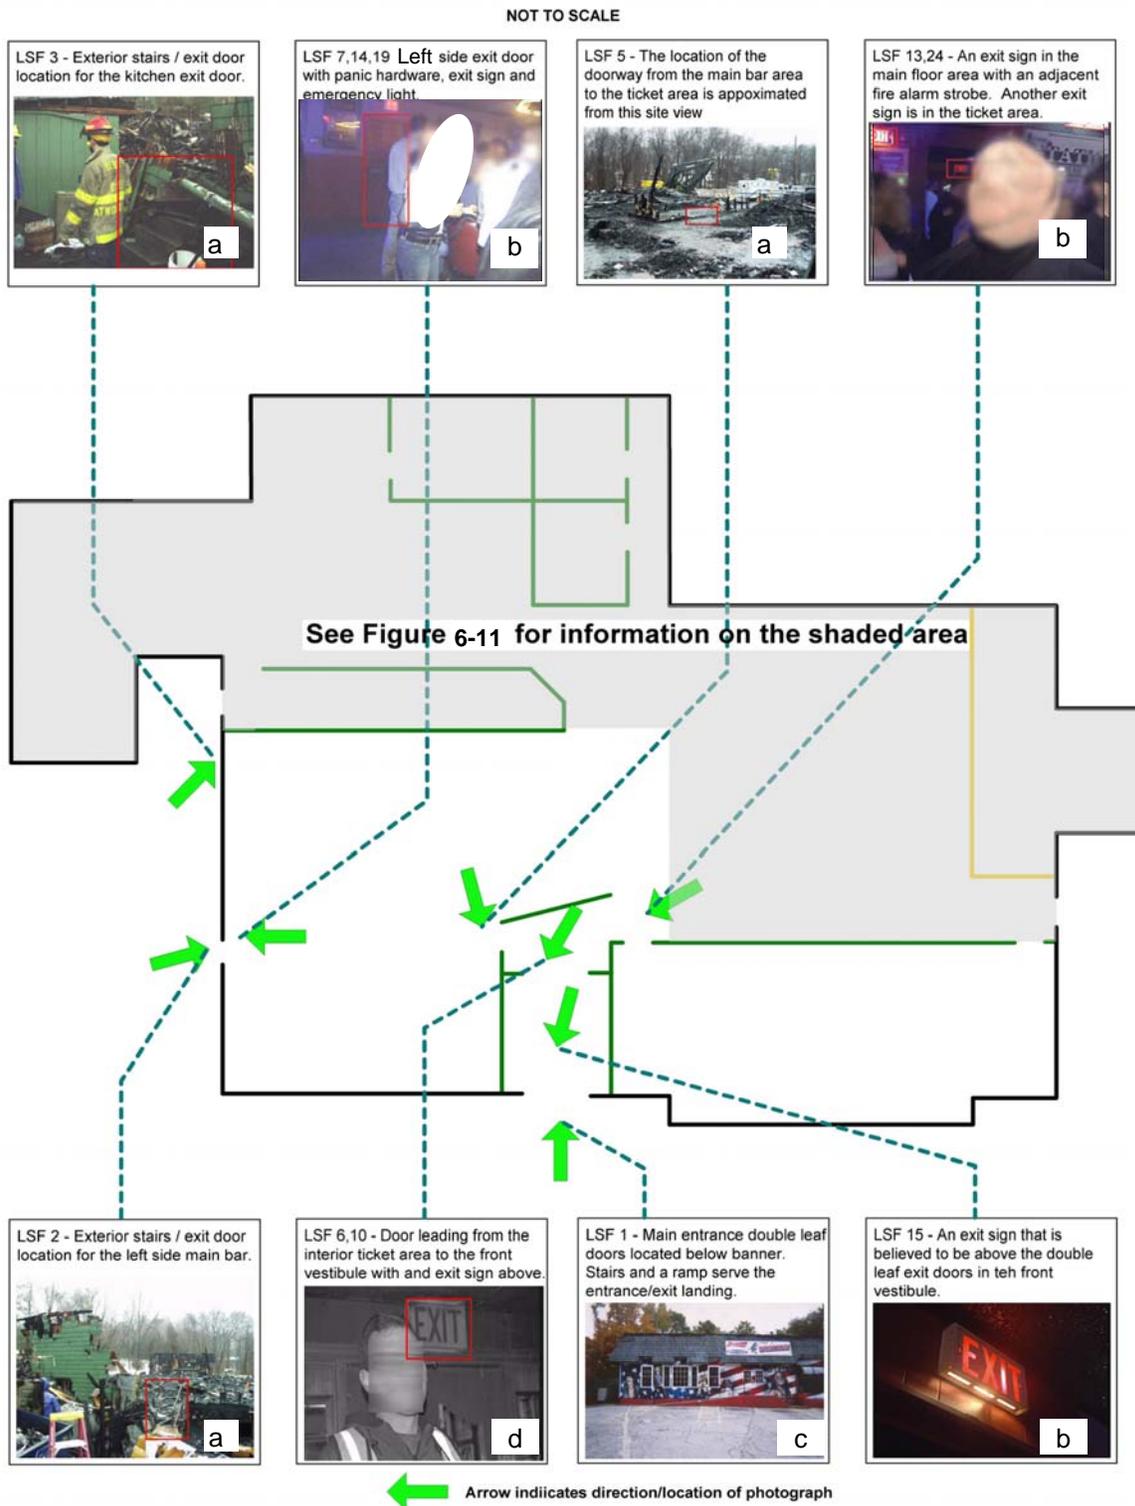
**Figure 6-10. Summary of Life Safety Features – Part 1**

Egress through the main entrance to the building was limited by a single interior door (LSF 6 in Figure 6-10) not the double doors that could be seen from outside the building.

LSF 9.	Exit sign located near the rear bar; it appears to be pointing toward the kitchen exit door.
LSF 10.	Exit sign above the door that leads from the ticket area to the front vestibule.
LSF 11.	Exit sign above the platform door. Note that in this image the sign is clearly illuminated.
LSF 12.	Exit sign above the platform door on February 20, 2003. Note that in this image the sign does not appear to be illuminated. NOTE: This is a duplicate of LSF 12, but was included to show that the exit sign may not have always been illuminated.
LSF 13.	Two exit signs. One located in the main floor area with an arrow towards the ticket area and another above the ticket area doors leading to the front vestibule.
LSF 14.	Exit sign over the left side main bar area exit door.
LSF 15.	Exit sign located in the front vestibule above the main double exit doors. This location is based upon similar wall and ceiling features observed in the WPRI video.

LSF 16.	Emergency light located near the rear bar.
LSF 17.	Emergency light above and to the right of the platform exit door.
LSF 18.	Emergency light on the wall adjacent to the kitchen by the main bar facing into the main floor area.
LSF 19.	Emergency light above and to the right of the left side exit door from the main bar area.
LSF 20.	Fire extinguisher located behind the rear bar.
LSF 21.	Detector (heat) located above the lighting grid on the ceiling near the platform.
LSF 22.	Fire alarm strobe adjacent to the exit sign above the platform exit door.
LSF 23.	Fire alarm strobe on the ceiling to the left and in front of the platform.
LSF 24.	Fire alarm strobe on the wall adjacent to the exit sign in the main floor area pointing toward the ticket area.

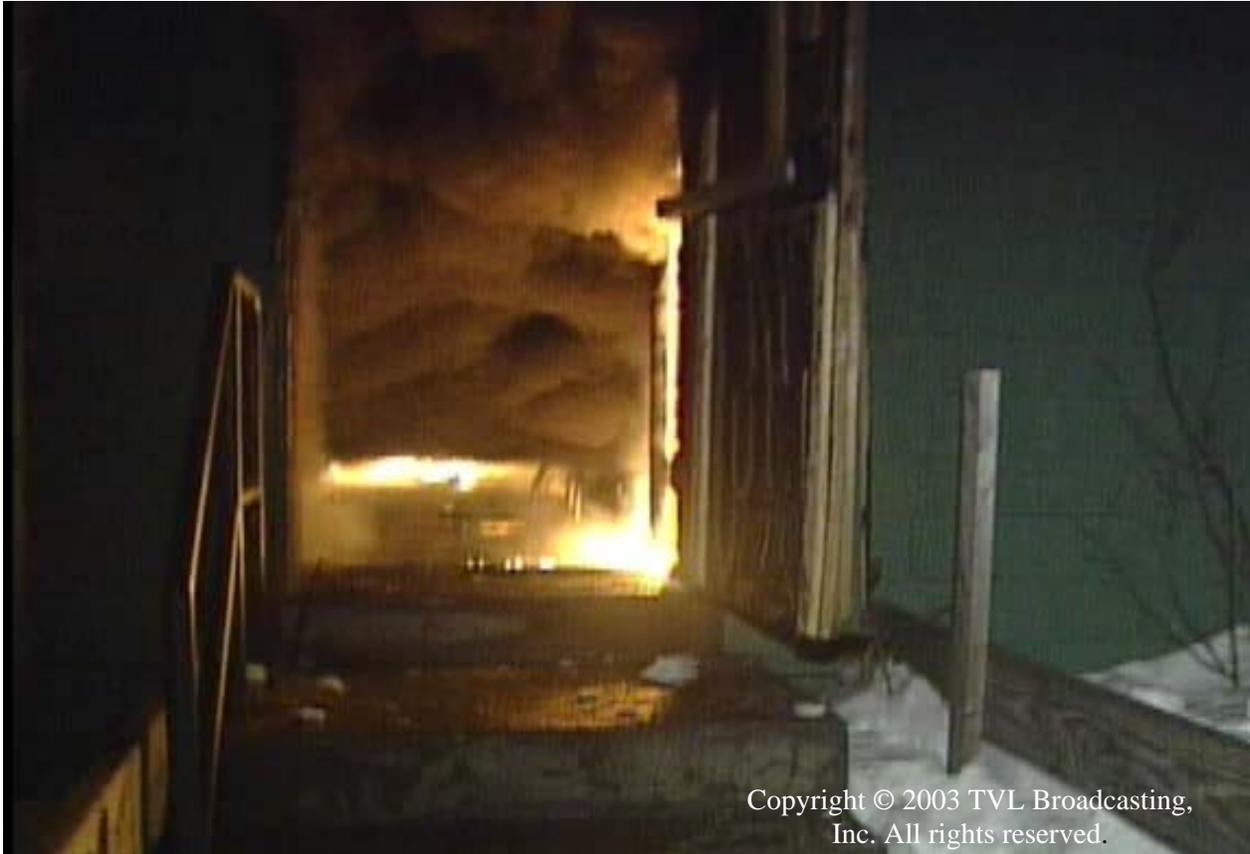
**Figure 6-13. Exit Door Near Platform [2]**

- Platform exit door swings in the wrong direction;
- Panic hardware on platform door is broken.

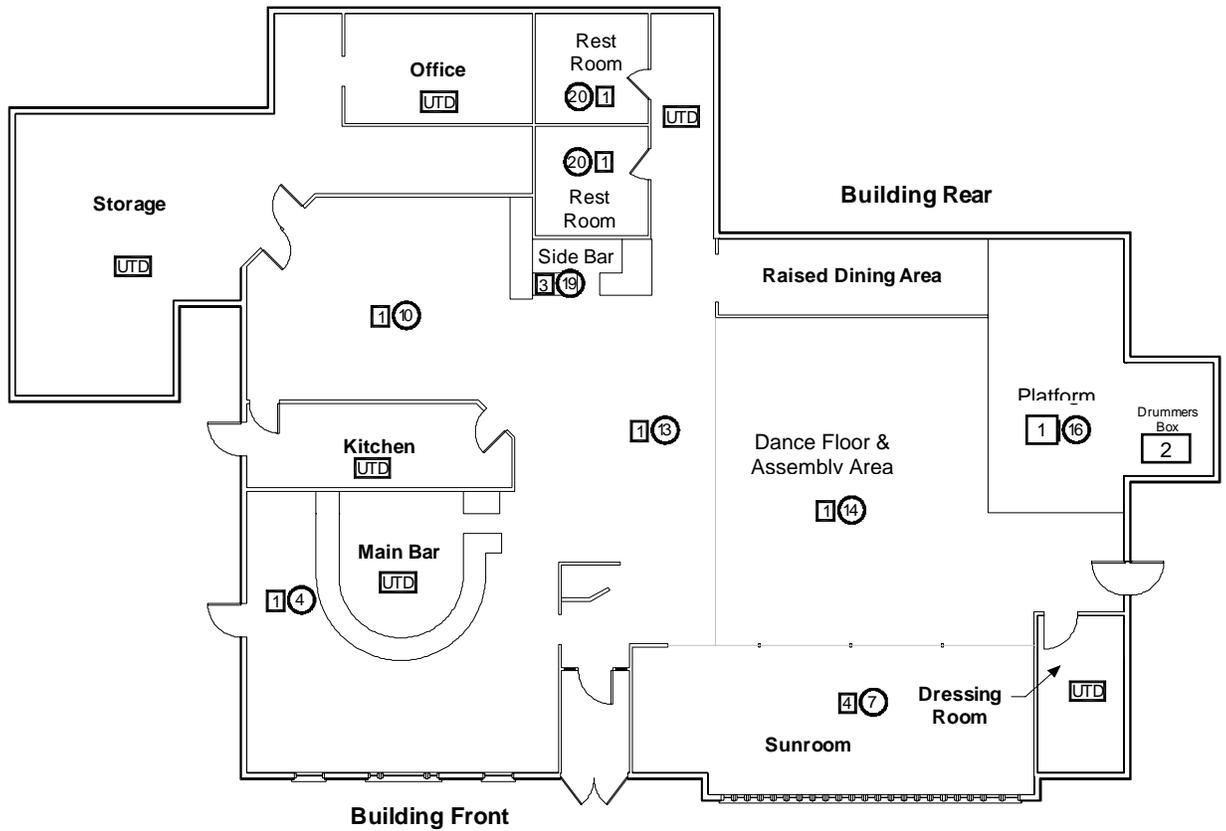
**Figure 7-1. Station Night Club Ceiling Interior Finish**

*Comment: As would be expected, the interior finish materials of the building varied greatly. The interior finish material was mapped and is shown in Figures 7-1 and 7-2. The interior wall finishes included wood paneling, bead board, painted gypsum, wafer board, and ceramic tile. Interior finishes were identified from photographic and video records. The finishes identified were estimates based on a video and photographs taken in the building. The finishes referred to as painted gypsum may be either gypsum wall board or plaster. Neither samples of products nor model and manufacture information were available. Accordingly, conclusions regarding flame spread ratings are based upon broad product categories. The ceramic tile and gypsum do not pose potential interior finish flame spread issues.*

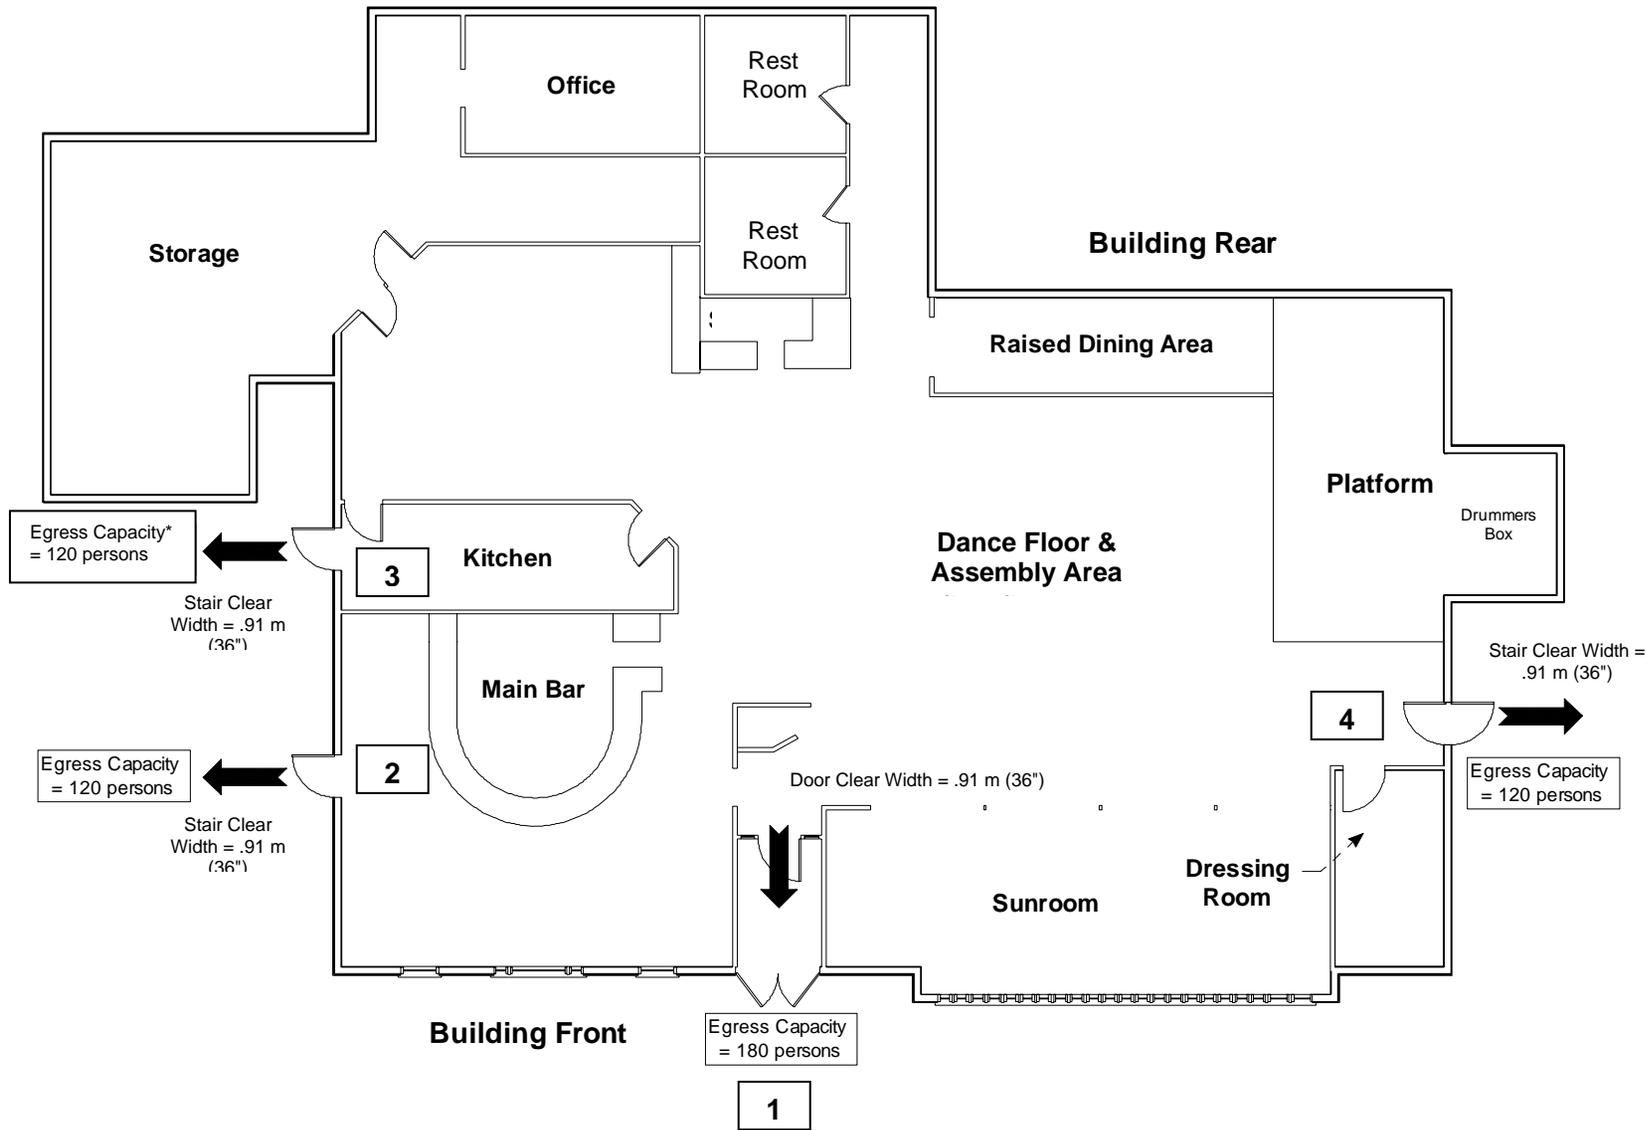
Figure 7-5. Station Nightclub Egress Capacity (\*Note that model codes exclude exiting through a kitchen when calculating occupancy limit.)

There were four exit routes from the building, as numbered in Figure 7-5: (1) the front main exit, (2) the main bar exit on the side, (3) the kitchen exit, and (4) the platform exit. The model codes govern their number, size, placement, and other details of design, as discussed in this section

*Comments: All doors exceeded the 0.81 m (32 in) minimum, and all door leaves swung in the direction of egress travel with the exception of the interior leaf at exit 4. (See Fig. 7-5.)*

*Comments: When viewed from the exterior, the right leaf of the front doors was not equipped with panic hardware. There was no visible hardware on either door. As of this writing, the type of hardware on the swinging door immediately inside the double exterior doors is undetermined. (See Fig. 7-5.)*
